# Structural analysis of the baroque parish church of Zsámbék

Miklós Armuth / Dezső Hegyi / András Árpád Sipos

## Abstract

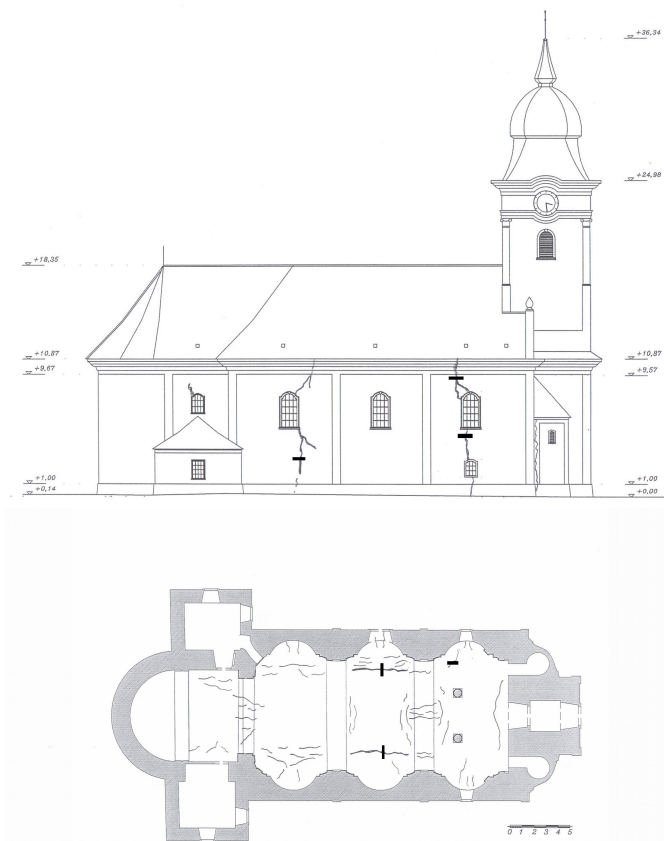
The main failures of the structural walls are vertical cracks, typically located around and above the windows (Fig. ??). The largest cracks appear in both longitudinal walls at the windows closest to the tower. The width of these cracks is between 0.4 and 0.7 mm. There are more cracks on the NW wall facing to the main road of the village; several cracks can also be found around the vestry.

The vaults above the nave have longitudinal cracks of 1.0-3.0 mm width. These cracks also appear on the arches supporting the vaults.

**Fig. 5.** The patterns of the visible cracks on the structural walls and the vaults (black boxes on the largest cracks)

The higher settlement due to the higher stresses in the soil around the main entrance separates the tower and the connecting part of the nave from the remaining walls. This separation takes place at the weakest cross section of the nave walls, namely at the location of the closest window to the tower (Fig. 5). At this point, not only the opening for the window, but the narrower width weakens the wall. Furthermore the different layering of the soil leads to an uneven settling under the foundations resulting in additional stresses in the masonry.

As we mentioned before, the higher settlement under the tower is one of the reasons for the movements. It explains the location of the largest cracks. This kind of failure is typical among churches built in a similar manner. However, the displacements have not just originated from settling. The separation of the tie rods and the main truss is a serious defect. Although the walls are safe from the horizontal reactions transferred from the vaults, the reactions lead to considerable horizontal displacements. These movements have generated the cracks on the lower surface of the vaults.

To limit the further increase in the crack widths and the occurrence of new cracks the tie rod connection between the arches and the main trusses of the roof must be restored. The position of the masonry around the cracks should be fixed by the application of steel elements. We suggest using the “Brutt Saver” system for this purpose. To assist the distribution of the horizontal loads steel Ø30mm bars should be placed on the top of the walls. Steel plates are needed at the end to provide efficient anchorage for the bars. A slight prestress should be applied to the bars, and a device for future prestressing should be integrated.

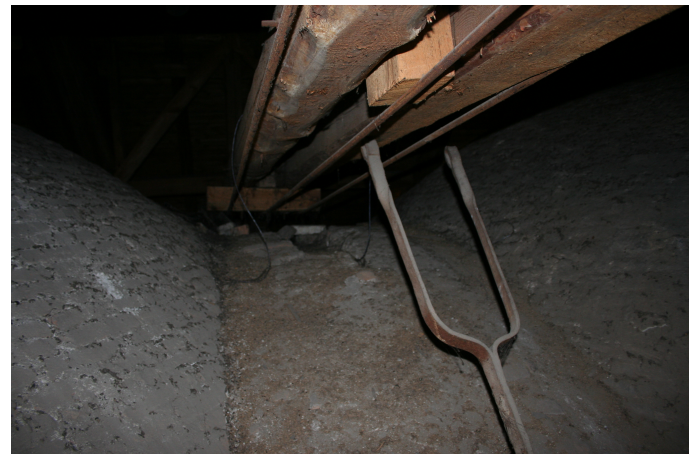
The major failure of the timber roof is the disconnection between the masonry arches and the main rafters. Originally, inclined tie rods were connected to the main trusses to support the horizontal reactions of the main arches (Fig. 6). This structure has been modified several times resulting in a higher position of the tie beams of the main trusses and separation of the inclined tie rods and the main trusses.

**Fig. 6.** Disconnected tie-bar over a main arch.

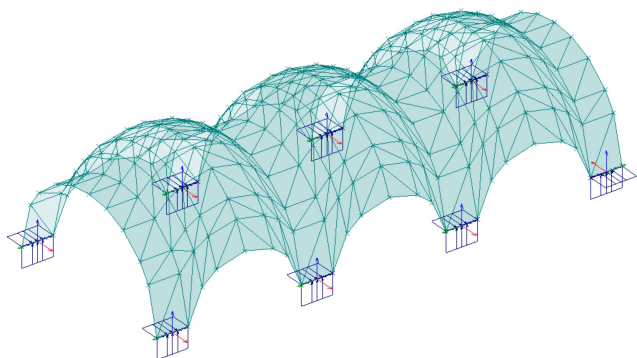
Although there is comprehensive literature on modelling vaults [7, 8], to gain a detailed insight to the structural behaviour the structural analysis was carried out by a finite element code FEM Design 8.0. We used triangular plate elements to model the vaults and the arches (Fig. 7). Due to the unclear connection between the structural walls and the vaults we applied a hinged line support only below the arches. The computational results confirm that the resistance of the masonry vaults is satisfactory in all the relevant load combinations.

Fig. 7. The FEM model of the vaults and the arches

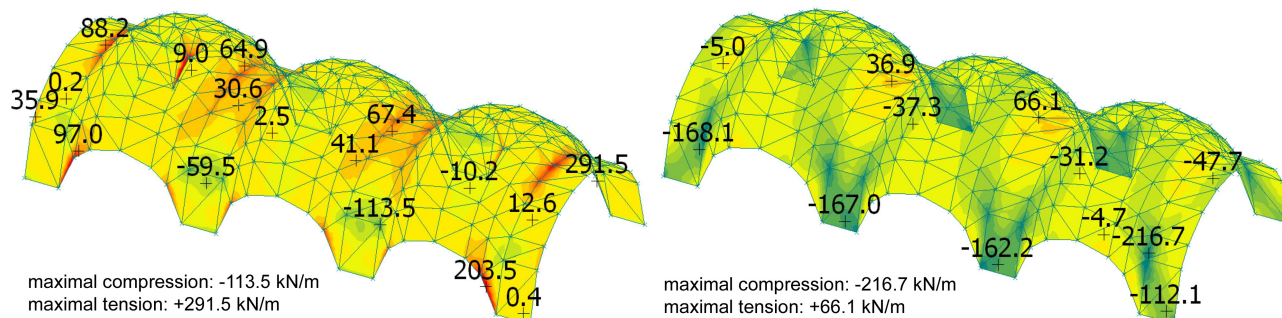
Due to the separation of the tie rods, the horizontal reactions of the vaults and arches are transferred to the top of the structural walls. The thrust computed for this load remains inside the wall and the maximal stress does not exceed 4.0 MPa thus the structure can be regarded as safe.

**Fig. 8.** The computational results: the maximal principal surface forces  $N_1$  (on the left) and  $N_2$  (on the right)
