Report about the architectural survey of the Parish Church of the settlement of Sanvignes-les-Mines

László Daragó / Dániel Bakonyi

Abstract

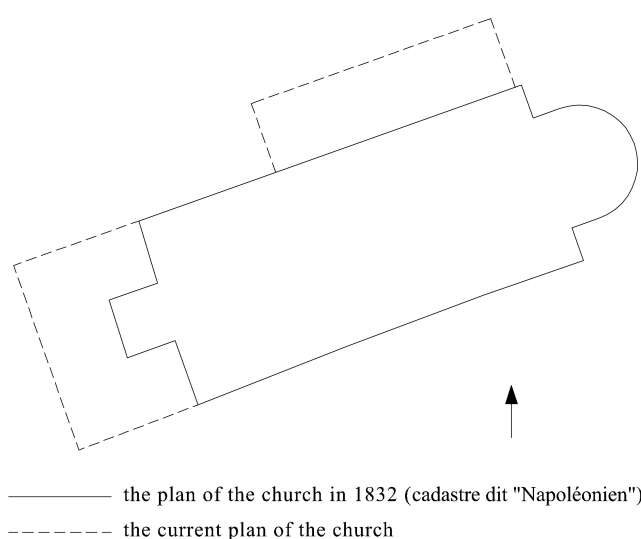
Fig. 2. The comparison of the survey plans from before and after the 19th and 20th century building works

The western facade of the church shows other oddities: the probably medieval doorway is framed into a 19th century wall-structure. A comparison of survey plans made from the area before and after the 19th century reconstruction shows, that the church was elongated with one bay to the west.

The whole gateway from the original western facade was moved to a new position. Another addition is the sacristy on the northern side that covers the northern wall of the transept and two-fifths of the nave.

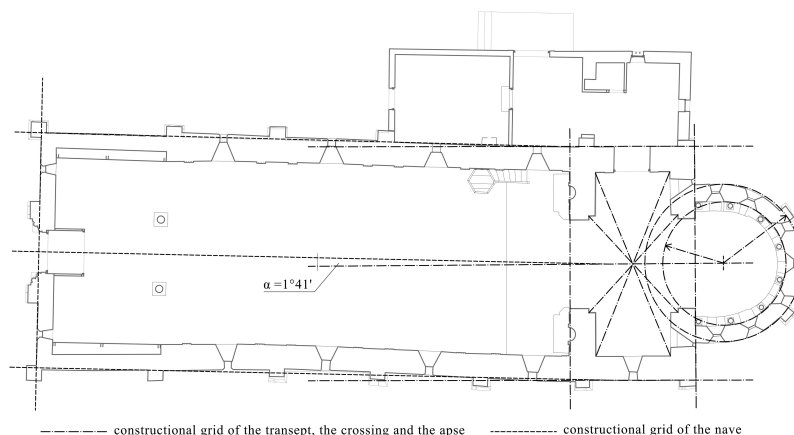
Fig. 3. The constructional grids of the church

Two major grid-systems can be observed on the building. The first is the grid staked out by the transept and the apse. The overlapping of the centre point of the apse and the longitudinal axis of the transept proves their common coordinate system.

The second grid is determined by the longitudinal walls of the nave. The 19th century addition to the western end of the nave and the current western facade also followed this system. The longitudinal axis of the nave is pointing directly at the centre point of the crossing, but it is rotated 1°41' to the north. At first glance, the curved walls of the nave do not seem to follow any kind of system, but on closer examination it is clear that the base of the northern wall is clearly following this second constructional grid, only the top of the wall is pointing in a direction further to the north due to a later deformation. Even the "S" shaped southern wall is in accordance with this system if we draw a line joining the two ends of this wall (between the transept and the end of the fourth bay of the nave).

This second grid could be the result of an incorrect staking out, because, as we see later, the nave belongs to a later building period than the transept and the apse. The curvature of the southern wall was probably caused by trying to connect the wall of the transept and the shifted western grid.

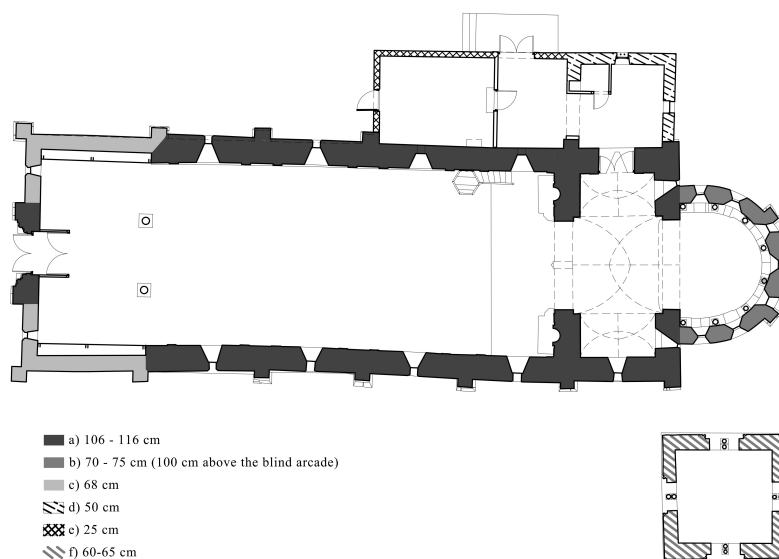
Fig. 4. The different wall thicknesses

According to the wall thicknesses, six different groups can be determined:

- a) The first is the transept and the first four bays of the nave. They have the thickest construction of all: between 106 and 116 cm. The dimensions of the longitudinal walls of the nave are hard to determine, because of their deformations, and the fact, that their internal and external surfaces are not always parallel (probably later corrections trying to mask the deformations). The medieval gate at the western facade also has the same measurements.

- b) The second group is the wall of the apse. Its thickness is 70 to 75 cm behind the false arcade, but 106 cm over the cornice and underneath at the plinth (which corresponds to group one).

- c) The western wall of the church and the last bay of the longitudinal walls have a thickness of 68 cm (40 cm for the gable wall).
- d) The eastern part of the sacristy has almost the same dimensions; its walls measure 50 to 60 cm.

- e) The western part of the sacristy, which is a 20th century addition housing the heating centre for the church, is only 25 cm thick.
- f) The walls of the bell tower measure 70-80 cm.

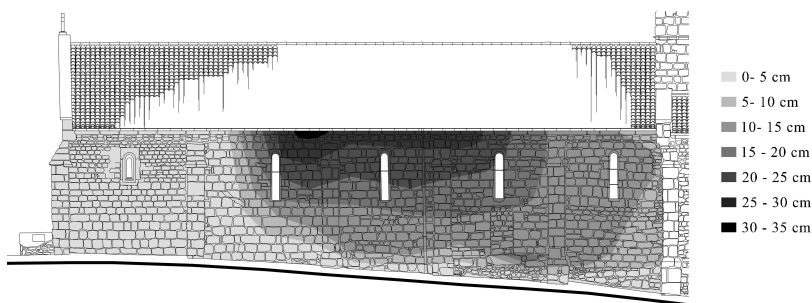
Fig. 5. The inward tilting of the nave's southern longitudinal wall (relative to the plinth)

As previously mentioned the two longitudinal walls of the nave show significant deformations. The southern longitudinal wall of the nave has an “S” shaped plan and it is tilting inwards (Fig. 5), while the northern wall is tilting outwards (Fig. 6). Therefore, they lean more or less parallel to the direction of the valley north of the building. Again, it has to be mentioned, that the nave was never vaulted, and even if it were, that would not explain the direction of these deformations. A much likelier explanation would be foundation problems. The hill, where the medieval fortress and church of Sanvignes was built, has a sandstone base that provided the raw material for the walls. The stone formations can even be observed on the surface along the road running past the church. The transept and the apse seem to be resting on this stone base (parts of the foundation are visible because the surrounding terrain was deepened). Perhaps the foundations of the western parts of the nave did not reach this stone base, and as a result the walls started to lean over and the southern wall may even have started to slide towards the valley. With the help of the digital tachymetry, these deformations could be measured very precisely in three dimensions. Figs. 5

On the southern facade, the wall of the transept is still vertical; as we head west the tilting starts to increase, but just before the fourth buttress of the nave the wall suddenly becomes vertical again. This is not surprising, if we consider that the western facade originally stood at this point, perpendicular to the direction of the deformations and it must have stabilised the end of the longitudinal wall helping it to remain vertical. The last bay is a later addition that did not suffer the same foundation problems, so it also remained vertical.

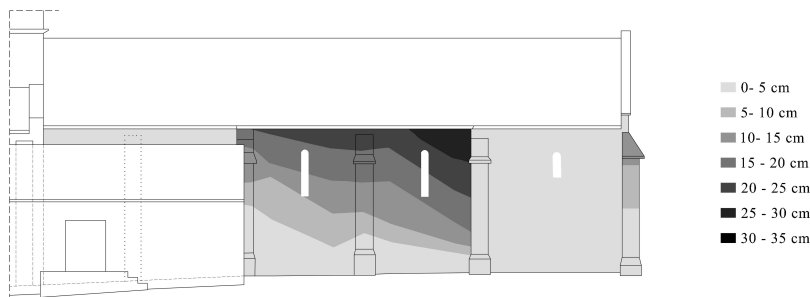
Fig. 6. The outward tilting of the nave's northern longitudinal wall (relative to the plinth)

The northern wall shows a different picture. The first two bays of the nave (heading from east to west) are almost entirely hidden by the sacristy. However, the last few rows of stone under the cornice are visible and their measurements compared to the plan show that this part of the northern wall remained vertical. This changes abruptly at the second buttress, the top of which is tilting nearly 25 cm towards the valley. This is only possible if these two parts of the wall are in fact separate constructions. In this case, the vertical part of the wall must be a later structure replacing the original first two bays of the wall,

which had collapsed or had been demolished. The sudden step in the exterior surface is not visible from the inside of the nave; later renovation works must have masked it, which explains the varying thickness of the longitudinal walls.

Unlike the southern wall, the northern wall shows the biggest tilting right at the point before the fourth buttress of the nave, where the western facade once stood. Because the northern wall was moving outwards, the resulting tensile forces could have

split the longitudinal walls away from the original western facade.

The 19th century walls of the last bay are once again vertical. Only the buttress in the north-west corner of the church is tilting outwards. Both of the corner buttresses at the western facade are positioned quite untectonically, they are barely interwoven with the rest of the masonry and north-west buttress is starting to dislocate from the rest of the construction.

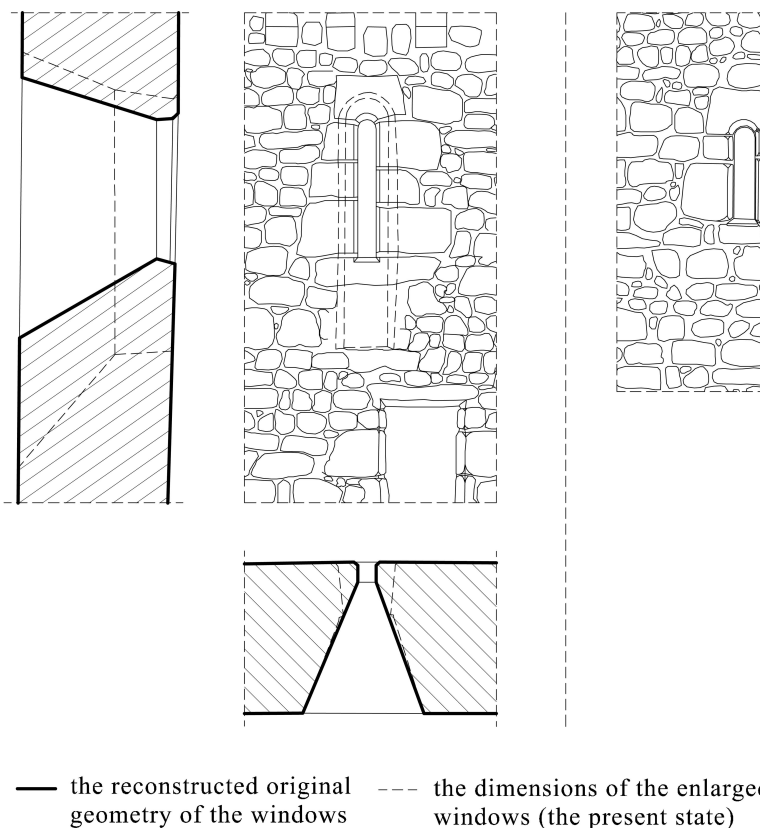
Fig. 7. left: the reconstructed geometry of the southern window of the transept right: the western window of the transept

The windows on the transept's and the nave's longitudinal walls have different, rather gothic proportions. A closer observation reveals, that they have all been altered, except for the northern window of the transept, which was walled-in when the sacristy was built. Fig. 7 shows the reconstruction of the opening's original geometry based on the unaltered northern window. It appears that all of the windows were fashioned after the eastern windows of the transept, and it was probably only during the 19th century, when the church was glazed, that they were elongated and widened to let in more light. That is probably when the four new windows of the apse were also opened.

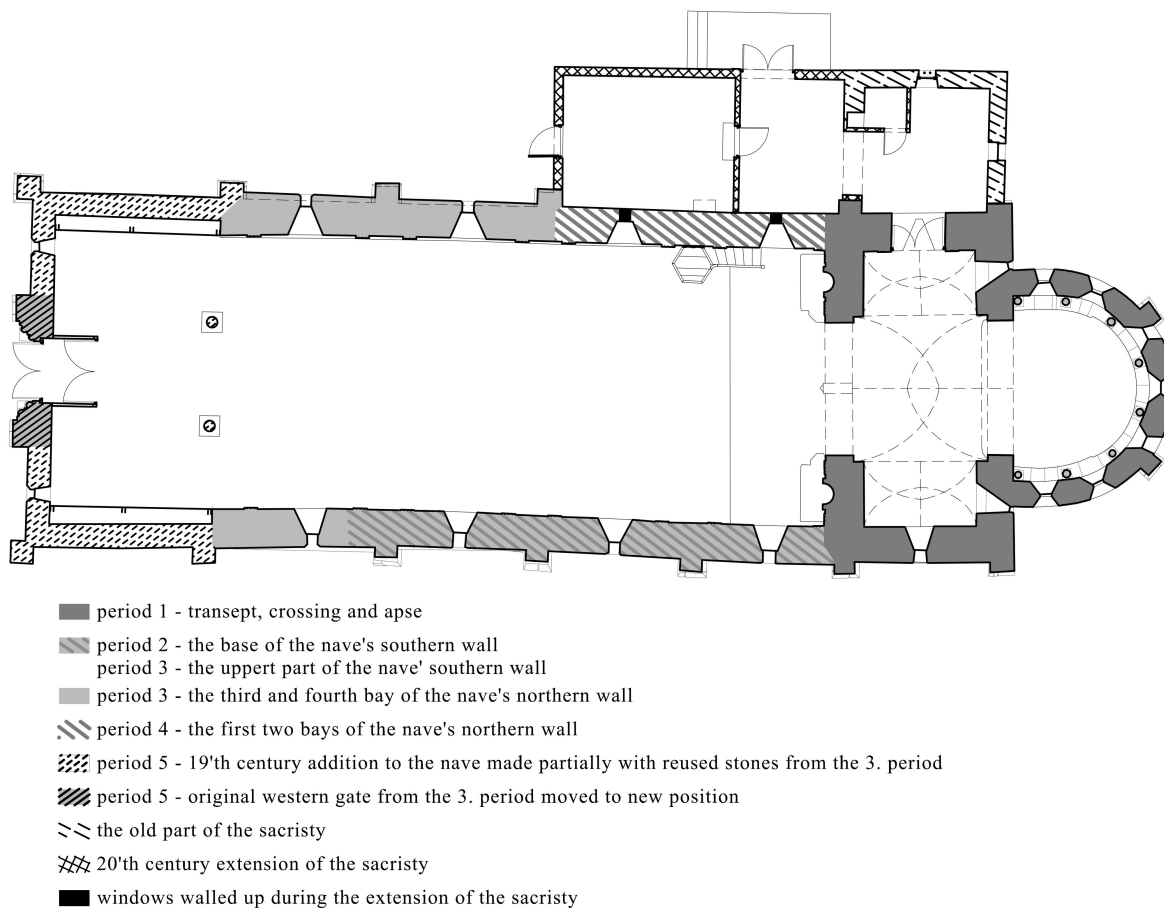
Fig. 9. Hypothetical periodisation of the church of Sanvignes, ground plan.

Period 1) The oldest parts of the church are unquestionably the transept, the crossing and the apse. The bell tower had not yet been built and the whole transept was probably covered by a single gable roof with the ridge pointing lengthwise. Whether Period 1 had an original nave is an open question.

Period 2) The bottom parts of the nave's southern wall belong to this period, and they are clearly a separate construction from Period 1. These walls already show the shifting of the constructional grid. The shape of the wall indicates that this constructional phase was simply not finished, perhaps due to insufficient funding.

Period 3) This period consists of the upper parts of the nave's second wall, the 3rd and 4th bay of the northern wall, the original western wall of which only the gateway remains, and the bell tower. Comparing the sculptured parts of the western gate and the apse, it is probable that the first three building periods followed each with relatively short intervals. The differences in the wall textures of these parts could be the result of different masonry workshops, otherwise the result is architecturally quite coherent.

Period 4) The 1st and 2nd bay of the nave's northern wall is a later substitution, which is revealed by the analysis of the wall tilting. The original wall probably had to be demolished because of the deformations. The age of this substitution is unclear. The masonry mimics the medieval wall of the transept, and it is certainly not a 19th century construction. It is possible that it belongs to the 1788 reconstruction works.

Sacristy 1) The old part of the sacristy was built sometime during the 19th century at the northern end of the transept; the northern window had to be walled-in. The sacristy's unplastered eastern wall suggests that it tried to mimic the medieval masonry of Period 1. The eastern window appears to be of a later origin, the original door probably faced westward.

Period 5) The extension of the nave belongs to this period: the last bays of the nave's longitudinal wall, the wooden gallery, the new western facade and the reconstruction of the bell

tower's western side. The old western facade was probably demolished to give way for the extension, and some of the stone material was reused in the new constructions. According to the few written documents and the old survey plans depicting the church, this took place towards the end of the 19th century.

Sacristy 2) The extension of the sacristy is a fairly recent 20th century construction. The first two windows of the nave's northern wall had to be walled-in and the first buttress chiselled away.

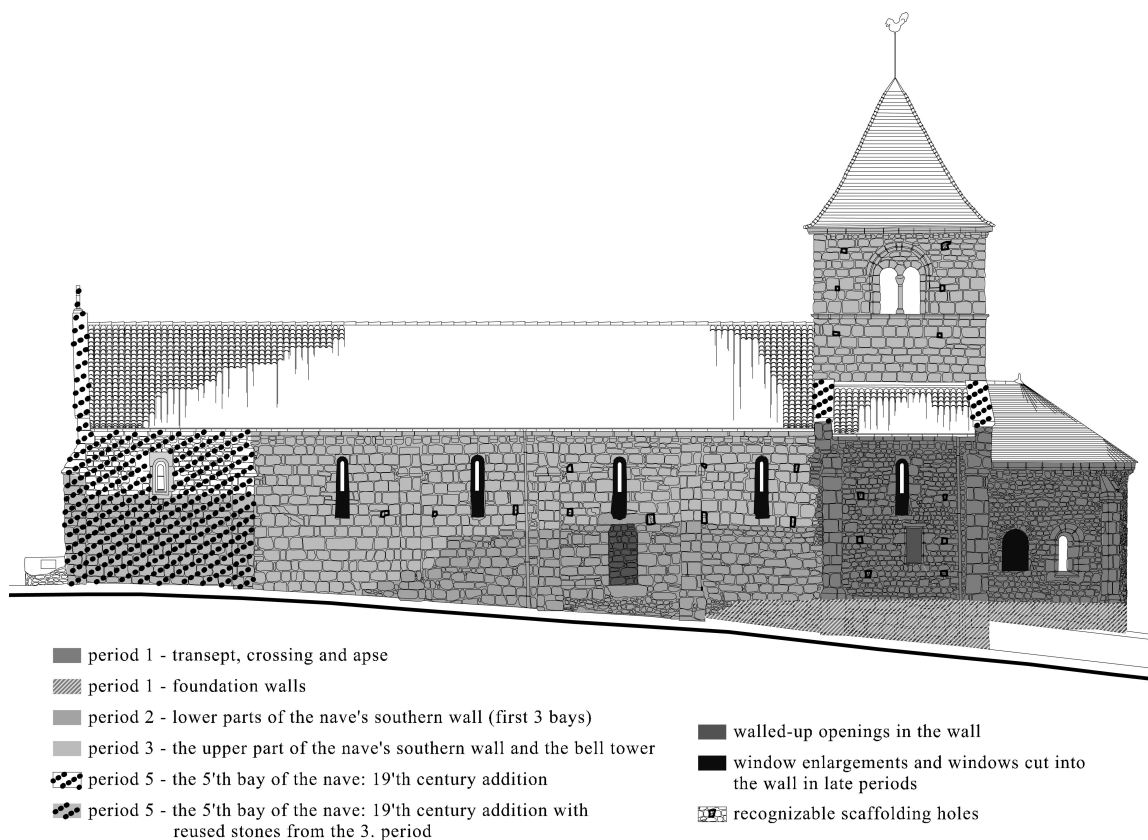
Fig. 10. Hypothetical periodisation of the church of Sanvignes, southern facade.

The tilting of the walls suggests that the problems with the nave's foundations started at this point, since the tilting during the southern wall's 2nd and 3rd period is quite homogeneous. Nevertheless, the nave must have suffered significant damage.

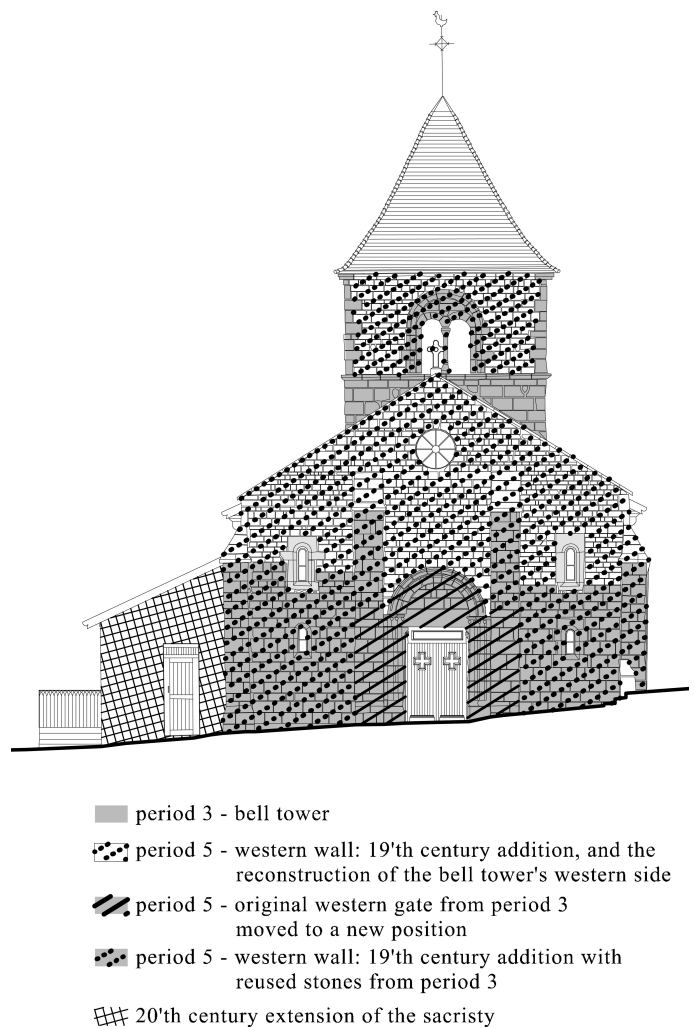
Fig. 12. Hypothetical periodisation of the church of Sanvignes, western facade.

The western gate and its surrounding wall is clearly of medieval origin and it belonged to a much thicker construction. However, the perfect interweaving with the rest of the western wall indicates that it was relocated stone-by-stone to its present status.

- f) The western side of the bell tower's upper level between the cornerstones appears to be a substitution. The masonry is identical with the 19th century structure of the western facade. Only the twin-arched window looks original, nevertheless the trunk of the dwarf-columns has clearly been replaced, and an upside-down capital was used as a base.
- g) The eastern wall of the sacristy seems to mimic the oldest medieval masonry of the apse and the transept. It is made of irregular stones of varying size and shape laid down in wavy rows. The corner ashlar are not very different from the regular elements and the sharp edges reveal their relatively recent origin.
- h) The northern and western walls of the sacristy are the only plastered surfaces on the exterior of the church.
