Report about the Architectural Survey of the Parish Church of the Settlement of Chiddes

RESEARCH ARTICLE

Romanesque ecclesiastic architecture, architectural survey, building archaeology, Chiddes

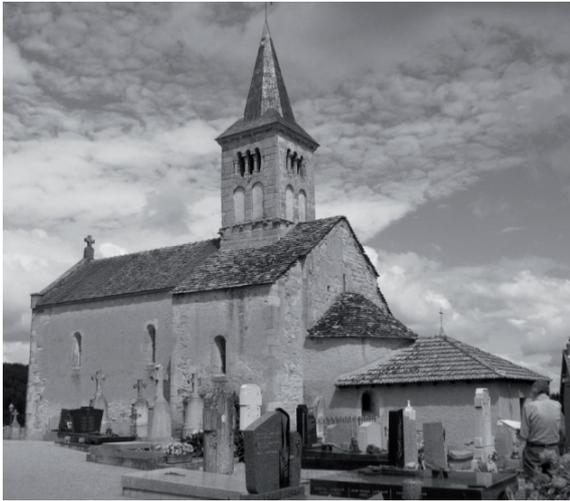
Fig. 1 The parish church of Chiddes

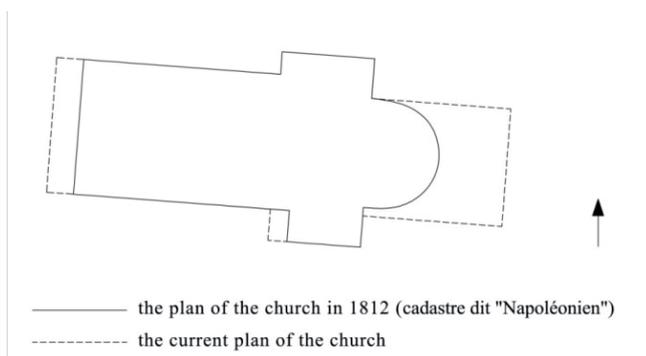
The 1812 survey (Fig. 2) shows a somewhat different state from what can be observed today. The nave seems to be somewhat shorter and the sacristy is missing – since it is a 20th century addition. However, the most interesting part is the southern transept, which appears to be smaller than its present state with its south-western corner missing. Granted, this could be just the result of some inaccuracy of the survey, but it could also be interpreted as an evidence of a real structural deficiency. As we will see later, there are some other findings that support the latter hypothesis.

Fig. 3 Comparison of the 19th century survey plan with the current one

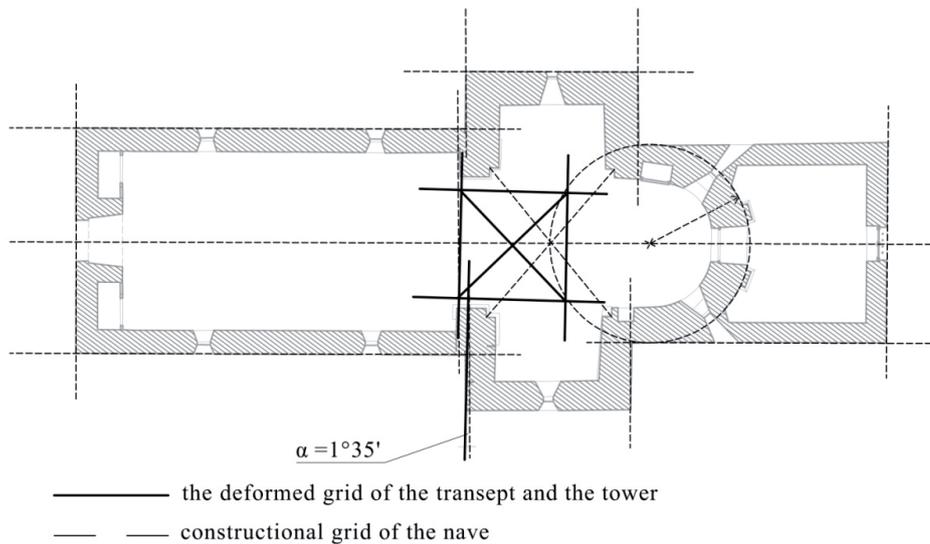
Analysing the orientation of the different parts of the church for the first time, one may be tempted to conclude that it is best described by a single grid-system. The longitudinal axis of this grid is staked out by the centre-point of the apse and the centre-point of the crossing. This grid also fits the apse, the northern transept, the eastern wall of the southern transept, the entire nave and with some tolerance: the sacristy. The interior surface of the eastern wall of the southern transept shows some deviation from the direction of this grid but only near the floor. This may be caused by a slight increase in the wall thickness or

Fig. 4 The constructional grids of the church

the plastering as a result of some correctional restorations. At any rate, this irregularity is so small that we cannot draw any far-reaching conclusions on this basis.

However, there are some parts that break this rule and can be regarded as following a slightly different system. This “deformed” grid seems to be twisted clockwise from the general grid. The western wall of the south transept and all parts of the tower belong to this deformed system. The deviation seems to increase towards the south-western corner of the transept where it reaches a maximum of $1^{\circ}35'$ from the original grid. Almost no perfectly parallel or perpendicular lines can be observed here, except for those parts mentioned earlier that fit to the main system.

It is confusing that there are elements belonging to the same structure (e.g. the transept or the crossing) but defined by different grids. This can either be the result of poor quality workmanship by the medieval masons (an inexact staking out), or the deformation of the construction in later times. The nature of these deviations is unlikely to be a result of only an inaccurate staking out as they are much too large for that, especially if we consider the accuracy of the rest of the medieval parts. The overlapping of the centre of the crossing with the chief grid of the non-deformed parts of the church indicates that the main grid was the original system used by the builders in the earliest building period, but subsequent deformation and perhaps reconstructions of *certain parts* departed from the original geometry. The key to answering the question of the grids is to analyse them together with the structures, the wall textures and the possible constructional periods and see whether we can find believable explanations that fit all of the findings.

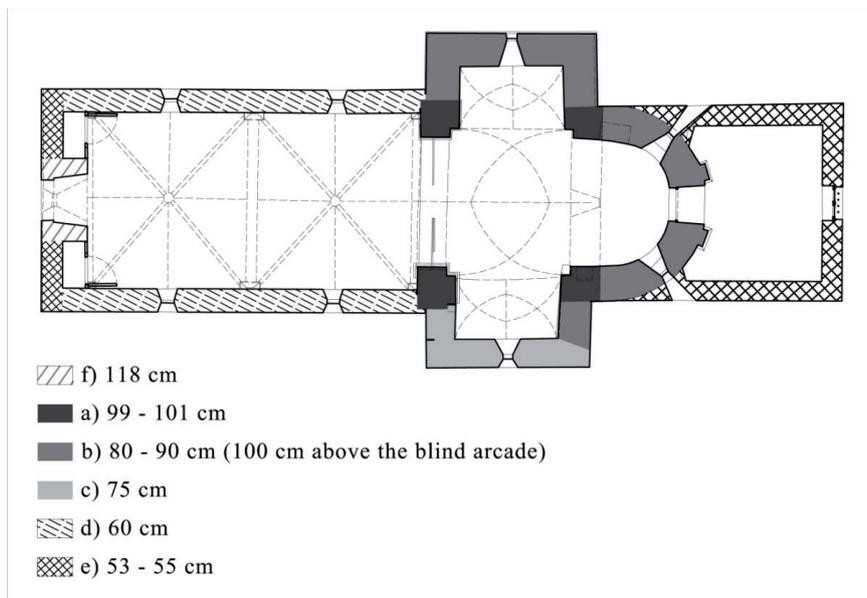
According to the wall thicknesses six different groups can be identified (see Fig. 4):

a) The thickest wall surrounds the western gate of the nave with 118 cm. The rest of this wall is much thinner, so as this part

of the church is clearly of 19th century origin, presumably from the 1863 reconstruction works; the huge thickness of the gate appears to be just an architectural trick to simulate a medieval construction. There are also some indications in town records that, in the 19th century, the village considered demolishing the damaged bell tower and building a much smaller bell wall above the western entrance, so this thick wall might have served as a support for this construction, although they clearly abandoned the idea. If this account is true, this would have been a particularly unusual construction for the region, even in the 19th century as the customary position of bell-walls since Romanesque times was over the western wall of the crossing, like in Saint-Martin-de-Lixy. Fortunately the bell tower was preserved, and this thick wall does not continue above the vaulting.

b) The four pillars of the crossing of around one metre are the thickest constructions of the church’s old parts. The larger dimensions of these pillars compared to the transept wall can be observed from the outside just under the roof. The pillars are almost always thicker than the ordinary walls; the reason can either be a natural tectonic aspect or a technological one. If we think of the pillars of the crossing as a skeleton construction, our natural sense of tectonic experiences force us to enlarge its structural profile, comparing it to a continuous wall. From a technological viewpoint, the “legs” of the crossing are made of ashlars on at least two sides; this may result in a somewhat different dimension than in the case of a wall made of irregular stones.

c) The walls of the northern transept, the apse, the eastern wall of the southern transept and the eastern gable wall of the crossing above the arch between the crossing and the apse, all measure 80 to 90 cm in thickness. A true approximate three feet thick wall typical of Romanesque times. Sometimes we find a somewhat thinner wall in the apse, but in most cases these thinner curved walls are bearing false arcades on the inner side, and their overall dimension of the whole construction is approximately three feet thick like in the case of the parish-churches of

Fig. 5 The different wall thicknesses

Sanvignes, Baron or Champlecy. Here, the apse has no articulation, so the thickness is evenly three feet all around the chancel.

d) The southern and western walls of the southern transept are 75 cm thick, noticeably thinner than the walls in group c), the difference being too large compared to the three feet medieval custom to put them in the same group. This is most interesting when we remember that the 1812 survey plan shows a different floor plan in precisely this part of the church. Furthermore, as we saw earlier, the southern and western walls of the transept also have a different constructional grid from their surroundings. All this strongly indicates that these two walls are of later origin and significant building works were carried out in this part of the church.

e) The two longitudinal walls of the nave are 60 cm thick, considerably weaker than the old parts. The bell tower over the crossing has also the same thickness, but this does not reflect upon its age as bell towers were always built as light as seemed possible to prevent them from putting too large a load on the system of vaultings and arches below.

f) The thinnest walls are of the sacristy and the western façade of the nave except for the gate and its immediate surroundings. These walls are only 53-55 cm thick. In the case of the nave, this indicates that the western façade may be from a different building period than its longitudinal companions. This is also supported by the 1812 survey plans where the church is depicted somewhat shorter in the western direction. Perhaps the current western façade built in the 19th century was erected further to the west than the previous one.

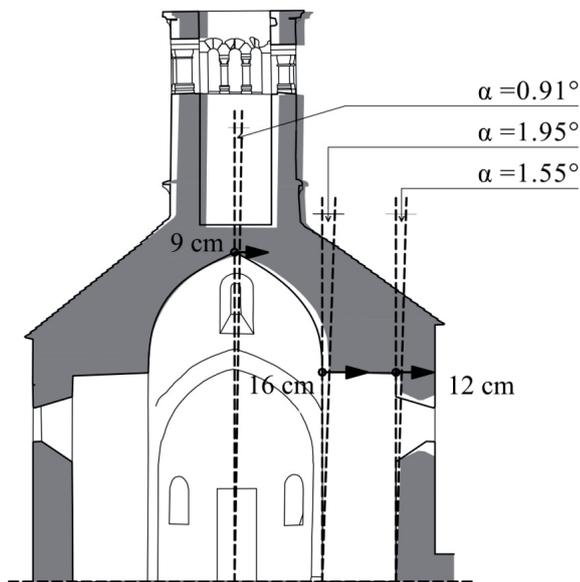
On first sight, most of the walls of the church seem to be perfectly vertical, but on closer inspection, some fairly significant structural movement can be observed: the whole of the crossing with the bell tower on top and the southern arm of the

transept are leaning in a south-west direction. These deformations are both observable in the floor plan of these parts – as seen earlier – and the tilting and deformations of the walls and vaults. The triumphal arch between the nave and the crossing is leaning 6 cm to the west perpendicular to its plane, while its keystone has moved 9 cm and its southern impost almost 14 cm to the south from its original position. The deformations of the arch between the crossing and the apse are somewhat smaller, with its keystone moving 7 cm and its impost only 5 cm to the south. The longitudinal facing pointed-arch barrel vault above the crossing is also heavily deformed: its southern support, the southern arch of the crossing has moved 16 cm to the south which is quite significant for a construction only 4.5 m tall. The south-east pillar of the crossing is also tilting 6 cm in the same direction. In this part of the church, only the southern and western walls of the southern transept are vertical, which also underlines their later origin.

The centre of the crossing remained the same, but the whole of the bell tower has moved more than 6 cm to the south-west. It is also leaning slightly to that direction, and as we saw earlier it has twisted in a clockwise direction (towards south-west). The question is: what was the cause of all these deformations?

The bell tower of the church is quite a bit smaller than the crossing on which it rests, therefore, only its western wall is supported directly by the western arch of the crossing, the rest is sitting on the pointed-arch barrel vault over the crossing itself. This produces large horizontal forces in this vault, which are in turn supported by the transversal barrel vaults and walls of the transepts. However, all indications show that some serious structural failure took place in the south-western corner of the crossing, the vaulting system lost its support, and the huge weight of the crossing started to push the southern supports in that direction while the northern and eastern supports remained intact. Why the south-west corner has failed is not entirely sure,

Fig. 6 Comparison of the current cross section with its hypothetical original undeformed state

but there is a case to be made that it might have been because of foundation problems. The church itself is located on top of a small hill with the village cemetery located to its south and west, as was the custom in the area. Even now, the graves are less than a meter away from the walls. Any combination of loosened soil, surface water not properly lead away but absorbed by the ground and insufficiently deep foundation levels could have resulted in foundation failure. Without a geotechnical survey, it is hard to speculate further.

When these movements took place cannot be exactly determined, but the church was described in texts as being in a ruinous state in 1675 and then again in 1746 (see in Oursel, 1969 and Rameau, 1899). As previously mentioned, the 1812 survey also depicts a possible damaged south-west corner; therefore, the current southern and western walls of the transept could originate from the 19th century (sometime after the survey). Since these two walls have remained vertical since then, the movements must have stopped; although, there are some recent cracks in the vaulting of the crossing near the crown, above the arch, between the crossing and the apse and the eastern wall of the southern transept.

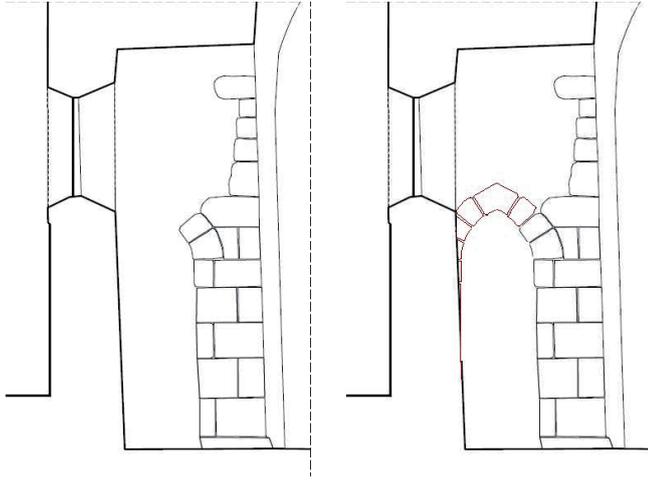
Fig. 7 The remnant of the southern doorway in the southern transept (as seen from the interior) and the theoretical reconstruction of the original form

blinded opening on the latter side. It is a rather low former doorway with a straight lintel. As the jamb-stones and the lintel are interwoven with the corner ashlar, we can say that these walls belong to each other. This Western wall of the Northern transept does not align with the Western wall of the crossing: the outer (Western) face of the Transept wall is to the east regarding the corresponding one of the crossing-wall. We can see this recess over the roof. This is not symmetrical with the Northern side where there is no such recess. This “jump” of the wall-face on the Southern side is an anomaly. Moreover, this wall (Western wall of the Southern transept) has another imprint from the past on its interior surface. There are some archivolt stones remaining from a preceding period. If we reconstruct the original vaulting of this door, it proves to be a pointed arch. If we imagine this doorway, the present Southern wall does not fit to it as the wall meets the opening. To determine the original position of the longitudinal Southern wall of the nave, we can draw its inner side from the point where the footing of the South-west pillar of the crossing ends (it does not run as far as the corner, the present inner face of the present wall); and we can fix the outer surface from the point where the recess of the transept wall is situated.

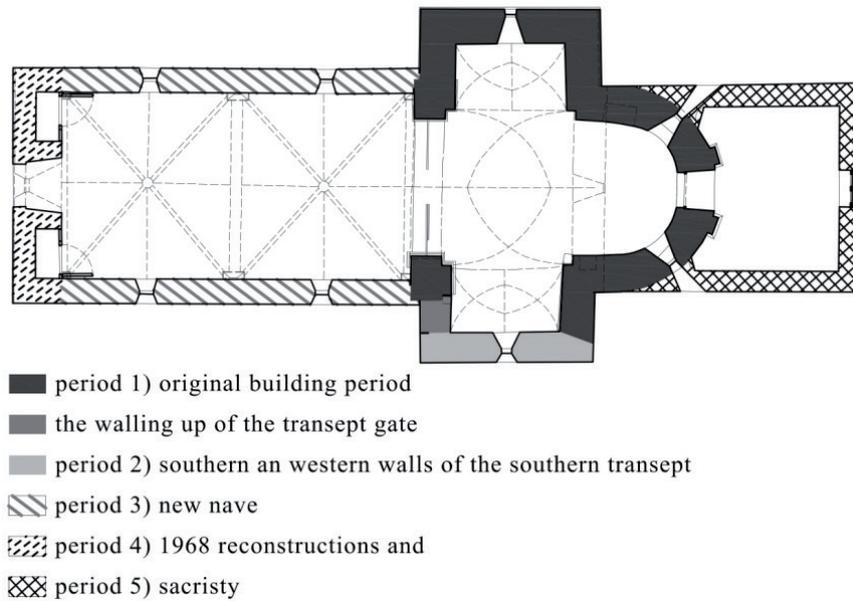
The described observations and investigations enabled us to create a hypothetical periodization of the different constructional parts of the church of Chiddes. Figs. 8, 9, 10 and 11 illustrate these findings.

Period 1) The oldest parts of the church are without doubt the pillars and vaultings of the crossing, the tower (although perhaps built in two periods close to each other), the whole of the northern transept up to the level of the vaulting, the eastern wall of the southern transept and the apse. There must have been an original nave dating to this period that was later demolished for some reason. Based on our findings, we can venture a hypothetical reconstruction of this original state: Fig. 11. The jump in the western wall of the crossing, the original footing of the western pillars of the crossing and the mysterious western gate of the southern transept all indicate geometrically that the nave must have been somewhat narrower than today, although not by much. In all likelihood, it was unvaulted since virtually no churches of the same size in the region in the 12th century had vaulted naves.

Period 2) Due to some damage (probably foundation problems), the south-western corner of the church had to be at least partially rebuilt. The southern and western walls of the southern transept may both have originated from this period. The western gate of the transept was preserved in this period as its new lintel stone is visible from the outside. The date of this intervention cannot be determined exactly, but it appears to have happened sometime before the 19th century, perhaps even in baroque times.

Period 3) The old nave was demolished and replaced with a new slightly bigger one. The reason for this intervention is

Fig. 8 Hypothetical periodization of the church of Chiddes, ground plan

unclear, most likely it was either due to some damage or it simply became too small for the community. The transformation of naves was commonplace in the region in the 19th century.

Period 4) As the village records reveal some urgent works had to be carried out in 1863: the gable walls of the transept and much of the cornices had to be repaired or rebuilt due to moisture damage. Some of the windows were enlarged. It is most likely that the current western façade was also built in this period by

demolishing the old one and slightly enlarging the nave. Records show that the tower was also in a critical condition, but luckily it was preserved and repaired, receiving a new roof.

Period 5) A sacristy was added to the eastern end of the church either at the very end of the 19th century or the beginning of the 20th century. The eastern central window of the apse was demolished to give way for a new door to the sacristy.

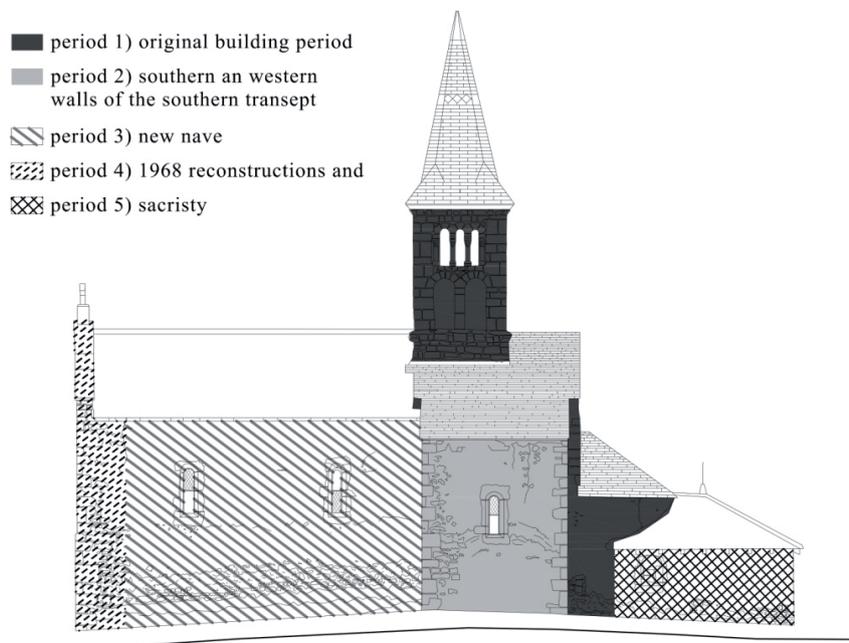
Fig. 9 Hypothetical periodization of the church of Chiddes, southern façade

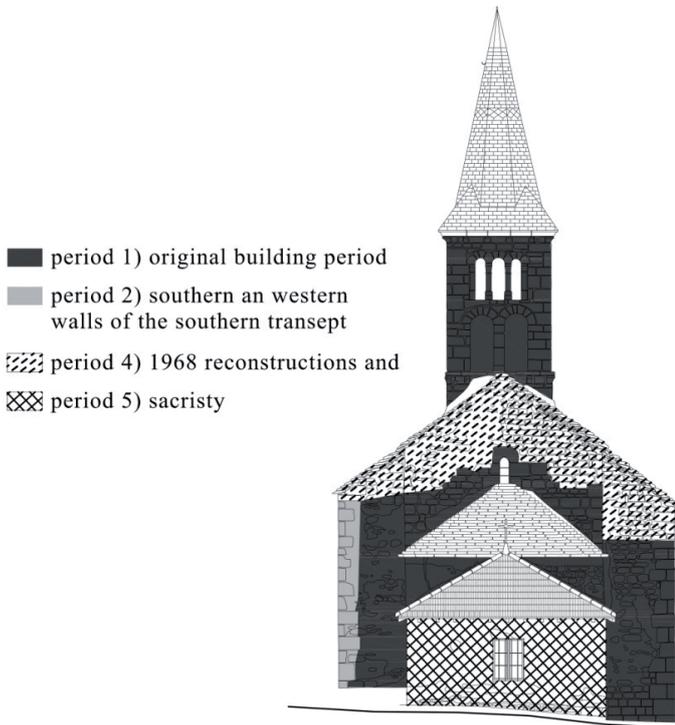
Fig. 10 Hypothetical periodization of the church of Chiddes, eastern façade

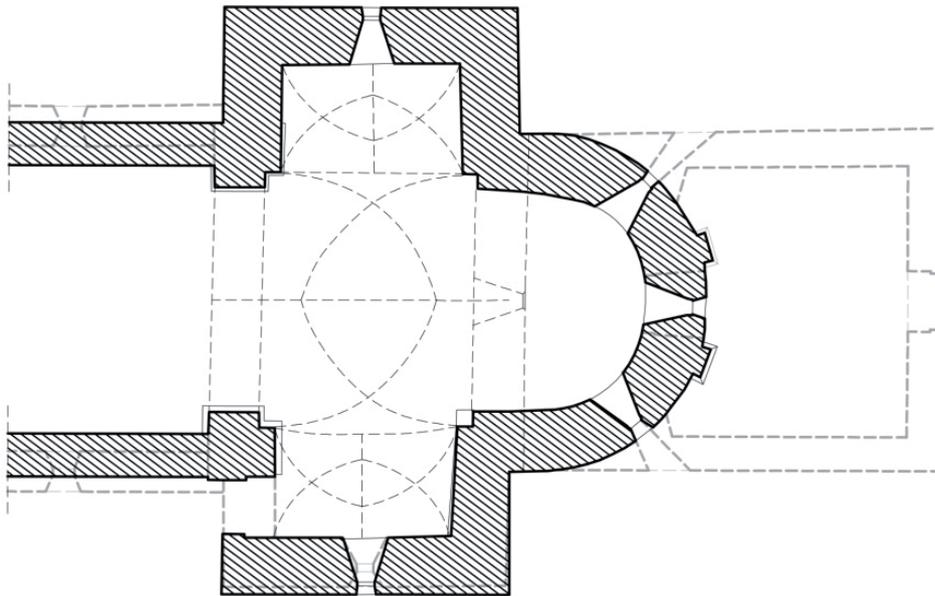
Fig. 11 The hypothetical reconstruction of the church's original plan compared to its present state
