# Experimental Investigation on Condition Monitoring Opportunities of Tramway Tracks

62(1), pp. 180–190, 2018

Ákos Vinkó<sup>1\*</sup>, Péter Bocz<sup>1</sup>

RESEARCH ARTICLE

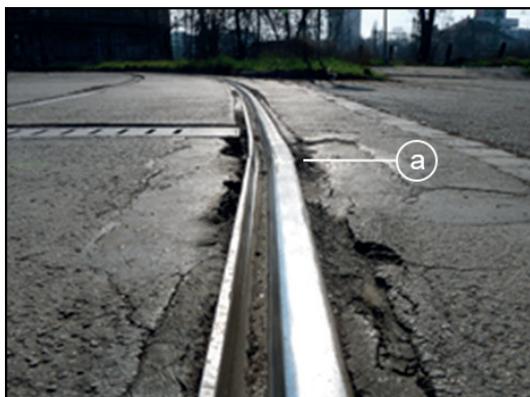
The acceleration peaks identified on left and right side are analysed and compared. There is one right-sided curve (segment no. 4) within this investigated track section. The left-sided wheel corresponding to the inner rail, while the right-sided wheel to the outer rail. In this curve, the wheelset is oriented to outer rail and the wheel flange is in contact to the rail gauge side, which causes significant differences in moving standard deviations of the left-, and right-sided wheel in Fig. 5c. Furthermore, a significant outstanding value can be observed at the place of (a) on right rail at 40 s (See Fig. 5c. and Fig. 5d), which refers to a misalignment rail illustrated in Fig. 7.

**Fig. 7** Lateral misalignment on the outer rail (right side) in curved segment (See Fig. 5c. outstanding values at the place of (a) about 40 s)

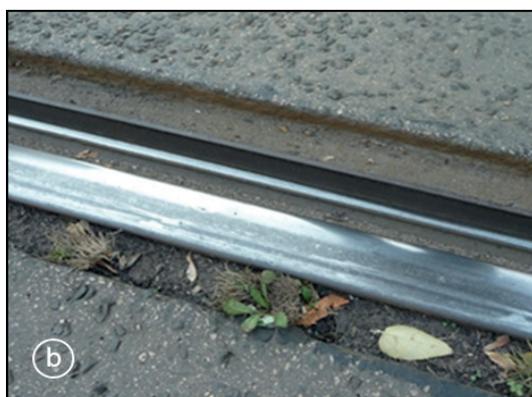
In the straight section no. 3 the grooved head of right rail has significant side wear (See Fig. 8), which generate significant differences between measured lateral accelerations on both sides. (See (b) and (d) on Fig. 5c and Fig. 5d).

**Fig. 8** Sunk rail and laterally worn rail grooved head (See Fig. 5c. outstanding values at the section of (b) between 55–63 s)

An approximately 40 Hz excitation is observed on the straight alignment segment number 3, (see Fig. 5e between 55 and 63 s) which refers to the contact between the wheel flange back and a grooved rail-grooved head. This situation can be formed only on faulted track section (See Fig. 8).

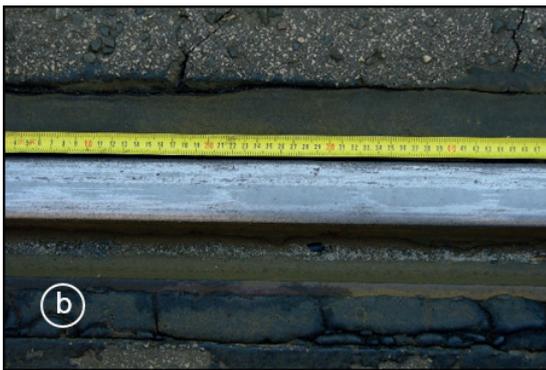
**Fig. 10** Vertical wear of rail head. The wheel flange running on the bottom of groove of the grooved rail. Long-wavelength rail corrugation on rail head. (See Fig. 6d. outstanding values at the section (b))

The exciter wavelength can be computed from the actual vehicle velocity and the identified resonant frequencies according to equation (1). The instrumented vehicle runs at 20 km/h, the identified resonant frequency is about 50 Hz, which means an approximately 11.1 cm wavelength rail corrugation (See Fig. 10).

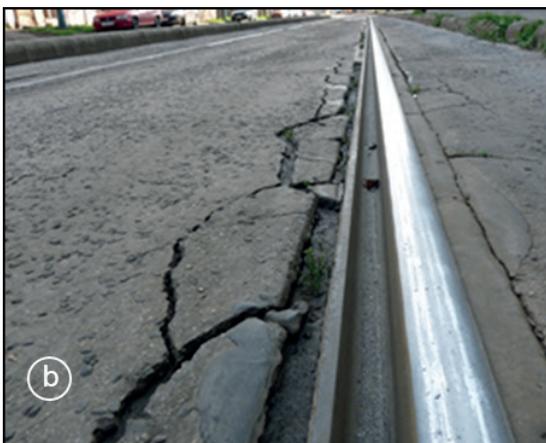
**Fig. 11** On the straight segment 3, the sunken rail and fragmented pavement (See Fig. 6d. outstanding values at the section (b) between 58–68 s)

can be identified per 4–6 meters, which is approximately equal to the distance between the fastenings of the track in straight section. Therefore, the power of these vertical lines refers to the condition of the fastenings. On the straight segment no. 3 the rail head is such intensively worn that the wheel flange runs on the bottom of the groove of grooved rail, which increases even more the above mentioned effect (see Fig. 11).
