Effects of Structural Parameters on Seismic Behaviour of Historical Masonry Minaret

Abstract

Van Ulu Mosque, Van earthquakes, operational modal analysis, seismic performance, brick masonry

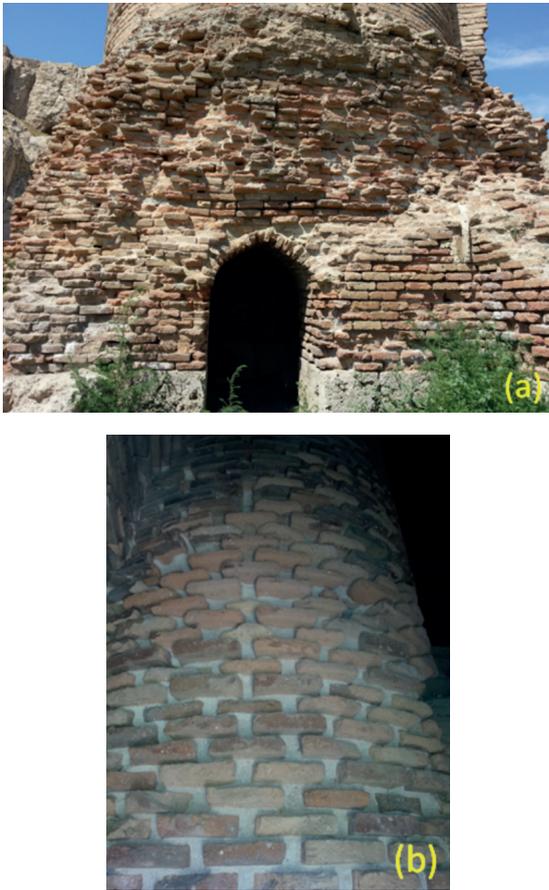
The minaret experiences several problems such as mortar disintegration, brick loss, cracking, crushing, and partial collapse. Mortar disintegrations are mainly at the pulpit as shown in Fig. 4. The pulpit had no significant deteriorations in 1913 because it was attached to the walls of the mosque. However, after losing the walls of the mosque the pulpit became open to the environmental effects, such as freeze-thaw, wind loads

and temperature changes and finally deteriorations took place. Although bricks are mainly in good condition, mortar layers deteriorated and were lost significantly at the exterior facade resulting in partial collapse of the bricks (Fig. 4.a). As for the interior bricks on the core facing to the door opening, although some portion of the mortar layers were lost, no disintegration was observed because there was still a considerable amount of mortar between the bricks (Fig. 4.b).

Fig. 4 a) Mortar loss and brick loss in the pulpit b) Mortar loss in the core

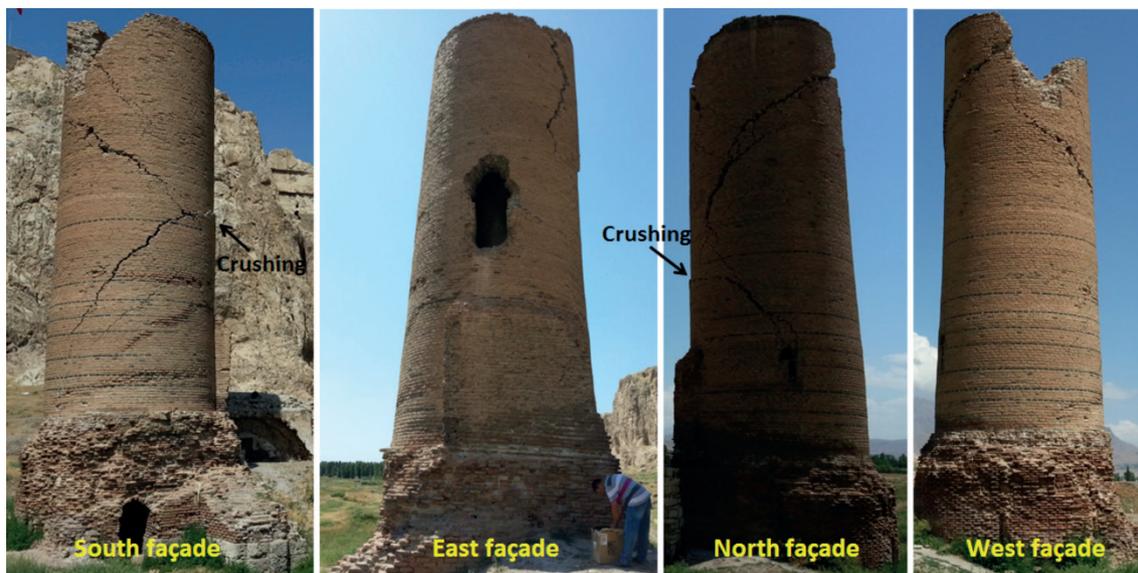
The October 23, 2011 ($M_w = 7.2$) and November 9, 2011 ($M_w = 5.6$) earthquakes increased the damage resulting in significant shear cracks and permanent deformations. Present situation of the minaret is given in Fig. 5. As it is seen, all facades have wide diagonal cracks. Crack widths reach almost 10 cm. There is a window opening at the east facade and the lintel bricks at this part were lost due to the cracking and mortar loss. Cracks are observed below the window opening and above the brace wall, and narrow diagonal cracks are also visible at the right hand side of the window. Moreover, a wide vertical crack is seen at the top. Besides, the cracks at the north facade are almost the mirror images of the south facade. The only difference is at the crack tip at the lower part which reaches to the small window opening. As for the west facade, in addition to the cracks at the upper part of the minaret projected from the south and north facades, cracks exist below the mid-height of the body.

Fig. 5 Present situation of the minaret

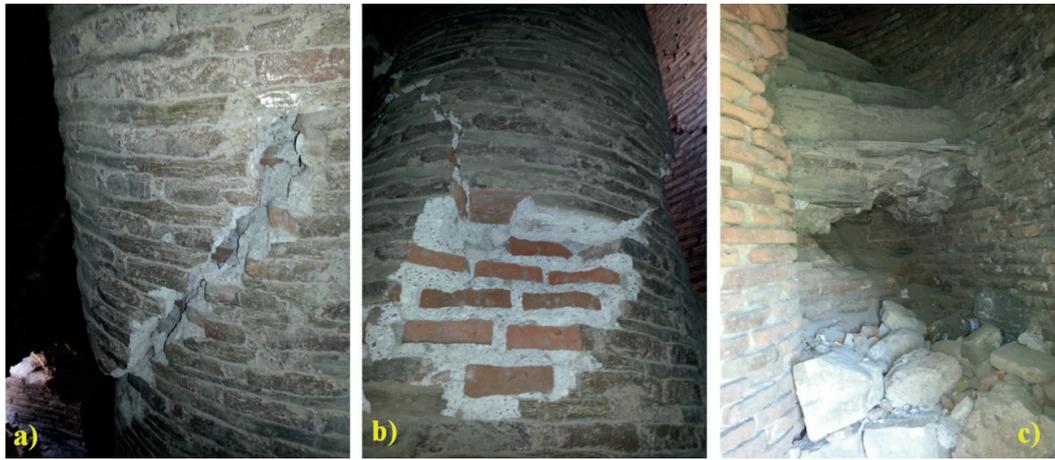
Cracks on the exterior facade are observed to extend through the core as given in Fig. 6. Diagonal cracks on the core result in separation and out-of-plane deformations, and significant crushing are also visible on the core. Moreover, partial collapse of the staircases exists at the ground level. Although those problems existed before the earthquakes in 2011, they were observed to increase afterwards. It is seen from the post-earthquake picture that the west facade experienced partial collapse at the top level.

Fig. 6 a) Cracks in the core b) Crushing in the core c) Partially collapsed staircase

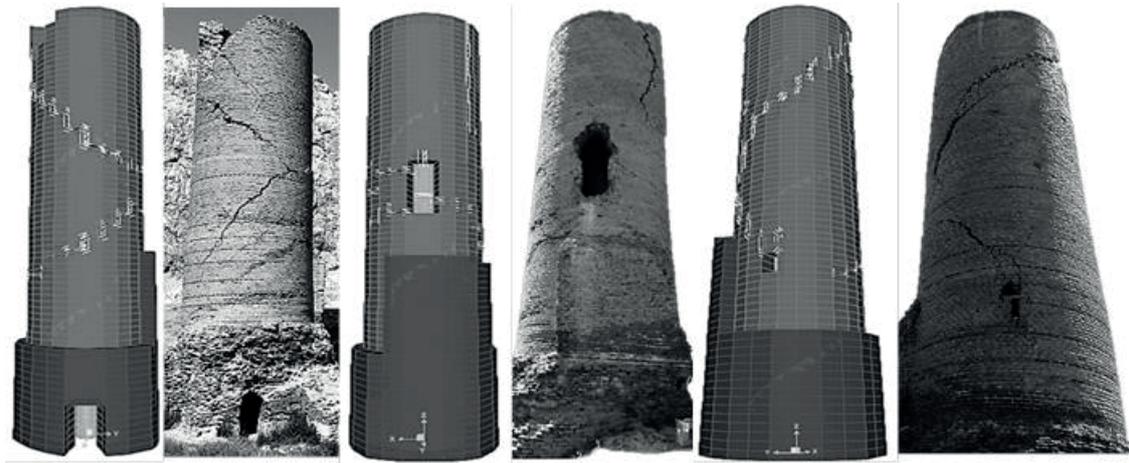
The minaret experienced several cracks with almost 10 cm width indicating a significant separation as mentioned in the previous sections. The main reason for the cracks is believed to be the earthquake shaking, because several great earthquakes occurred in the region in the past. The last earthquakes were on October 23, 2011 with $M_w = 7.2$ and November 9, 2011 with $M_w = 5.6$ [25]. Those earthquakes increased the existing damage but did not lead to total collapse.

In order to create a model representing the current state of the structure, existing cracks should be introduced. Since those cracks are wide enough, non-linear gap elements were used to represent the behaviour at the cracked locations. Tensile resistance of the gap element is assumed to be zero due to the lost connection between the elements and it only carries compressive loads. It was assumed that gap elements behave only in the first principal direction (direction 1) since the main separation is in that direction. The effective stiffness to be used in linear analysis was taken as zero. It was found from the field investigation that widths of cracks vary between 2 and 10 cm. Therefore to be consistent with the existing cracks, 2, 4, 7 and 10 cm gaps were defined and assigned to the relevant locations. The model M-4 and the structure are given in Fig. 14, comparatively. As it is seen, almost all of the cracks were introduced in the model.

After defining the cracks, static and dynamic analyses were performed to understand the behaviour of the current state. From the modal analysis it was found that the stiffness in x-direction reduced significantly resulting in higher natural vibration periods as shown in Table 6. With the reduction in stiffness, roof displacements increased 116% in x-direction but only 50% in y-direction. No shear stress predictions were made, since the structure had already cracked.

Fig. 14 Comparative view of the model M-4 and the structure

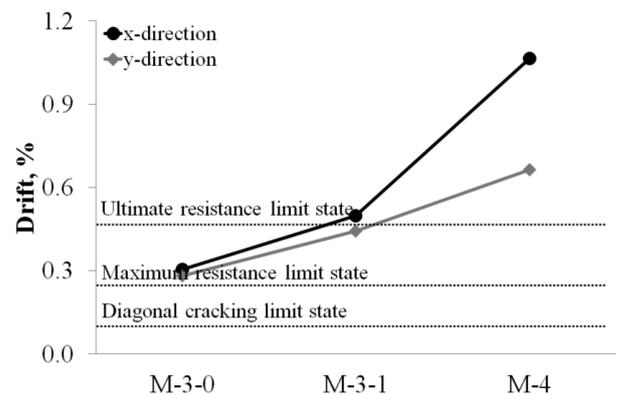
The main problem of the structure is the stability associated with the drifts. According to in-plane tests on masonry walls composed of solid fired clay brick with mortar, diagonal cracking was stated to develop at approximately 0.1% drift, maximum drift was found to be almost 0.25% and ultimate drift was observed to be at 0.47% [24]. Since the materials used in those tests had similar characteristics as in this study, same limits are assumed to apply in the concerned minaret. Fig. 15 gives drifts of the three models (M-3-0, M-3-1 and M-4) under combined gravitational and earthquake loading together with the drift limits. M-3-0 represents the as built case, M-3-1 stands for the deteriorated but uncracked case and M-4 simulates the cracked condition. In general, drifts in x-direction are higher than the ones in y-direction because of the unsymmetrical stiffness distribution. From Fig. 15 it is seen that M-3-0 has drifts almost equal to the maximum resistance limit state indicating that diagonal cracks are inevitable under earthquake loading. With deteriorations and material loss on the pulpit and the brace wall, stiffness degradation leading to higher drifts is possible. Drifts in M-3-1 are beyond the ones found from M-3-0 and they are around ultimate resistance limit state showing that significant damage is possible. Since the current state of the minaret reveals the significant damage, limit states given by Javed [24] seems reasonable. Although drifts in M-3-1 are almost equal to the ultimate resistance limit state, they are far beyond this level and indicate a much more dangerous situation in M-4. Drifts in x-direction increase considerably upon cracking. It should be reminded that those values are just an estimate and do not reflect the real behaviour because of the difficulty in modelling such a highly vulnerable structure. However the results can be interpreted as a clue about the behaviour to be expected

in the future incase no strengthening is applied. Although the structure survived in 2011 Van Earthquakes it may not have sufficient resistance for the next one.

Fig. 15 Change in drifts

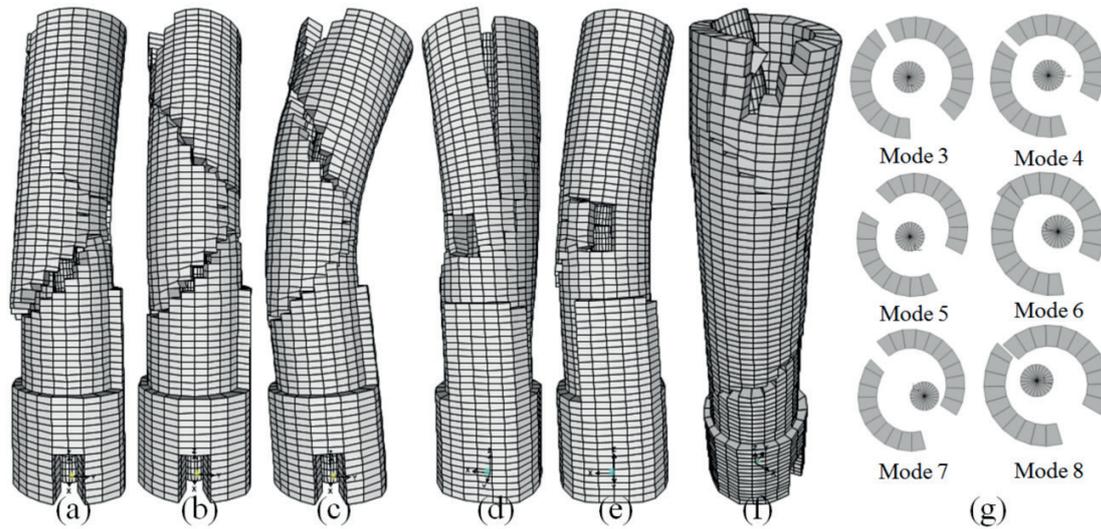
Fig. 16 Possible failure mechanisms and mode shapes of the minaret

Fig. 16 depicts the possible failure mechanisms of the minaret. Since the cracks are wide and cause significant separation, they endanger the whole structure and have ability to cause total collapse. Cracks divided the upper part of the minaret into several pieces and ended up little or no interaction between those pieces. There exist six possible failure mechanisms as shown in the figure:

- a) upper structure may be separated from the lower stiff structure due to the cracks below the east window extending through the lower part,
- b) upper structure may be divided into two separate parts and collapse accordingly,
- c) the cracks from east window to the top of the west facade may cause the upper portion to collapse,
- d) the body may be torn up due to the vertical cracks at the top,
- e) significant cracks at the window opening may cause upper part to collapse partially and

f) the core and the staircase may behave separately forcing the body to displace out-of-plane.

In Fig. 16, mode shapes of the structure are also shown from the top view to see the degree of separation and difference in the behaviour between the body and the core. Since the body has diagonal and vertical cracks, each part of the body has different response resulting either closure or opening of the cracks. It is seen from all the possible failure mechanisms and mode shapes that the structure has instability issue and significant drifts are likely to result in total collapse. Those possible failure mechanisms should be kept in mind while proposing a strengthening method. On the contrary to the upper part of the structure, no noticeable cracks or failure is expected at the pulpit and the brace wall since the elements at these locations still hold the integrity and have sufficient stiffness.

Although the structure survived in 2011 Van Earthquakes it may not have sufficient resistance for the next one. It is recommended that the structure should be handled immediately because it is on the verge of total collapse. The structural condition should be improved such that the signs of earthquake damage are still visible to remind people significance of the earthquake. Besides it should be preserved to respect its strength since it survived in the earthquakes in 2011 even though several reinforced concrete buildings collapsed in the region.
