Ylber Muceku^{1*}, Olgert Jaupaj²

TECHNICAL NOTES

Abstract

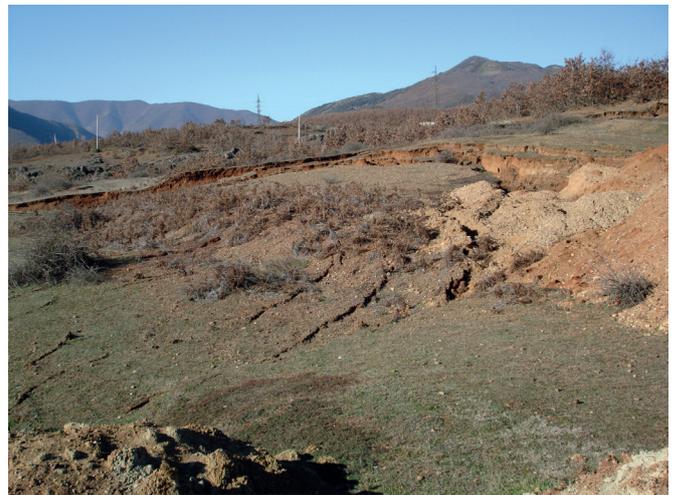
Fig. 2 Earth slide occurred before motorway construction, January 2006

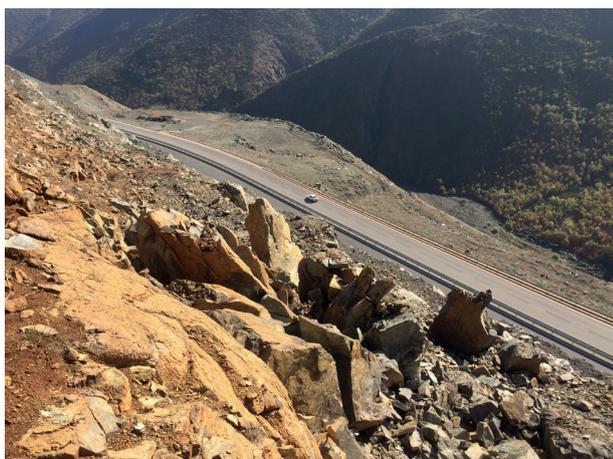
From the current geotechnical observations, it has been revealed that the rock masses (limestones, ultrabasic, basalts, gabbro, dacites, etc.) that build the cut slopes are intensively weathered, tectonized and fractured due to excavation works (i.e. blasts). Thus, during the freeze–thaw periods, many rock blocks (1.0–1.7 m³ up to 2.0–3.0 m³) and fragments (0.25–0.50 m³) are in loose and unstable state, ready to be detached and to fall (Figs. 5, 6). The rock falls with sizes of 0.25–3.0 m³ occur on about 40 cut-slopes occasionally during heavy rainfall (Figs. 5, 6). Most of rockfalls are observed on the following cut slopes (6.6–7.1 km, 14.6–15.3 km, 18.0–19.2 km and 21.2 to 93.3 km of motorway) during the wet period (October–March) in the first 24h of rainfalls with high intensity (bigger than 90 mm/ 24 h) [17]. The authorities have reported that during the

wet period, the rock blocks and stones are falling into motorway 1–3 times during year in all cut slopes. The materials consist of rock blocks and broken stones of ultrabasics, gabbros, basalts, andesites, sheeted dike and dacites.

Fig. 5 It shows the loose blocks on cut slopes

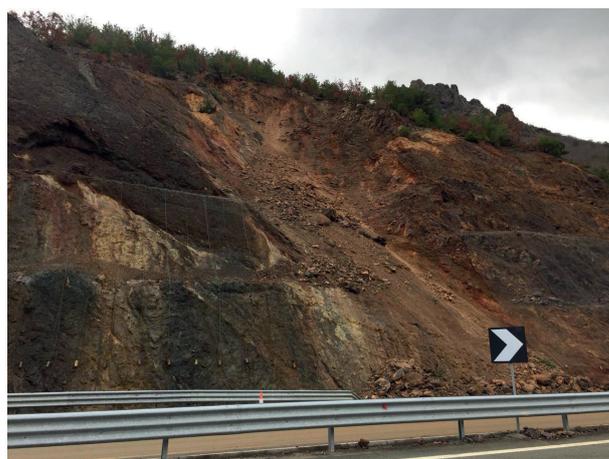
Due to man-made works and weathering processes of ultrabasic, basalts and gabbro formations, as well as rainfall water erosion and transport, on the cut slopes along the motorway, there are deposited unconsolidated granular materials-soils (rubbles-cobbles-gravel mixture with no fines). These soils are in unstable state, ready to slide down in form of debris flow. Along the path of the motorway, especially from 14.0 km to 89.5 km, there are 26 locations where the debris flow has occurred. Over the past years, the biggest debris flows were observed on 24 November 2015 (54.75–54.80 km, 1950.0–2000.0 m³ of volume) and 03 March 2018 (52+450 to 52.485 km, 2600.0 m³ of volume) and caused a road block for several hours (Figs. 7).

Fig. 7 Debris flow occurred on 03 March, 2018 (km 52.0)

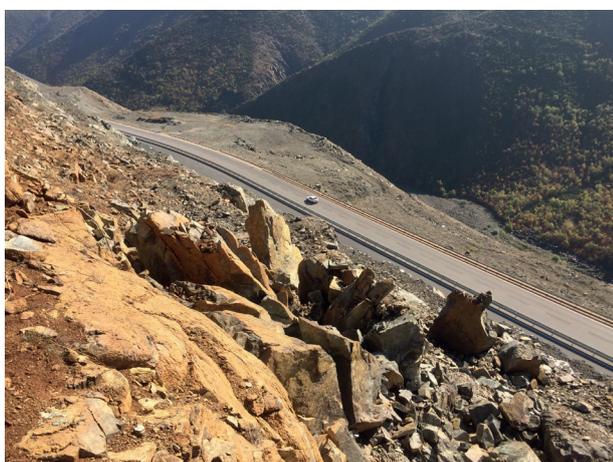
Fig. 6 Rockfalls occurred on 08 March, 2018 (km 18.4)

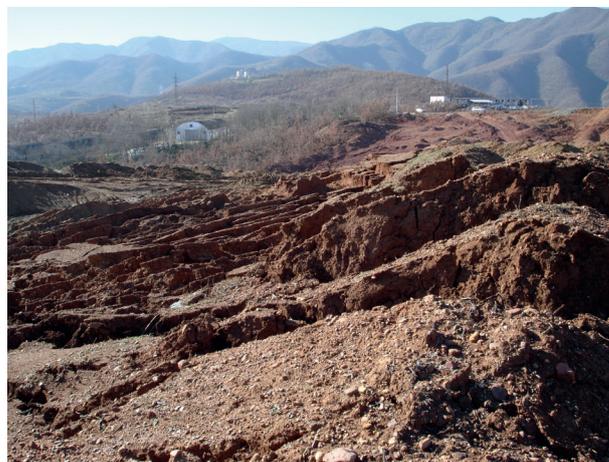
Fig. 8 Earth slide occurred during motorway construction, 2007

cut slopes of highway with inclination 18° – 35° . They are from 20.0–50.0 m to 70.0–100.0 m long, from 15.0–30.0 m to 50.0–75.0 m wide and 2.8–3.5 m to 5.5–7.0 m thick. The earth slides are the translational slide type with slow velocity [4].

From the geotechnical analyses carried out on this area, 49 earth slides have been mapped (Fig. 4) [16]. They are located to the north of Rresheni town, Ndërfusha, Mashtekori-Bisaku and ZallXhuxha villages (Fig. 4). The landslides body consists of inorganic silts and very fine sands [1] (Figs. 8, 9).

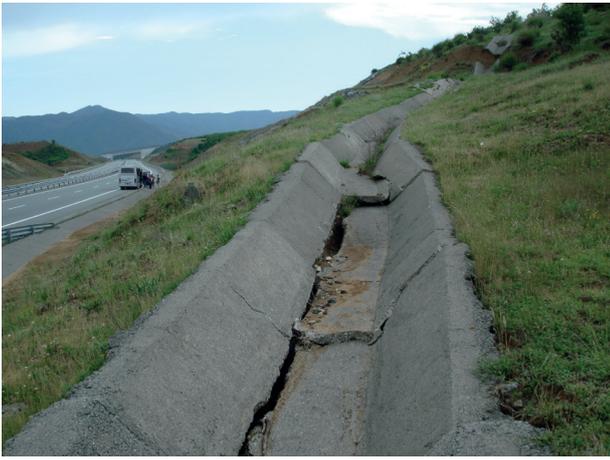
Fig. 9 Earth slide occurred current time

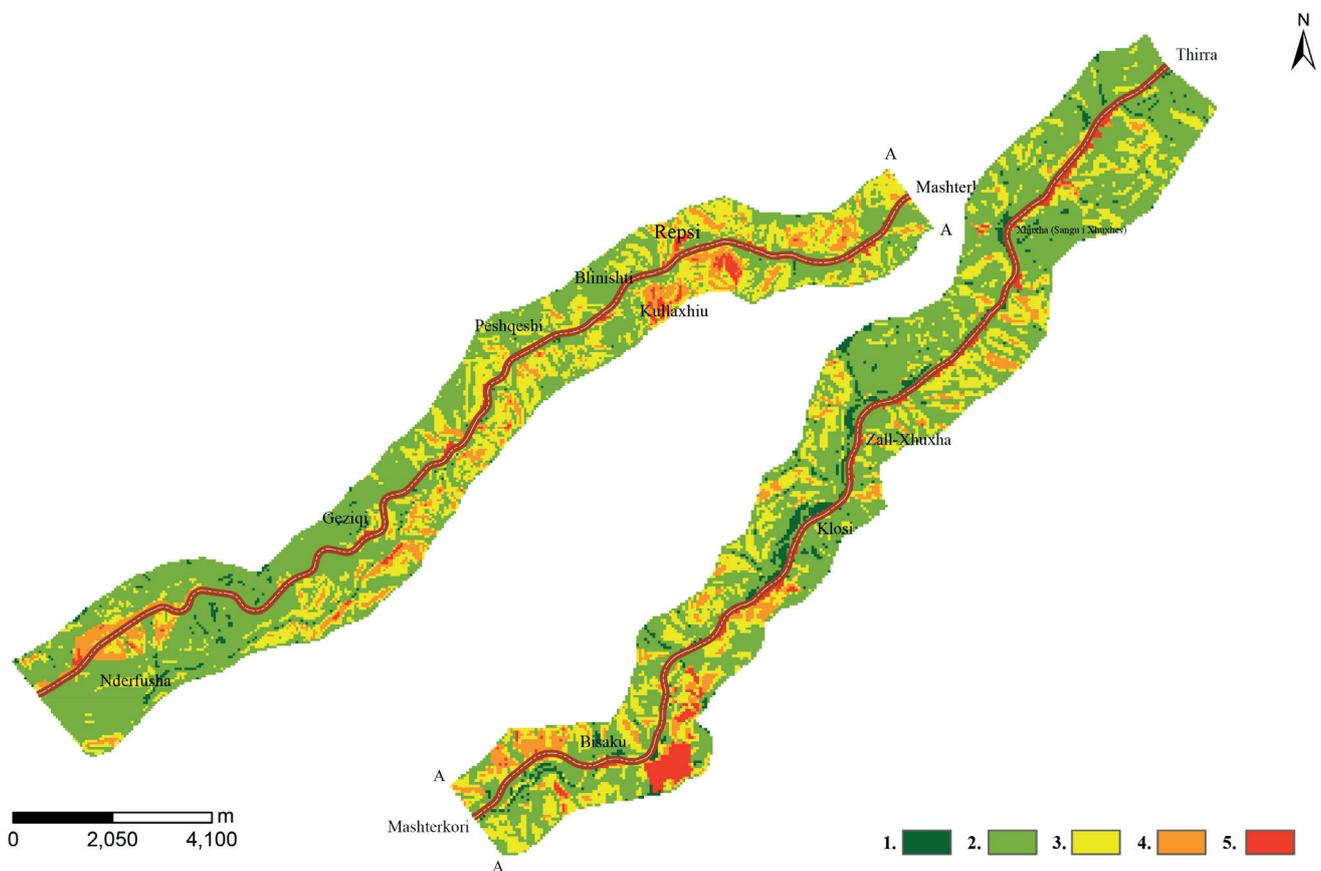
Fig. 14 Landslide hazard zonation map before construction of motorway

In Fig. 14 [7, 15, 20], is given LHZ map, which represents the landslide hazard evaluation of the period before the motorway construction. It shows some interesting data about the landslide hazard in the case of natural conditions of the motorway area. This map reveals that 5% of the study area is involved in very low hazard, 58% low hazard, 26 % moderate hazard, 8% high hazard and 3 % as very high hazard. While, in Fig. 15 [8, 16, 21], is presented LHZ map, which evaluate the landslide hazard after the motorway construction. As above mentioned it, for the motorway construction has been carried out a large excavation volume (blasts). Here, at the hazard level, besides natural and geological factors, the manmade works have been influenced, as well. The map indicates that 5% of the study area is involved in very low hazard, 30% low hazard, 32% moderate hazard, 21% high hazard and 12 % as very high hazard. From the analysis made of the two maps (Figs. 14 and 15), it was found that the level of high hazard and very high hazard of the studied area after the motorway construction has been increased respectively 2.62 and 4 times. Hence, it was revealed that the main reasons of the mass movement in the studied area are man-made works (blasting excavation). Consequently, from these works there is increased the mass movement occurrence, at the same time the risk to travelers, cars and road infrastructure.

- i). For the period before the motorway building 5% of the study area is involved in very low hazard, 58% low hazard, 26 % moderate hazard, 8% high hazard and 3 % as very high hazard (Fig. 14).
- ii). For the period after the motorway building 5% of the study area is involved in very low hazard, 30% low hazard, 32% moderate hazard, 21% high hazard and 12 % as very high hazard (Fig. 15).

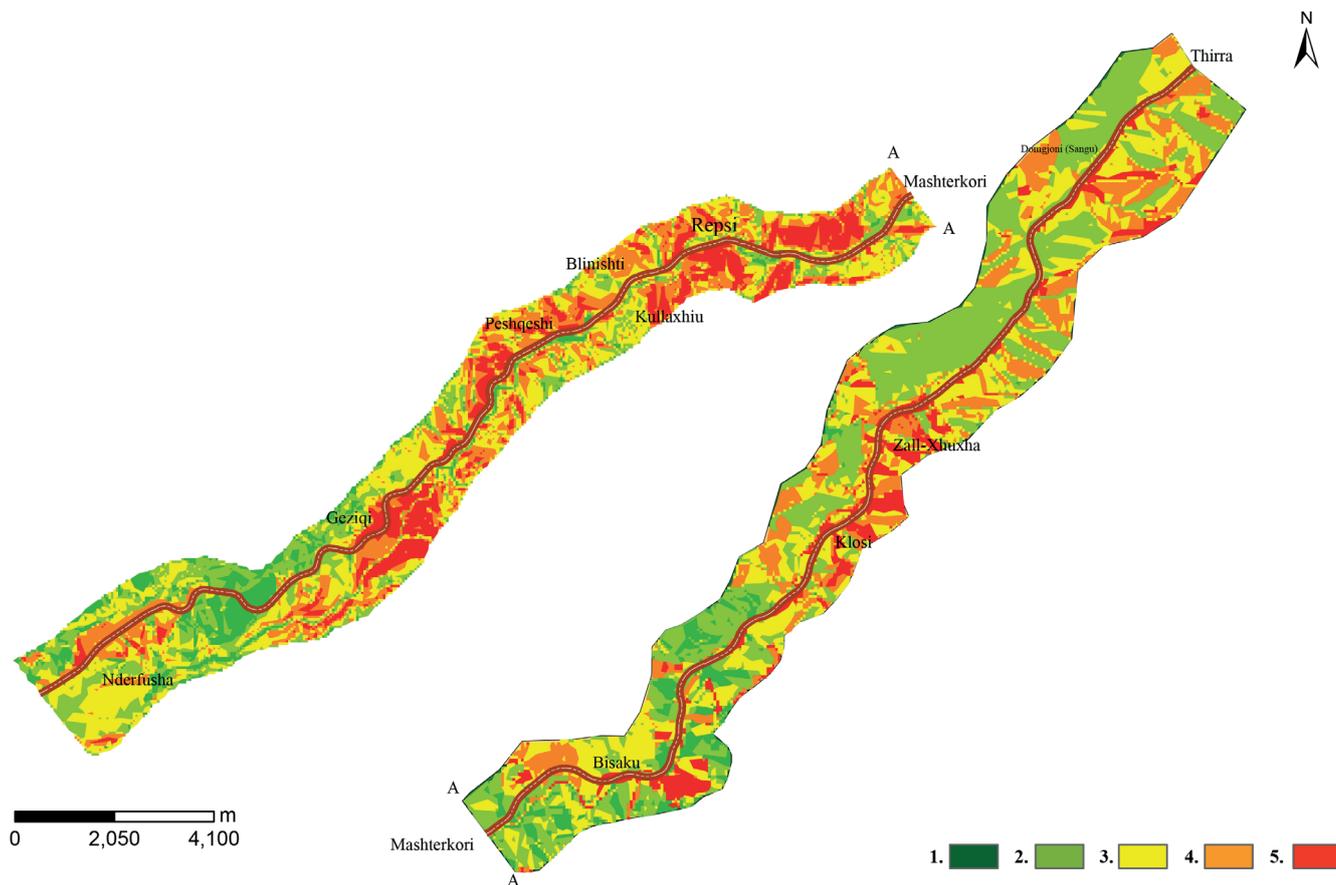
Fig. 15 Landslide hazard zonation map after construction of motorway

The southwestern (19.5–22.5km), central (29.5–70.0km) and northeastern part (78.0–89.5km) of the motorway area is categorized in as high and very high hazard zone. These zones are located within highly-completely weathered and intensive fractured of molasses, ultrabasic, gabbro, mélange and volcanoes formations. Almost the hazardous landslide areas are extended over cut slopes of motorway area. Thus, there is an urgent need to take necessary rehabilitation works, mitigation of risk and protective engineering measures against mass movement activity to avoid any potential hazard that can be occurred in the motorway area.

So, the above results show that the level of high hazard and very high hazard of the studied area after the motorway construction has been increased 2.62 and 4 times, respectively. This shows that the landslide occurrence is increased 4–5 times, at once endangering the lives of passengers, car's traffic to travelers and road infrastructure. It should be noted that the main cause for the mass movement in the studied area is the anthropogenic activities (excavation by blasting cutting).

Finally, it is concluded that in high and very high hazard areas, a systematic planning of protective engineering measures is required to prevent the mass movement occurrence.

The landslide hazard evaluation of the Milot-Kukës motorway reported the urgent need for rehabilitation works, mitigation of risk and protective engineering measures against mass movement activity to avoid any potential hazard in the motorway area.
