Thermal Imaging for Detection of Defects in Envelopes of Buildings in Use: Qualitative and Quantitative Analysis of Building Energy Performance

Anna Ostańska^{1*}

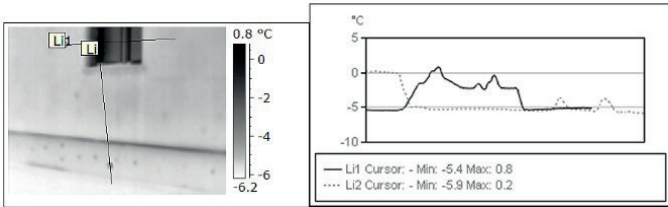
Let us consider the basement wall (Fig. 3, Fig. 4). Measurements in four selected areas and their statistical analysis confirmed that only the area no. 1 was insulated correctly: the temperature measured on site was not statistically different ($p > 0.05$)

Fig. 3 Thermal image of a fragment of elevation of the insulated building and the analysis of a window and basement wall – description in the text

The cause of thermal bridging at the basement walls was the unsealed joint between the insulation of the ground floor wall and the basement wall. As a result (Table 3, item 1), there was a local reduction in thermal quality of the envelope – over 45% in comparison with the properly insulated basement wall. This joint was recommended for insulation in the routine mode (the insulation should be completed within five years). The thermal effect of a correct insulation of the basement wall with a 7 cm polystyrene boards without a thermal bridge in the joint, is shown in Table 3, item 2. It was confirmed that it is possible to tighten the insulation and to avoid thermal bridging on the basement wall, and the cause of increased heat efflux at

the contact of the insulation boards was the result of careless fitting of insulation elements. A properly installed basement wall insulation, consistent with the design, would not require any improvements.

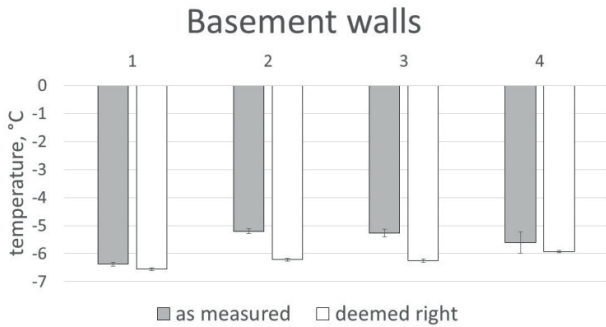
Fig. 4 Mean differences in temperature between the selected areas of basement walls and correctly insulated wall; “deemed right” means the temperature of a properly insulated surface

from the temperature deemed correct, as expected on the outer surface of the properly insulated wall. In the case of the remaining areas (2–4), the difference between the measured temperature and the temperature deemed correct were statistically significant ($p < 0.05$).

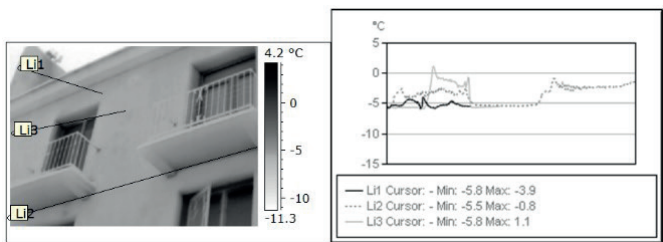
Fig. 6 Thermal image of a fragment of elevation of the insulated building and the analysis of a fragment of the external wall with balconies – description in the text

As for the lintels (Fig. 5, Fig. 6, Fig. 7), measurements were taken in three selected areas and their statistical analysis indicated that the lintels were not correctly insulated. The temperature measured on site was statistically different ($p < 0.001$) from the temperature deemed correct, so expected from a properly insulated element.

The cause of the thermal bridge in the outer reveal surfaces was the lack of planned insulation in the design [30]. The effect of the thermal bridge on lintels (Table 3, item 4) was local reduction of thermal quality; its actual heat transfer coefficient was $0.50 \pm 0.17 \text{ W/m}^2\text{K}$, so over 110% higher than that of the correctly insulated envelope. The lack of insulation on the reveal calls for a high priority repair (up to 1 year).

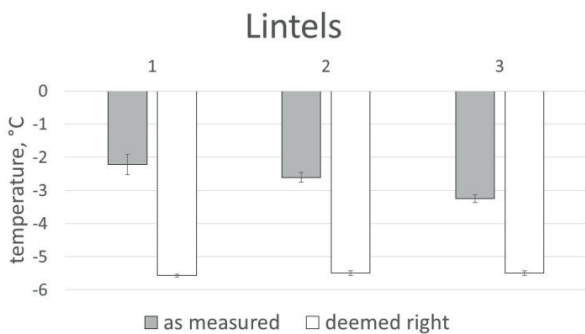
Fig. 7 Mean differences in temperature between selected areas of a lintel and correctly insulated wall; “deemed right” means the temperature of a properly insulated surface

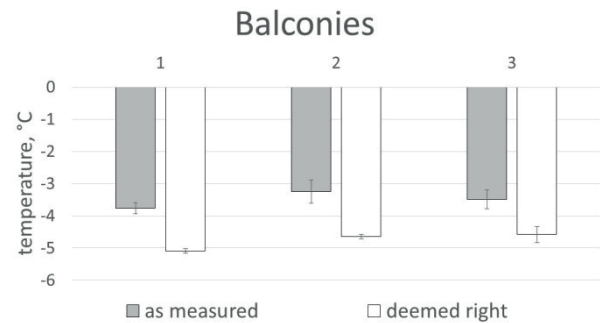
Balconies (Fig. 8, Fig. 9) were checked in a similar manner and proved to be inadequately insulated. The temperature measured on site was statistically different ($p < 0.001$) from the expected temperature. The measurements were taken on the outer surface of the corner between the balcony slab and the wall.

Fig. 9 Mean differences in temperature between selected areas of balconies and a correctly insulated wall; “deemed right” means the temperature of a properly insulated surface

The analysis confirmed the presence of linear thermal bridges at the balconies (Table 3, item 3), whose actual heat transfer coefficient was $0.36 \pm 0.04 \text{ W/m}^2\text{K}$ and was slightly over 50% higher than assumed in the audit [31]. In the case of this element, a thermal bridge on the contact of the balcony with the basement wall has been found and this item was recommended for repair in the routine mode (within 5 years).

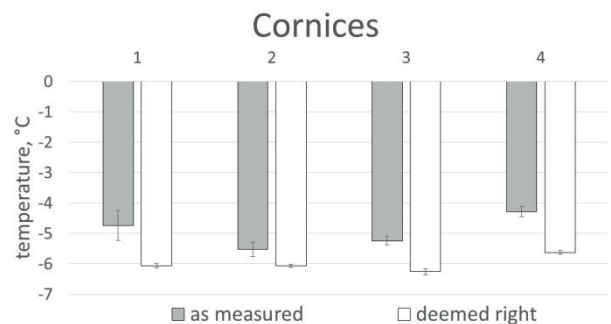
Fig. 10 Mean differences in temperature between selected areas of a cornice between floors and a correctly insulated wall; “deemed right” means the temperature of a properly insulated surface

Cornices between floors (Fig. 10) occurred to be uninsulated. Measurements were taken in four selected areas on their surface. The measured temperature was statistically different ($p < 0.001$) from the temperature considered correct.

Another important thermal bridges were cornices between floors (Table 3, item 5), whose calculated actual heat transfer coefficient was $0.49 \pm 0.09 \text{ W/m}^2\text{K}$, so more than twice as high as the number given by the audit. The *in-situ* studies have confirmed the absence of insulation of the cornice (Tables 1–2), though the specification [30] clearly indicated that it was required. As in the case of the lintels, this gives the cornices a high priority status (the insulation should be completed within one year).
