Assessments of Masonry Buildings and Historical Structures during the 2020 Sivrice-Elazığ Earthquake

Alper Özmen^{1*}, Müslüm Murat Maraş¹, Yaşar Ayaz¹, Erkut Sayın²

2020 Sivrice earthquake, seismic performance, masonry buildings, structural damages, field investigation

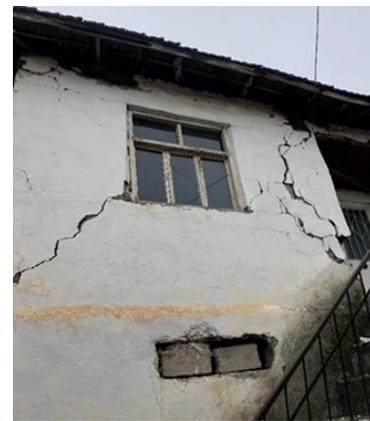
In-plane mechanism was observed in most of these buildings that are affected by shear cracking in the earthquake area. Figs. 9 and 10 show in-plane wall failure (diagonal cracking) due to the in-plane load. In the area struck by the Elazığ-Sivrice earthquake, most of the masonry buildings did not have sufficient and proper bond beams to enhance the lateral strength of the walls. The stiffness

Fig. 10 Diagonal cracking in masonry buildings

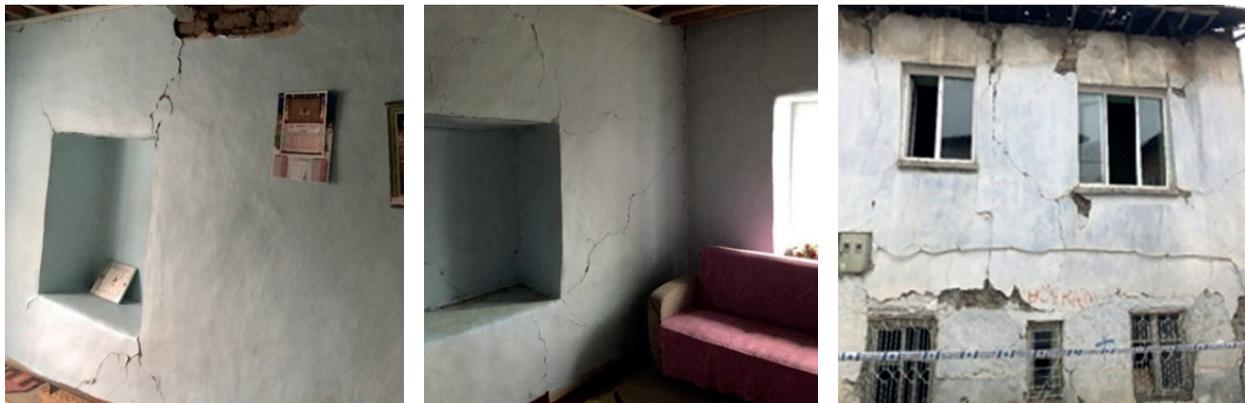
Fig. 9 Diagonal cracking in adobe buildings

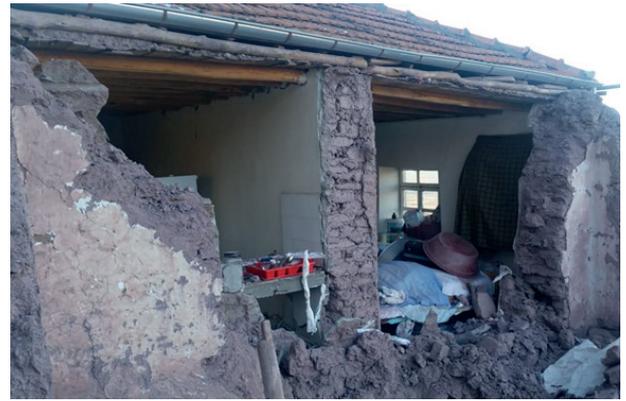
Wooden logs are mostly used as roof beams in Turkey. These logs are placed on two parallel load-bearing walls. Thus, the perpendicular walls which are not restrained at the roof level may easily overturn. Figs. 15 and 16 illustrate out-of-plane movement of the façade wall in an adobe and masonry building, respectively.

Fig. 15 Out-of-plane wall failure of façade wall in an adobe building

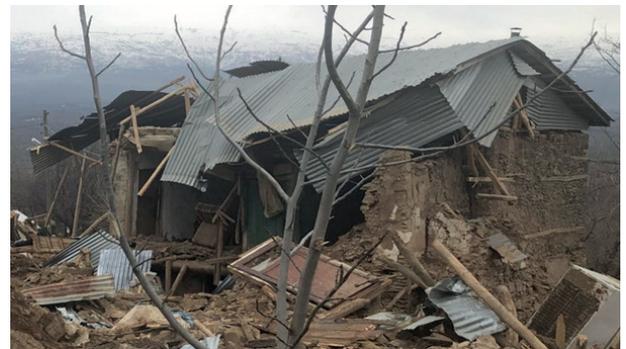
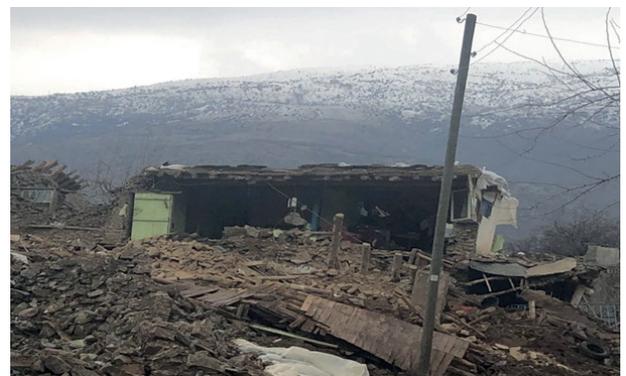
Fig. 16 Out-of-plane wall failure of façade wall in masonry buildings

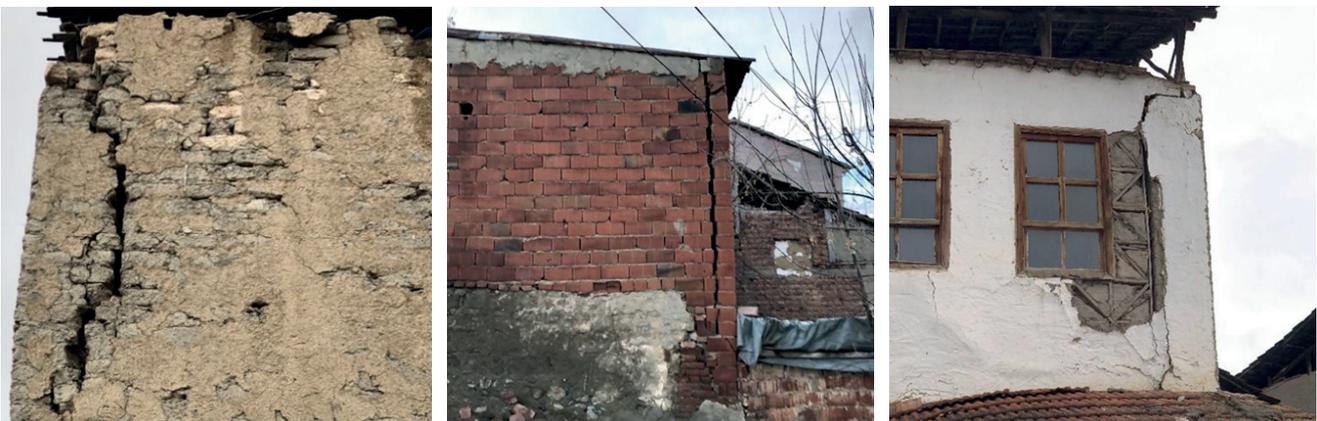
Fig. 17 shows overturning of the facades perpendicular to each other. Also, vertical cracks can see in Fig. 17. To prevent these behaviors in masonry buildings, the Seismic Code requires that the maximum unsupported length of a wall should not exceed 5.5 m in the Seismic Design Category (SDC) 1, 1a, 2 and 2a and 7.5 m SDC 3, 3a, 4 and 4a in the plan (Fig. 18(a)). Every 4 m long vertical bond beams should be used in the plan. Also, the unsupported wall length should not exceed 16 m (Fig. 18(b)) [10]. However, most of the masonry structures in the earthquake region did not meet these specifications.

Fig. 17 Out-of-plane wall failure of façade wall in masonry buildings

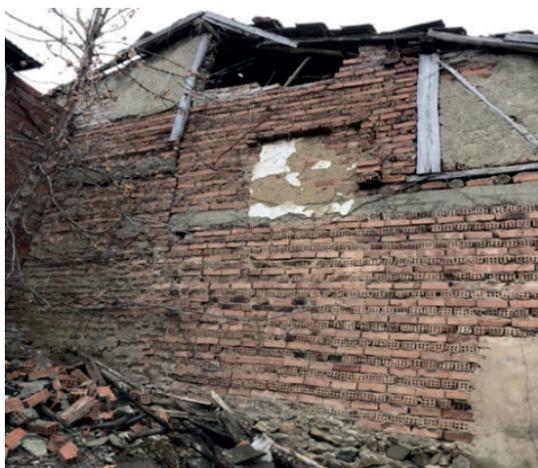
Also, out-of-plane failure of gable walls were observed in the earthquake region. These components are very vulnerable to out-of-plane lateral loads because they have large unsupported infill walls. They are not well connected to the floor and roof of the structure. Fig. 19 shows the damage of a gable wall.

Fig. 19 Gable wall damages

If the gable walls exceed 2 m in height, Seismic Code requires using vertical and inclined reinforced concrete bond beams to prevent gable wall damages as shown in Fig. 20. Owing to the lack of connection between loadbearing walls and the absence of bond beams, corner damages occur at wall to wall and wall to roof connections when subjected to out-of-plane behavior. Corners connections have high stress concentrations during the earthquake. Due

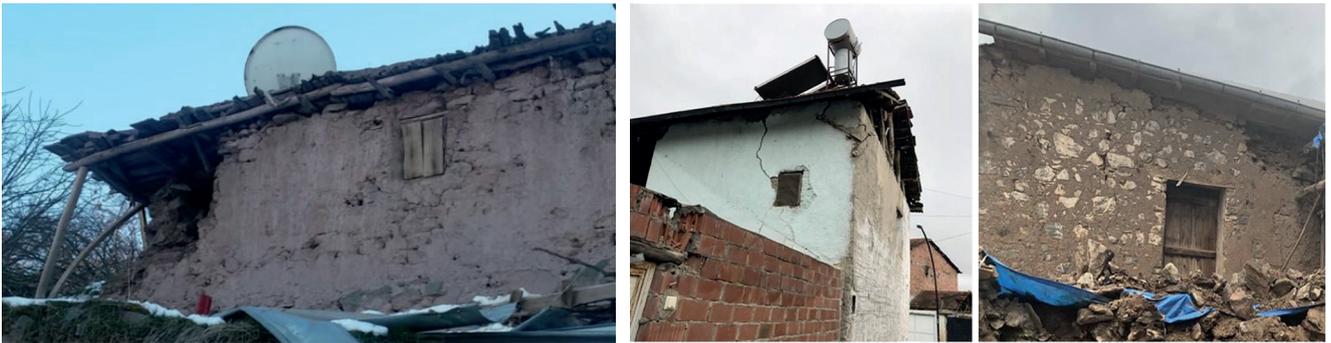
to cantilever-like behavior, top corners of the buildings are more vulnerable. TSC requires reinforced concrete vertical bond beams to limit corner damage (Fig. 18). These beams increase the seismic performance and lateral stiffness of masonry buildings. Corner damage was a common damage type in the earthquake region. Fig. 21 presents corner damage to masonry and adobe buildings.

Fig. 21 Corner damages to adobe and masonry building; a) Adobe building, b) Masonry building

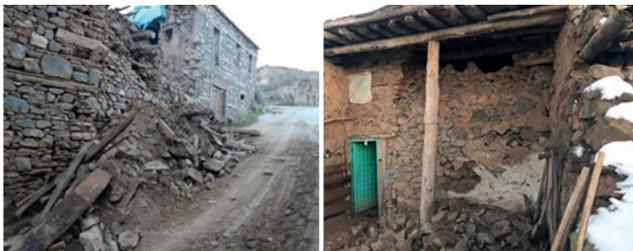
Also, disintegration of masonry walls was observed in stone masonry buildings in the earthquake region. Stone masonry buildings which are located on the earthquake area were constructed with multi-leaf walls. Large coarse stones were adopted to arrange the external leaves of the bearing walls, and they covered an internal filling made of with small size stones and mud mortar. Insufficient connections were observed between the exterior and interior layers of the wall. Therefore, layers of these walls behaved independently and separated from each other very easily during the earthquake. Delamination as generally localized in the upper part of the masonry walls. The thickness of these stone walls was approximately 50–60 cm (Fig. 22).

Fig. 22 Disintegration of stone masonry walls (insufficient connection between layers)

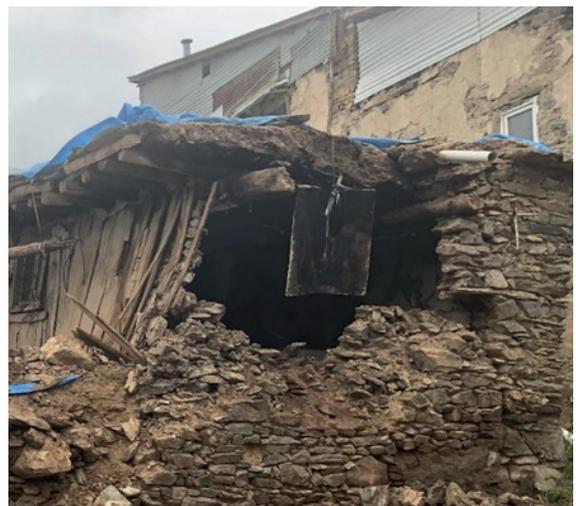
In the earthquake region, heavy earthen roofs were constructed over wooden logs especially in adobe buildings to provide water and thermal insulation. The roofs were generally constituted of dried mud whose thickness ranged between 30 and 100 cm [43, 46]. Because of weather conditions, these roofs lose their effectiveness in winter and the residents made a new earthen layer on top of the existing roof. Therefore, the thickness and weight of the earthen roof increased in time. This type of heavy earthen roofs increased the mass of the buildings and caused large inertial forces during the earthquake motion. Fig. 23 shows the heavy earthen roof and damaged stone masonry building in the earthquake region.

Fig. 23 Heavy earthen roof and damaged stone masonry building

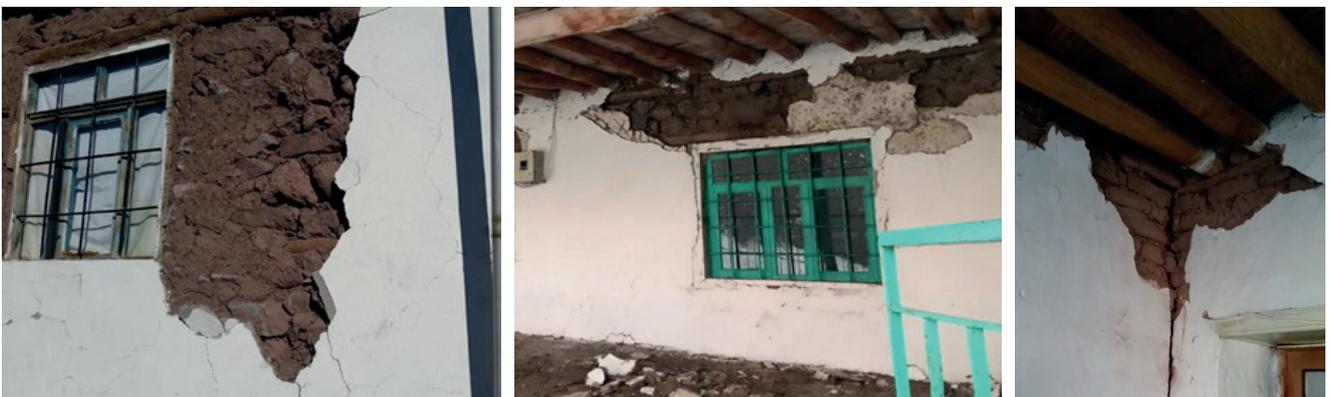
Also, the interior or exterior plaster of adobe and stone masonry walls was partially or totally spalled (Fig. 24). Due to the effects of the strong future aftershocks, these walls can be collapse.

Fig. 24 Plaster spalling of the masonry and adobe walls

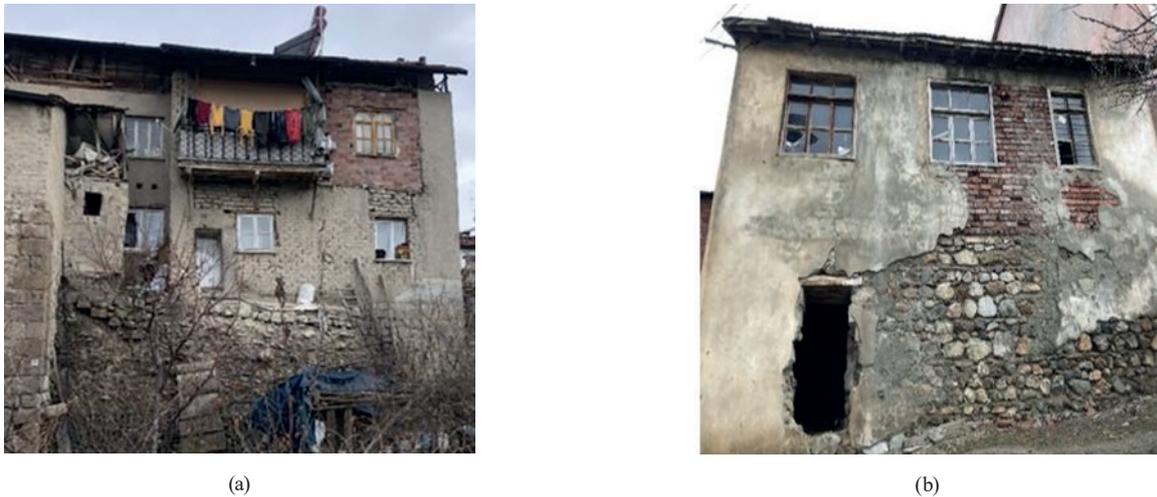
or different parts of the buildings located in the earthquake region (Fig. 25). Turkish Seismic Code does not allow these type buildings. Different materials caused stiffness and strength concentration in some portions of a wall or in some parts of a building. Under the earthquake loads, this different configuration caused load redistribution problems. Also, additional torsional moments could occur.

Fig. 25 Masonry buildings having different material; a) Brick and adobe, b) Brick and stone

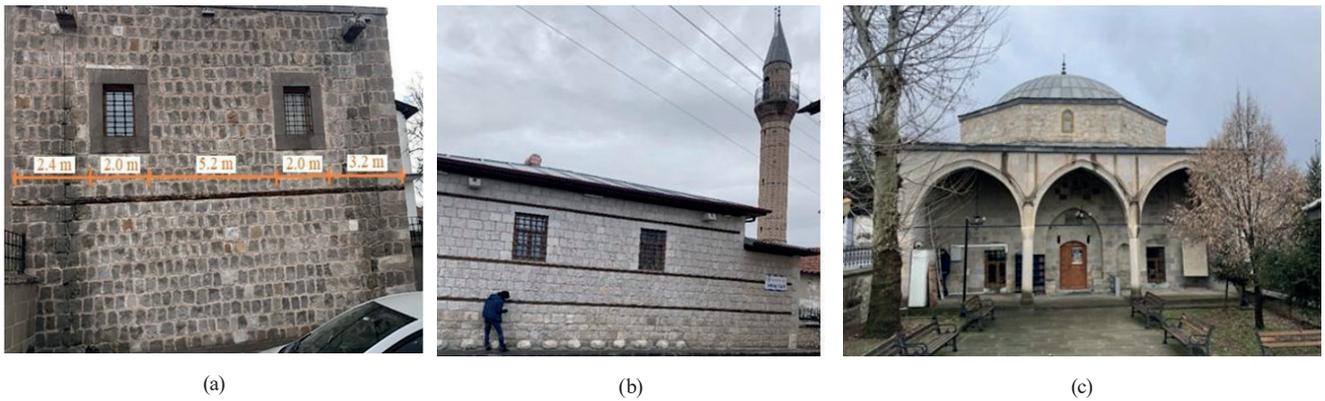
Fig. 27 Undamaged historical structures after the earthquake; a) Karahan mosque, b) Toptaş mosque, c) Akminare mosque

These historical structures had no damage. Karahan and Toptaş mosques are the oldest mosques in the region (Fig. 27(a)–(b)). Karahan and Toptaş mosques were built in 1582 and 1588, respectively. Also, these mosques do not have a dome. Akminare mosque was constructed in 1792 (Fig. 27(c)). Horizontal tie beams were used in these mosques. Openings which increased the shear effects during the earthquake were not close to the corner and each other and these openings were not large.

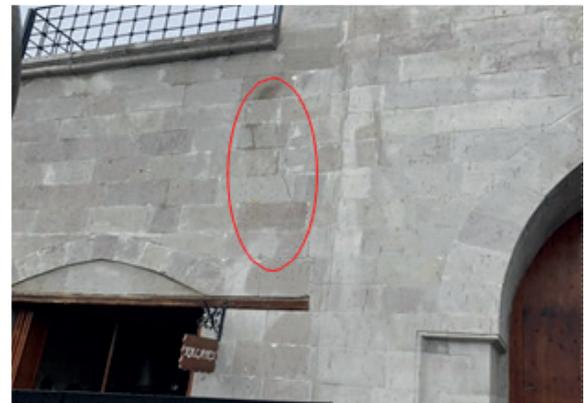
Also, some thin cracks with limited length were observed at the Silahtar Paşa Caravanserai after the earthquake (Fig. 28). The Silahtar Paşa Caravanserai located in Battalgazi was constructed in 1637 (Fig. 29).

Fig. 28 Damage to Silahtar Paşa caravanserai

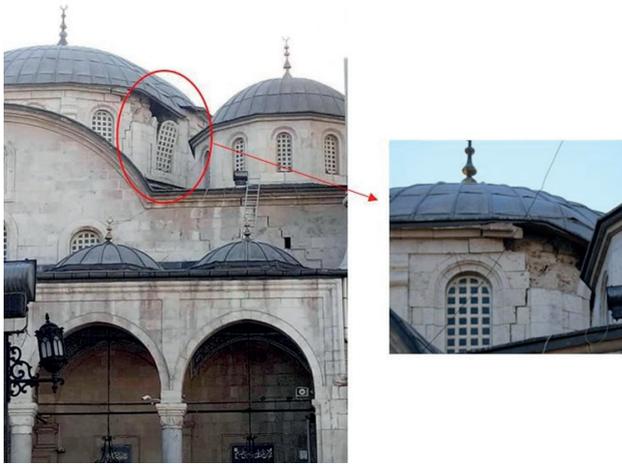
Another historical building is the Yeni Mosque in Malatya. Yeni Mosque was destroyed during the earthquake in 1895. The mosque was rebuilt using cut stones in 1912 with a square plan of 28.5 m. It has five domes, one main dome and four small domes. It was damaged again on June 14, 1964, Adiyaman-Sincik earthquake. The mosque was again repaired after the earthquake. The main dome of the mosque was damaged during the Sivrice-Elazığ earthquake. Some diagonal stepped cracks observed on the wall under the main dome and façade wall of the mosque

Fig. 30 Damages to Yeni Mosque

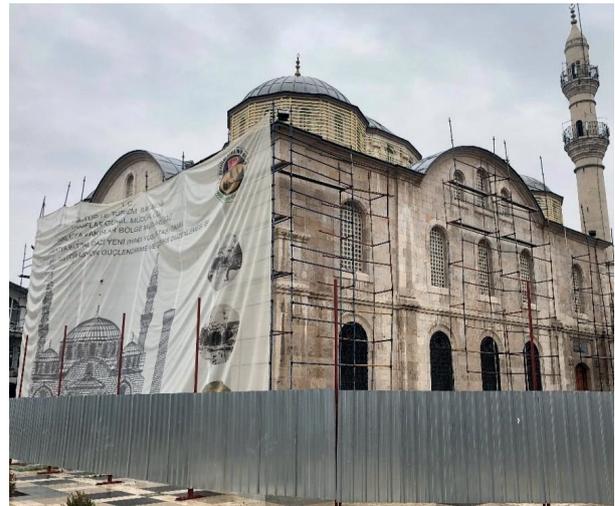
(Fig. 30). Also, some minor cracks were observed in various parts of the walls. It was closed to worship after the earthquake for repairing (Fig. 31).

Fig. 31 General view of the Yeni Mosque after the Sivrice-Elazığ earthquake
