Failure Mechanism of the Toppling Rock Slope with Different Numbers of Free Faces Caused by Excavation: a Case Study in Jiacha Hydropower Station (China)

Shao-Ping Huang^{1,2}, Kai-Ming Cao^{1,2}, Chang Zhou³, Heng-Lin Xiao^{1,2}, E-Chuan Yan^{4*}, Lu Cong⁵

Received: 18 June 2024, Accepted: 07 August 2024, Published online: 30 August 2024

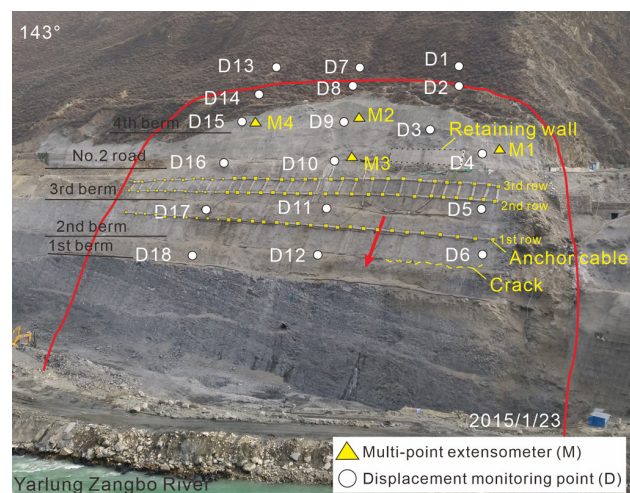
was equipped to record the deformation characteristics of the slope (Fig. 2). Eighteen temporary monitoring points (D1–D18) were installed on the surfaces of the slope. The spacing of the monitoring points is about 26 m along the sliding direction. Four multi-point extensometers were installed on the upslope. One extensometer contains five measurement units with a vertical spacing of 10 m, 15 m, 20 m, and 25 m from the shallow part of the slope to the inside.

Fig. 2 Monitoring system of the toppling soft rock slope

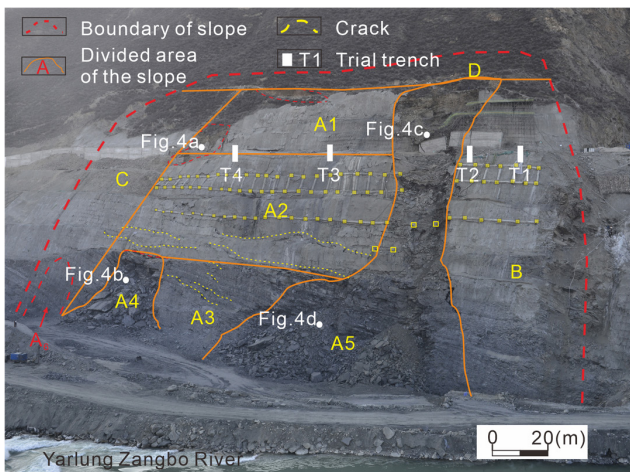
According to the deformation characteristics based on the monitoring results, and failure mechanism, this slope was divided into four parts (Fig. 3): the bending deformation areas (A1, A2, A3), the collapse areas (A4, A5, A6), the potential collapse areas (B and C) and the slope influence area (D). Their deformation characteristics were analyzed in detail.

Fig. 3 Division of deformation area. (Note the white rectangles are the location of four trial trenches named T1 to T4.)

Potential sliding area (B and C area): B and C area are located on both sides of the slope and are currently stable as a whole, with only partial cracks developing on the slope surface, but under the combined effect of groundwater and unloading, further deformation and damage to the slope will occur, leading to overall instability. For example, the toe of the C area (A6) collapsed on Feb. 9, 2015 (Fig. 3), and many cracks were formed.

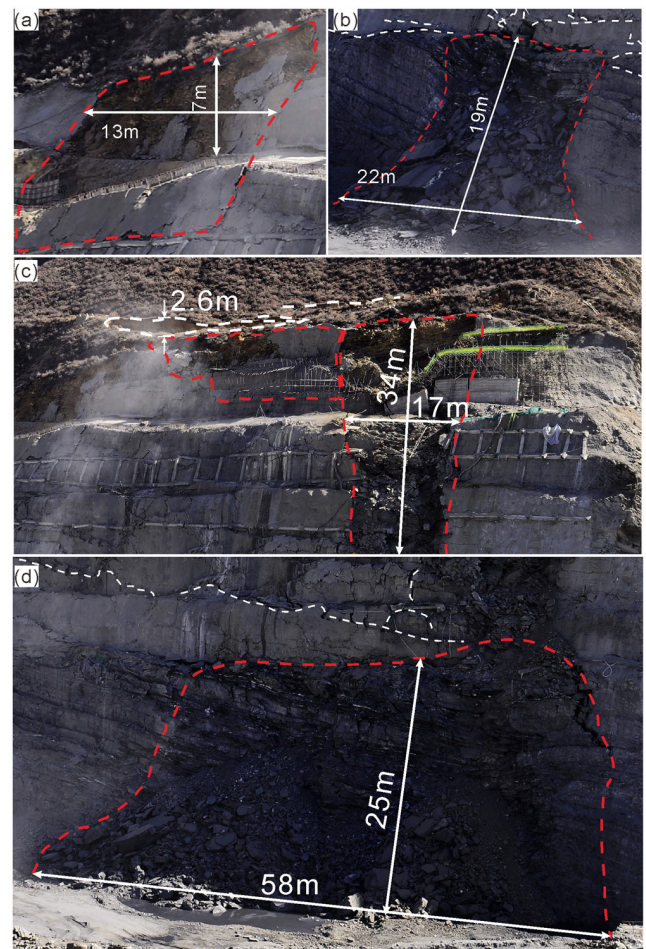
Collapse area: A4 and A5 were firstly collapsed and deposits accumulated at the toe of the slope. The shapes of those areas were a pyramid with approximately 500 m² and 3300 m², respectively. There were some cracks on both sides of the A4 and A5. The majority of the deposit are debris (Fig. 4(b, d)).

Fig. 4 Deformation characteristics of sub-divided landslide. a) collapse in the lower left corner of the A1 area; b) A4 area; c) A1, D, and upper part of A5; d) downhill portion of the A5 area

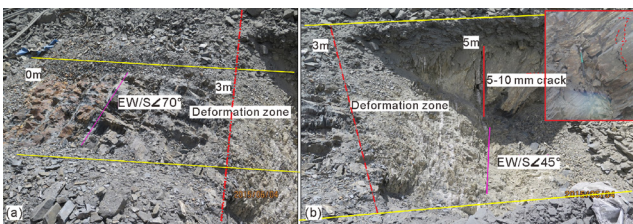
structure. It should be noted that the trial trench explored that the inclination of the strata gradually decreased from upstream to downstream. In the T1 trial trench, the inclination of the strata in the stable zone (0–3 m) is 70° (Fig. 5(a)), but in the deformation zone, it changes to 45° (Fig. 5(b)). A crack was observed with the width of 5–10 mm (Fig. 5(b)), and other one also was found in the rock perpendicular to the strata. In the T2 trial trench (Fig. 6(a)), the inclination decreased from 55° to 10° from the uphill to the downhill side of the trial trench. Three cracks were formed perpendicular to the sliding direction of the slope and extended into the slope (Fig. 6(b)).

Fig. 5 Strata exposed by T1 trial trench, a) upstream of the B area, b) downstream of the B area

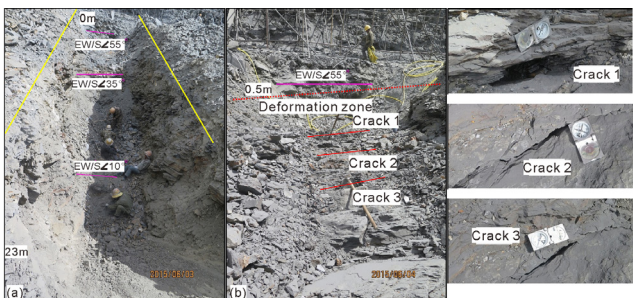
Fig. 6 Strata exposed by T2 trial trench, a) upstream of the B area, b) downstream of the B area

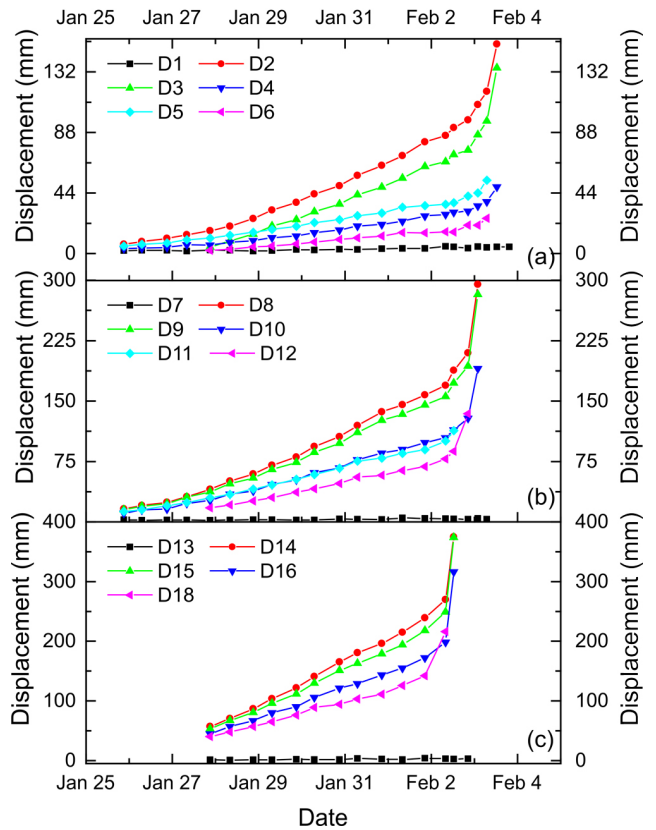
Fig. 7 shows the accumulated displacement of the slope surface. All the curves have a similar trend: the displacement of the measurement points increased with a constant velocity initially and then rapidly accelerated after Feb 2. The D2 and D3 had the largest displacement in the potential sliding area (Fig. 7(a)). Furthermore, they gradually increased at an average velocity of 13 mm/day, but their velocity rapidly increased to 80 mm/day after Feb 3. The displacement of the middle portion (D4, D5, and D6) is smaller than that of D2 and D3 whose locations are close to the collapse area. However, the displacements at points D1, D7, and D13 were very small (< 5 mm) (Fig. 7(b)). In addition to the above points, other monitoring points were located in the bending deformation area. The displacement of the rock slope

Fig. 7 Relation curves of the long-term external deformation monitoring data with time, a) B area, b) A area, c) C area

gradually decreased from the upstream to downstream and from the east side to the west side. The displacement of those points tended to rapidly increase with a high velocity. For example, the average rate of the D14 (Fig. 7(c)) was 38 mm/day which is three times of the D2.

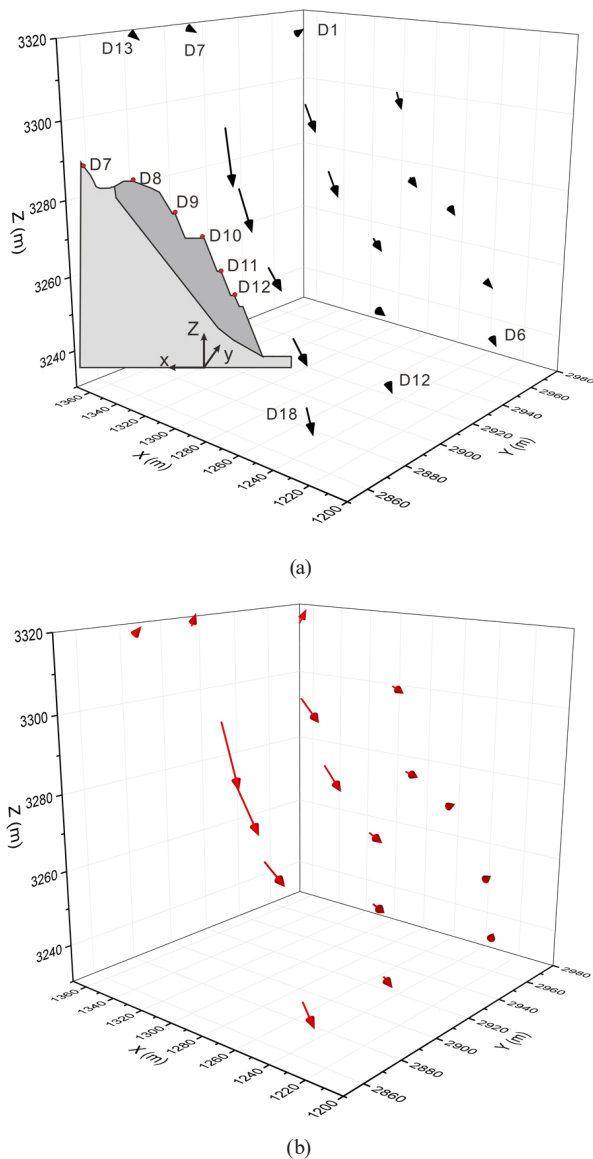
The 3D displacement vectors of the monitoring points are depicted in Fig. 8 at different times. All monitoring points have different degrees of deformation in B area. This is a significant finding with regards to no matter in which direction, D1 displacement was the smallest, while D2 was the largest. In other words, the displacement of two adjacent points had a significant difference in each direction. From the top to bottom of the monitoring points except for D1, the displacement gradually decreases, which indicates that the anchoring project on-site limits the development of slope cracks. Furthermore, Fig. 8 shows that all monitoring points in B area had the largest displacement in the X direction. However, the collapse of the downhill part of the slope provided a free face for the B area. As a result, a slope with three free faces was generated, this slope occurred a typical 'nodding and slouching type' toppling deformation due to gravity and external forces. The slope slipped along the sliding direction and the deformation mainly occurred in the middle

portion. As shown in Fig. 8, the different portions have different sliding directions. The displacement vectors direction of the A1 area firstly vertically downward, and then gradually changed to the horizontal direction. At the same time, the amount of the vectors also increased. However, in the A2 area, the direction of those vectors became more and more horizontal. The horizontal angle of the displacement vectors at the uphill side of the A2 (D12, D18) gradually decreased and their amount also decreased. In the B area, the displacement vectors' direction and values were different from that in the A1 and A2. First, the directions of the vectors slope downward (Fig. 8(a)), but on February 2, they become upwards slope (Fig. 8(b)). Secondly, the values of the vectors were smaller than other monitoring points. Compared with

Fig. 8 3D displacement velocity of the monitoring points on (a) Jan 30; (b) Feb 2

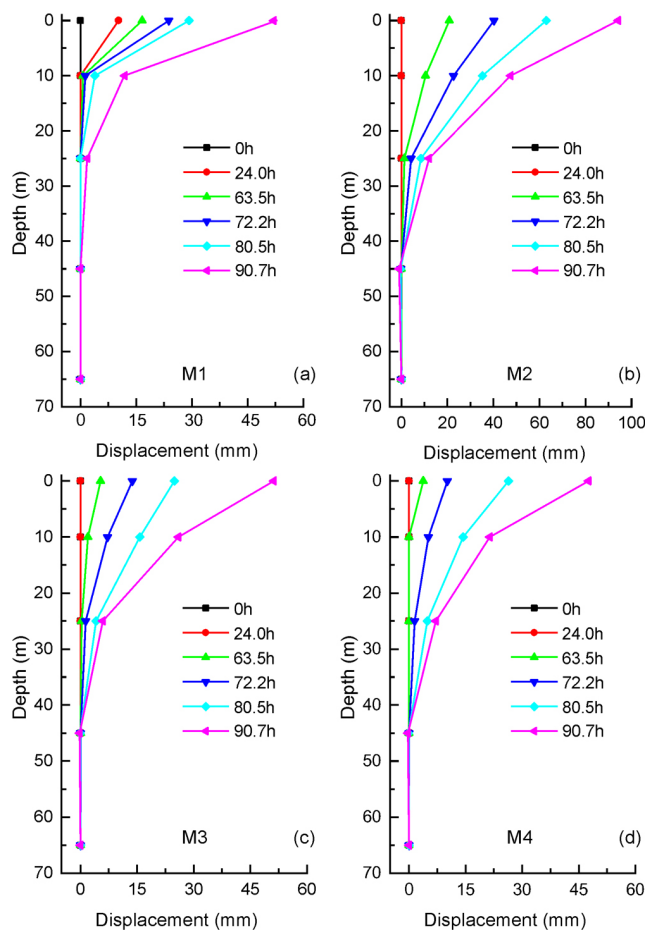
In order to understand the inside deformation characteristics of the slope, multi-point extensometers were installed at 0 m, 10 m, 25 m, 45 m and 65 m away from the slope surface. The monitoring results are as graphically demonstrated in Fig. 9. Firstly, the monitoring points at M2 (Fig. 9(b)), which

Fig. 9 Multipoint monitoring results, a) M1, b) M2, c) M3, D) M4

is close to the collapse zone A1 with two free faces, had the largest displacement and deformation depth compared with others. The deformation of these monitoring points gradually decreased as the increase of depths and reach 0 mm at depths of 25–35 m, which indicated that the deformation depth of the slope is 25–35 m. The monitoring point at M3 (Fig. 9(c)) had a lower evaluation and smaller displacement than M2. Secondly, the displacements of the monitoring points accelerated, especially near the shallow slope. As result, the collapse area was produced. Moreover, it can be seen from Fig. 9 that at the beginning of the monitoring work, there is no displacement at all points at the time of 0 h, but at 24 h, the deformation first begins at M1 and reaches a depth of 10 mm. After that the deformation rate begins to decrease gradually at M1 after the collapse area occurred and is mainly attributed to the fact the anchoring system still had a reinforcement effect to stabilize the slope. Thirdly, it also can be seen that the maximum displacement of M2 reached 85 mm which is larger than that of M3 (44 mm), indicating that the rear of the slope squeezes the front movement. In addition, the displacement monitoring results (Fig. 9 (a, b, c, d)) also show that the displacement gradually decreased from upstream to downstream, indicating the deformation model of the slope is toppling deformation. A5 area failure provides a new free face for B area and a new rock slope with three faces is generated. The shallow part of the slope integrally slips along the sliding surface. However, in the deformation area, the monitoring points are closer to the deposit area (A5) and have larger displacement, which could be inferred that the slope gradually deformed towards two open surfaces. The results of the drilling and deep deformation monitoring also show that the closer to the free face, the greater the depth of the deformation zone. This can be explained by the fact that the formation of the upstream collapse area gives rise to one free face turned into two free faces in the slope. In addition, this agrees well with the external deformation monitoring results.

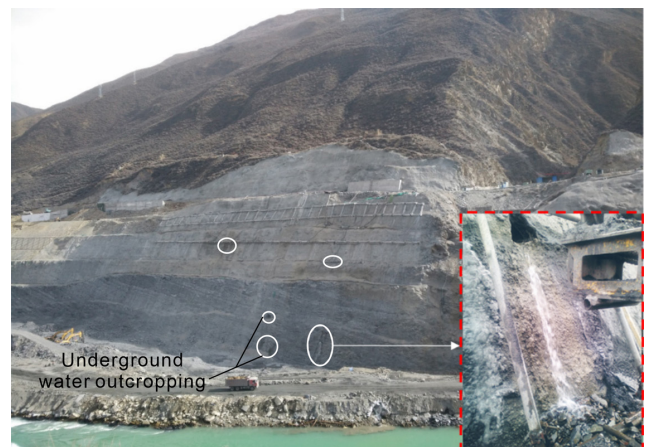
4. Underground water: Data from the detailed field investigation shows that the factor of safety for slopes can decrease significantly with increasing the groundwater level, and the impact is more significant on slopes with steeper joints. For example, after the rain and snowfall in mid-January 2015, ice and snow melt water infiltrated along the surface cracks, and the infiltration of ice and snow melt water reduced the physical and mechanical strength of the rock body on the one hand, and made the deformation modulus of carbonaceous slate in the rock body of the slope significantly reduced on the other hand, making the slope appear deformation and compression space. In addition, the volume of the groundwater expands after freezing, and the ice-splitting effect is unusually powerful, further increasing the crack opening width. Furthermore, the alternating effect of positive and negative temperatures during day and night, and the repeated freezing and thawing of fracture water, lead to large deformation of the slope. Thus, the slope had obvious deformation where the groundwater outcropped. Fig. 10 shows the outlet locations of groundwater, and this underground water outcropping is mainly located in the collapse area. The water content has a great effect on the compressive strength of the carbonaceous slate which decreases by 48.8% under saturation state and its softening coefficient is 0.52. After excavation, the underground water is developed and outcropped (Fig. 14). Moreover, the downslope was excavated over 50 m, and the unload rebound crack/fracture of rock mass is serious. As a result, the downslope is easy to fail and the deposit is fragmented (Fig. 3). Without the reinforcement of the downslope, the middle portion of the landslide gradually deforms and many tension cracks are formed. The A5 area

Fig. 14 The outcropping of the spring water

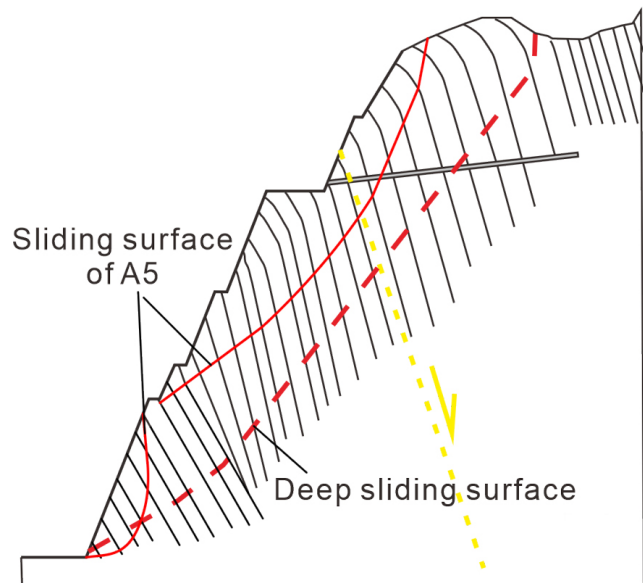
In conclusion, under the integrative action of the fault, unloading, gravity, in situ stress and groundwater, the toppling rock slope's upward progressively bending and deforming. The bending rock layer pushes and compresses the middle and front parts of the slope. The dynamic load is the main factor causing the failure of the slope. In the initial stage of excavation, the rate of dumping deformation increased, the horizontal displacement led to the protrusion of the slope, the vertical downward displacement increased rapidly, and the uphill part of the slope was deformed and affected to a greater depth. In the late stage of excavation, the deformation of the rock slope decreases and the slope gradually self-stabilizes. At the same time, under the softening of groundwater and compression of rock mass, the middle and uphill parts of the A5 area slipped and is cut out from the first berm path, while the lower rock mass is compressed and broken, and local collapse occurred (Fig. 15). The upper part of the slope produces many local collapses.

Fig. 15 Failure model of the Jiacha slope
