# REASONING ABOUT THE DAMAGE IN THE CENTRAL BUILDING OF THE TECHNICAL UNIVERSITY OF BUDAPEST

Ernő Biczók<sup>1</sup>

## Abstract

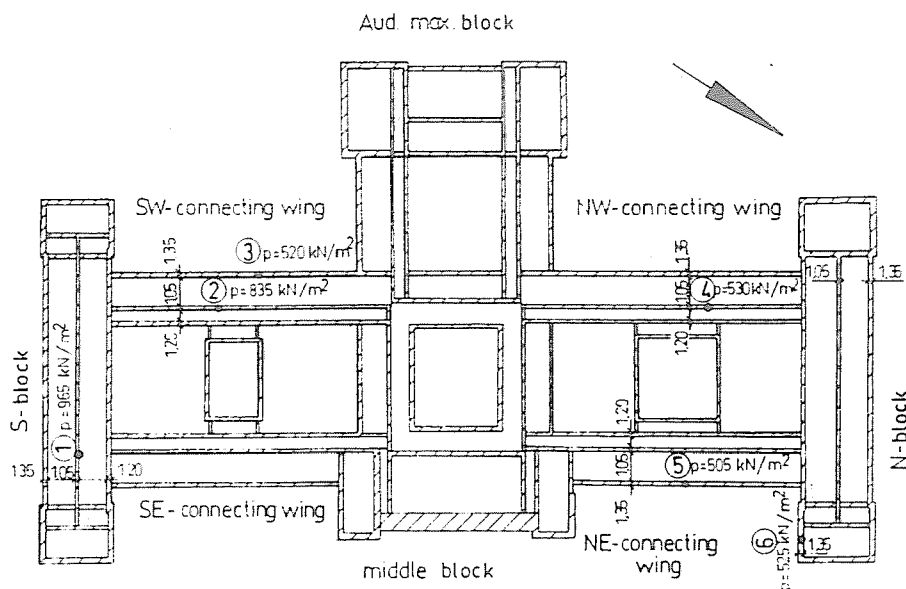
Fig. 3. Foundation system of the building

Several exploration pits revealed — surprisingly — that the width of strip foundations were consequently narrower below the more heavily loaded middle walls than below the main edge walls.

The foundation system with pertinent loads in the building is shown in *Fig. 3*. In the view of the present design practice the remark has to be raised that foundation stresses achieved extremely high values ( $\sigma_{\max} \approx 950 \text{ kN/m}^2$ ) which were not allowed today under even more advantageous soil conditions.

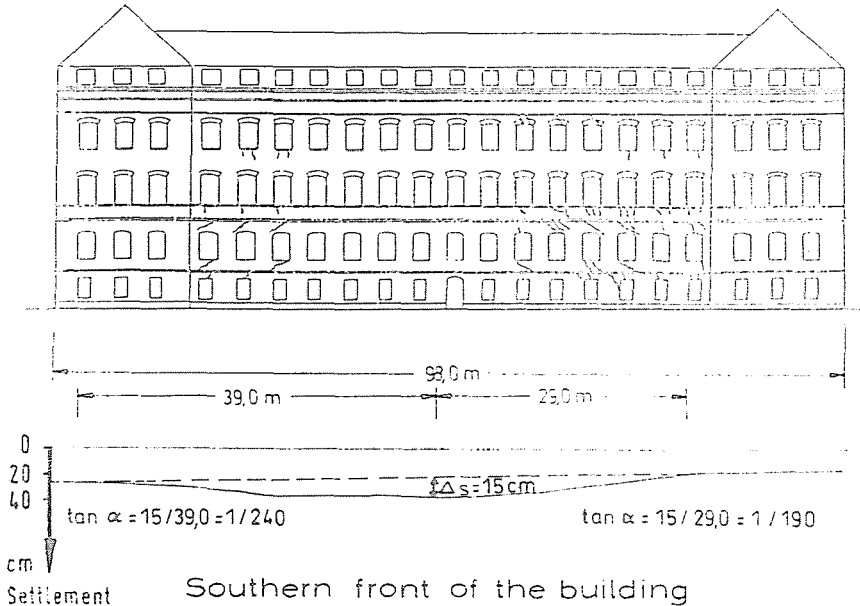
*Fig. 4.* Pattern of cracks on the southern front

Predominantly the southern block, even more expressively its mid section between the two turrets and the SE connecting wing were affected by damage. The pattern of cracks on the southern face of the building refers to reasons of subground origin (*Fig. 4*).

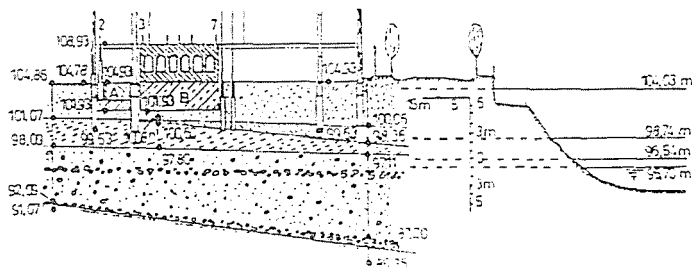
Fig. 5. Some results of professor Oltai

- the foundation block heaved or sunk always parallelly with the alteration of the buoying force provoked by the fluctuation of water level in the Danube. Magnitude of this movement attained e.g. 1.1 mm for a 4.5 m change of the water level;
- both the foundation block and the surrounding edge walls suffered a continuous settlement of about 0.5 mm to 0.6 mm in every year;
- the fluctuation of the ground-water level followed regularly and without a time lapse the change of water level in the Danube.

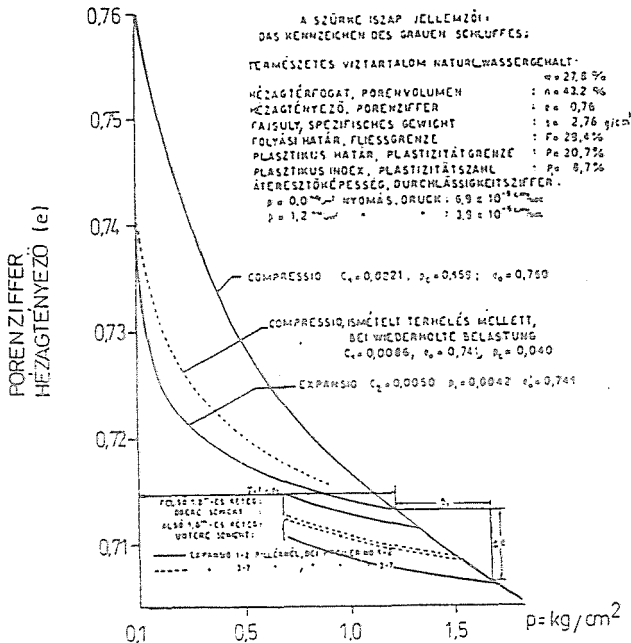
Fig. 6. Compression of a silt sample (from professor Jáki, 1933)

Professor Jáky completed an investigation about the compressibility of the silty strata below the concrete block in the Surveying Institute in 1933(!). Alternating loading effects were imposed on the specimen, imitating the variation of heaving forces in the wake of water level fluctuations.

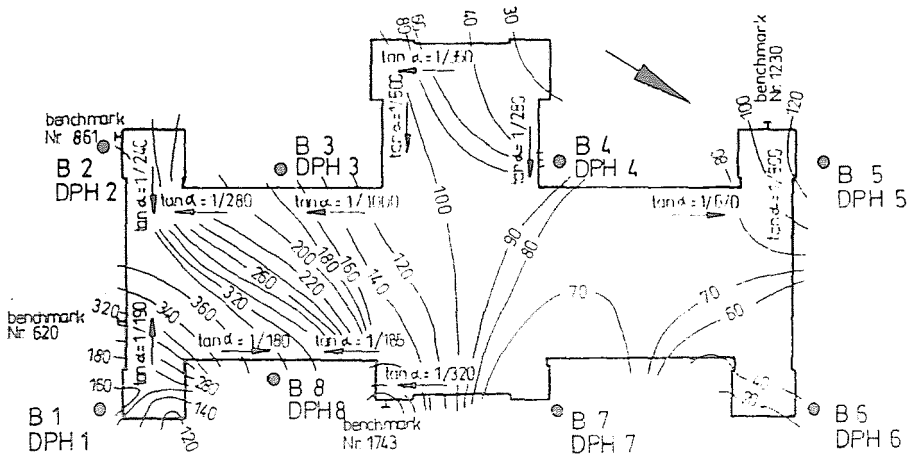
Fig. 7. Levelling data

It can surely be assumed that the wall footing was originally designed with horizontal lines. Its elevation was levelled in 1991. The isohypses deduced from the general survey are presented in *Fig. 7*.

The contour lines show a plain view about ensued settlements. The total settlements in the southern building block and in the SE connecting wing amounted to 36 cm.

Exactly similar results were obtained from the levelling of the first and second floor passageways. Differential settlements of 290 mm and 195 mm were measured on the first and the second floor, respectively.

Analysis of settlements infers that the movements started already during the time of construction: signs of trying to rectify their influence can be traced at various elevations in the building. It might be supposed that approximately 7 cm settlement had developed when the building height reached up to elevation of the first floor and an additional 9 cm, i.e. altogether 16 cm settlement, by the time when the second floor was completed.

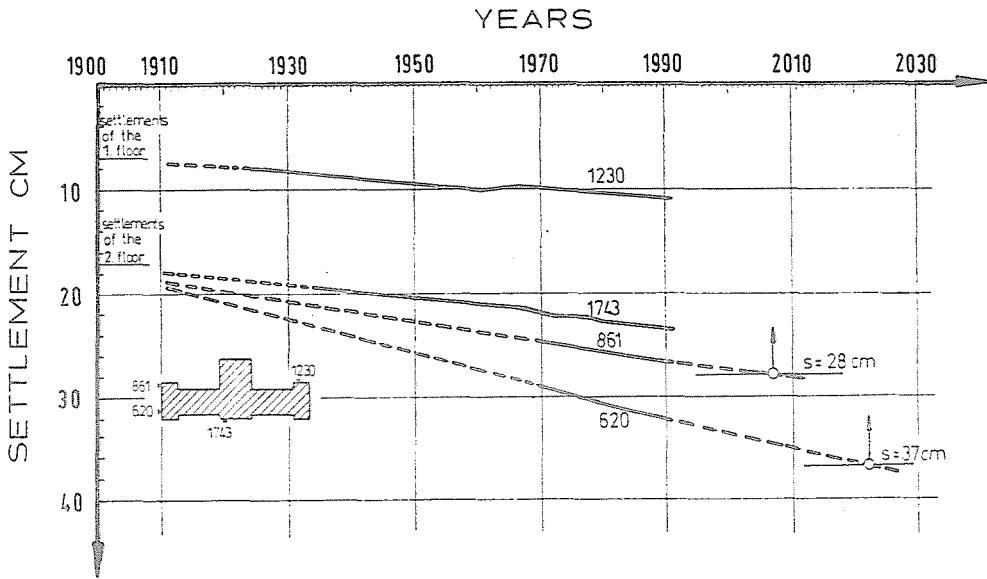
Fig. 8. Time dependent settlement of the benchmarks

Time dependent settlement of the benchmarks is shown in *Fig. 8*. Principle of this evaluation was that measured settlements were plotted backwards in time, starting from the present elevation of the wall footing, known from most recent levelling results.

- the northern part of the building suffered less displacement than the southern part of it and even more settlement took place in the front wall to the Danube;
- the character of settlement appears to be linear and not that of a conventional consolidation curve;
- the tendency in the settlement of benchmark No 1743 shows an abrupt increase after 1967; this fact might be accounted for the influence of increased loads arisen by the reconstruction work in the roof space in 1963-64.

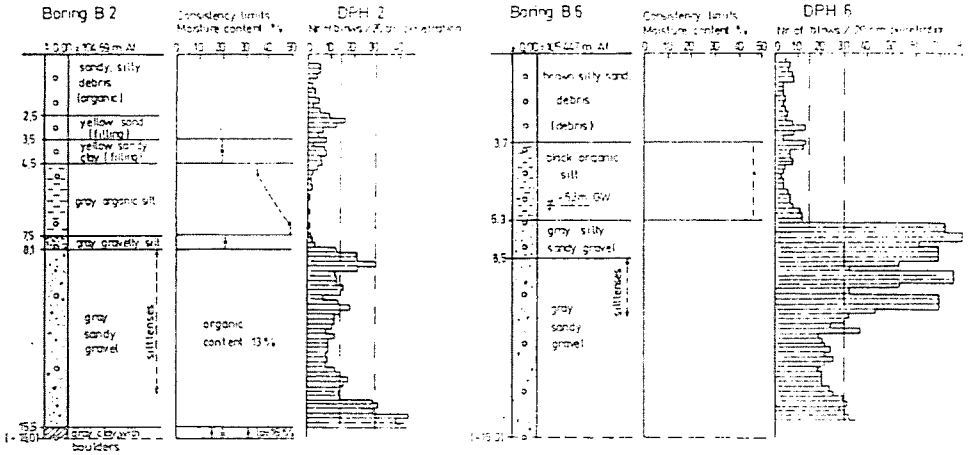
Fig. 9. Typical soil profiles and sounding results

Results of heavy dynamic probings show significant differences in the density of the sandy gravel below the southern and northern parts of the building. In the southern part resistance of  $n_{20} = 8$  to 15 has been experienced, showing a rather loose condition in the average. On the northern part values of  $n_{20} = 30$ , or greater were achieved, i.e. the sandy gravel was in a dense to very dense condition at these places.

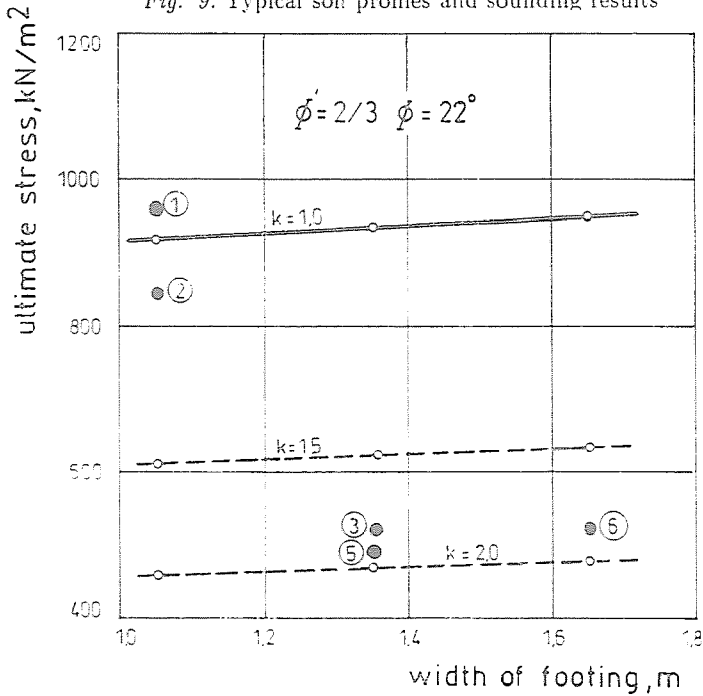
Fig. 10. Load bearing capacity and factor of safety

The stresses belonging to different safety factors (e.g.  $k = 1$  means the ultimate bearing capacity) vs. foundation width are illustrated on the Fig. 10. Plotting the actual stresses according to Fig. 3 (dots 1 to 6) can be seen that the factor of safety for the internal walls lies about  $k = 1.0$ . It means that a local failure might occur during the construction of the building. Most probably, it manifested itself in a sudden, subsidence- or collapsing-like settlement.

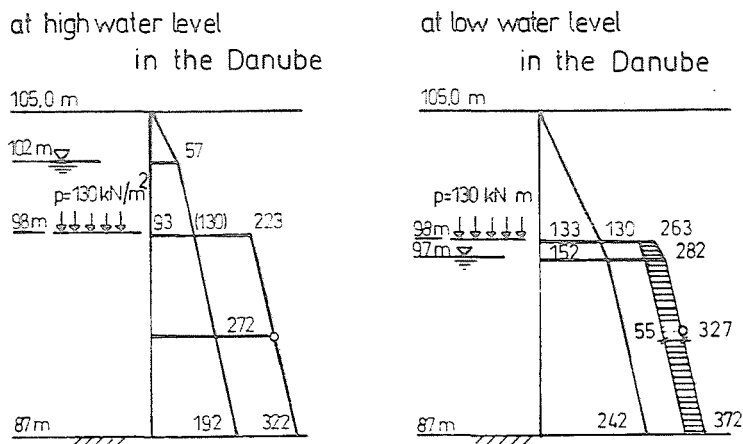
Fig. 11. Stress diagrams at high and low water level

Fluctuation of ground-water level induces significant changes in effective stresses in the soil. Repeated subsequent increase and decrease of stresses cause additional compression in the granular soil skeleton (Fig. 11).

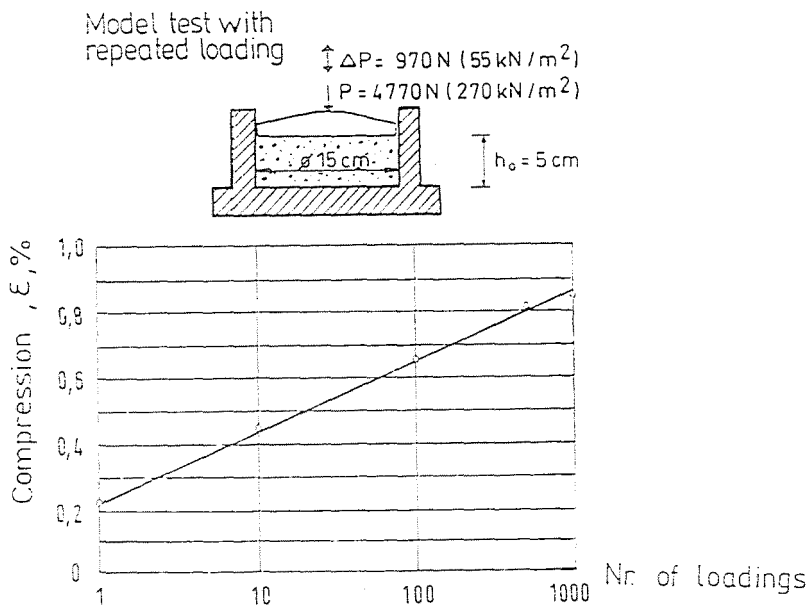
Fig. 12. Arrangement of model test and test result

A model test has been completed to clarify this phenomenon. Arrangement of the testing procedure and the results are shown in Fig. 12. Alternating loads in the range of pressures caused by the dead weight, the

live weight from the building and the stress due to fluctuation of the water level in the Danube were sequentially imposed on the soil specimen.

The test has proved that with increasing number of repeated loads (i.e. cycles of flood) compression is continuously progressing, though in a diminutive rate (logarithmic scale).

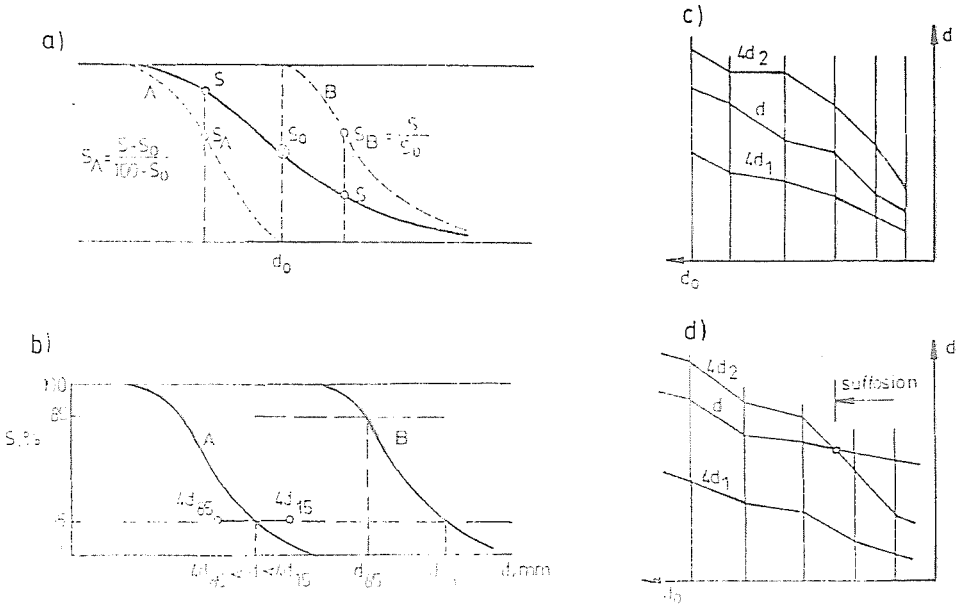
Fig. 13. Examination of self-filtering capacity

Thezagh's filtering rule will be used. When the self-filtering capacity of a soil is examined, the soil is divided into two portions at any arbitrary grain size,  $d_0$  (respectively soils *A* and *B*, Fig. 13a). It has to be checked whether part *A* would satisfy the filtering rule against part *B* (Fig. 13b). The procedure is then to be repeated for several  $d_0$  grain sizes. Plotting the results in a  $d_0 - d$  coordinate system, it can also be read off whether the soil was capable for self-filtering (Fig. 13c) or not, respectively which grain sizes are prone to being leached out (Fig. 13d).

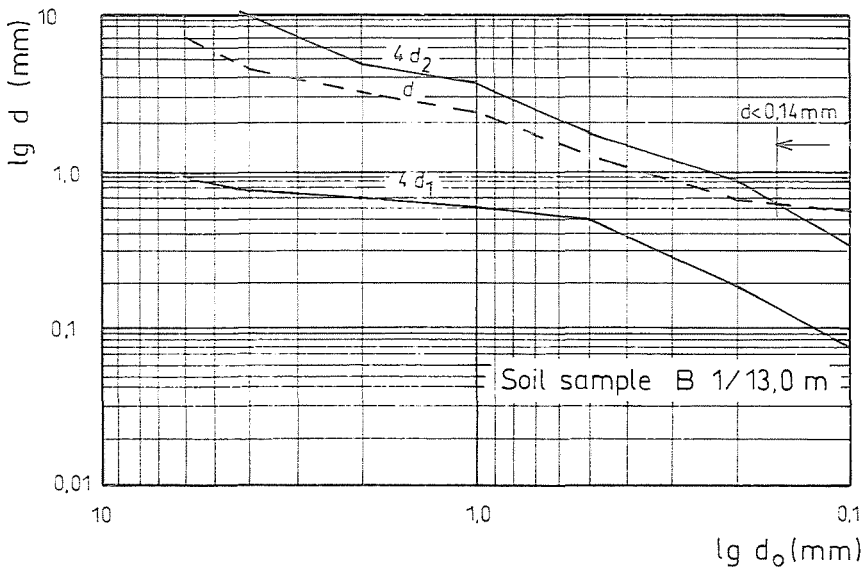
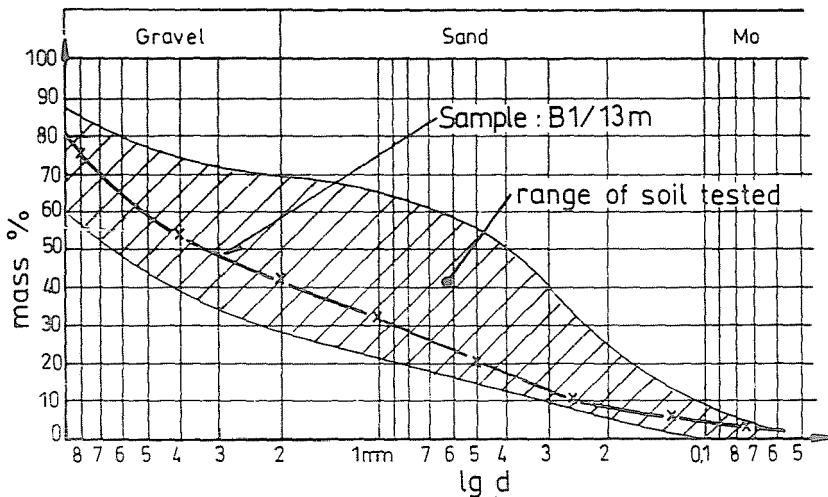
Fig. 14 shows an example about a completed test. On the Fig. 15 the range of tested soils is illustrated.

Our tests have proven that the sandy gravel has no self-filtering capacity and potentially about 20 per cent of the grains might be washed out from it.

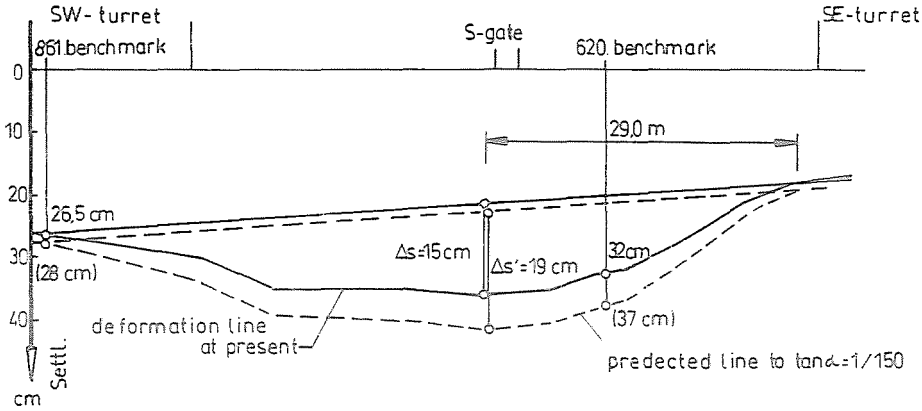
Fig. 16. Predicted deformation line to  $\tan \alpha = 1/150$

Records from the longlasting observation period enable a prediction about the future performance of the building. In Fig. 16 the deformation line of the wall footing of the building's southern front is presented. Calculations show that the critical angular distortion ( $\tan \alpha = 1/150$ ) will be reached at a settlement of  $s = 19$  cm. The corresponding deformation line can be constructed and from that curve the anticipated settlement of the bench marks can be predicted. The expected time for such settlement can be read off from the extrapolated deformation line in Fig. 8 — the southern part of the building may get into critical situation in 25 to 30 years.

To stop the continuity of the settlement the loose sandy gravel has to be excluded from the bearing capacity. Loads should be transferred to the underlying load bearing strata e.g. by means of:

- underpinning the walls by small diameter injected piles
- underpinning the wall foundations by 'jet-grouting'
- strengthening the loose sandy gravel by grouting.
