THE DAMAGE OF THE TALL BUILDING AT PÉCS

Á. OROSZ

Department of Reinforced Concrete Structures
Technical University of Budapest

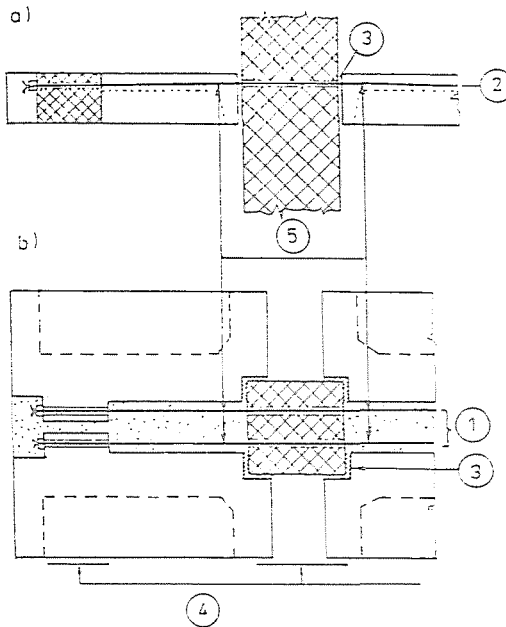
- from the 80 places investigated
 - at 70 % strong corrosion,
 - at 30 % failure of the prestressing tendons were found;
- the corrosion was caused by the high chloride content of the filling mortar – the UP paste – applied at the column floor-slab joints, the chloride corrosion always occurs in the neighborhood of the UP paste;
- the corrosion is an increasingly accelerating process which can cause a dangerous situation in a few years;
- at the crossing of the columns and at the cantilevers the prestressing wires are not properly grouted (*Fig. 2*); they are in a critical state especially at the cantilevers subjected to weather effects and the facade elements supported by them.

Fig. 2. The places of the wire corrosion and the ungrouted sections
 a.) section, b.) ground plan,
 1. cast in situ concrete, 2. prestressed wire,
 3. joining mortar (PU), 4. ungrouted sections,
 5. corroded tendons

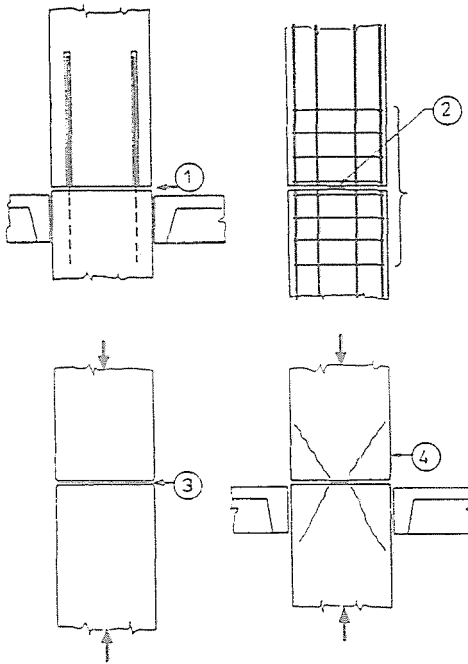
- At the joint of the columns at some places the grouting was not carried out or in several places instead of cement mortar plastic mortar was applied which according to the exposure in some places is still in plastic state. This is dangerous because at the joints the force transfer is made by 100 x 100 mm large steel sheet and at the ends of the columns against bursting the amount of stirrups is not satisfactory.

Fig. 3. The places of the column joint deficiencies

1. ungrouted joint,
2. steel plate,
3. effectively grouted joint,
4. cracks, splitting

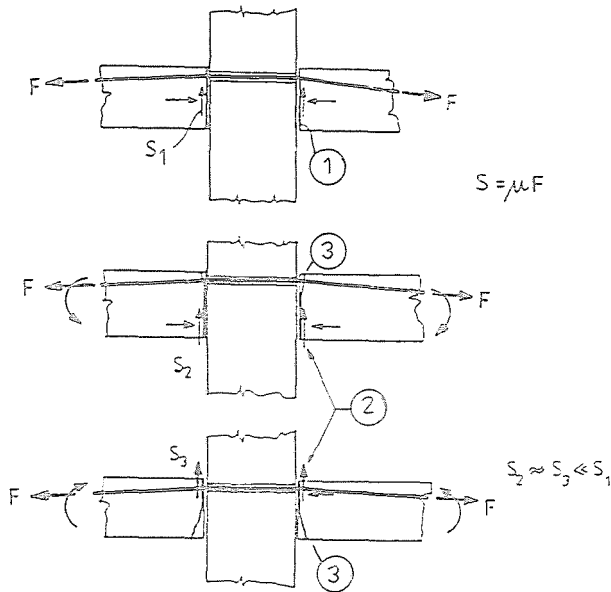
- there is a need of compensation of the prestressing force (*Fig. 4*);
- the prestressing force is anchored beside the column in a 1–1.5 meter length by bond, in the length between the columns the prestressing force is acting (remaining prestressing) and so the prestressing is unnecessary;
- the subsequent prestressing in the middle section therefore can be disadvantageous;
- the subsequent prestressing is acting on the whole floor system. At the columns only a smaller part of the prestressing is effective and so the increase of the frictional force is hardly attainable. In the internal sections of a long building the effectiveness of the subsequent prestressing computationally cannot be followed.

Fig. 4. The static state of the column-floor-slab interaction
 $S = \mu F$ force of friction,
 1. The full cross-sectional area is under compression,
 2. the area under compression,
 3. cracks

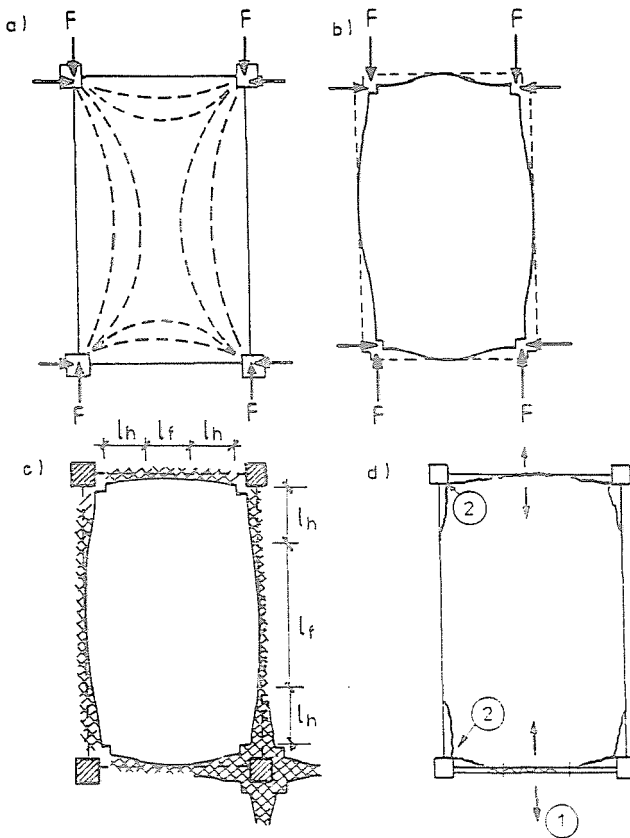
Fig. 5. The effects of prestressing in the floor-slabs
 a. The distribution of the prestressing force. (Initial state),
 b. The deformations after the prestressing.
 c. State after the corrosion:
 l_h - the length of anchorage
 l_f - active prestressing length
 d. Tension (1) and compression (2) in the floor-slabs

The checking of the precast floor elements showed that the middle part of the lattice could bear the actual loading merely by normal reinforcement. In spite of this that strengthening method is effective which is suitable to restore the initial force equilibrium state (Fig. 5). It is not easy to find such a method therefore it is necessary to satisfy the following requirements:

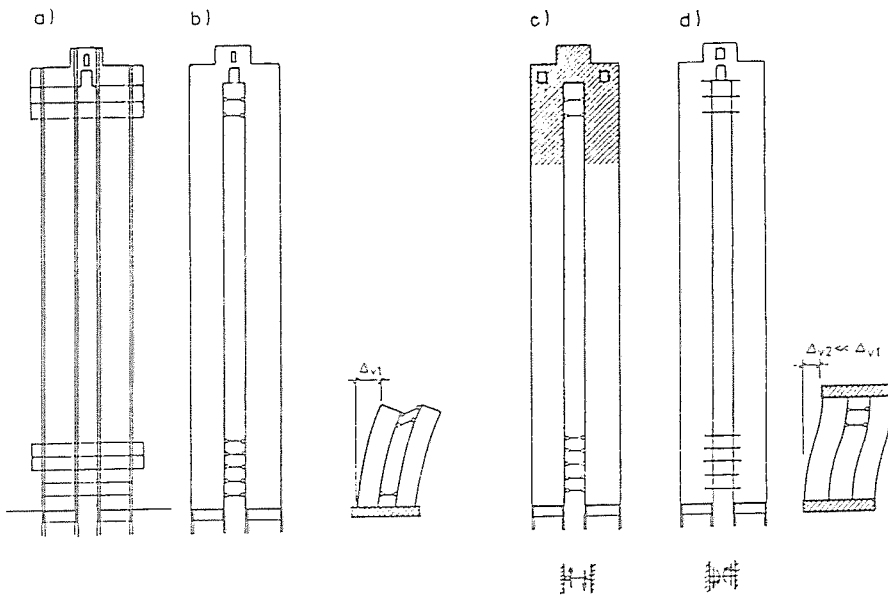
The lateral stiffening system in its actual state is shown in *Fig. 11a*. According to the control calculations the actual top braces are overloaded. The possible variants of the strengthening are:

- to build in new shear walls;
- to alter the statical system of the existing walls, i.e.
- the strengthening of the internal braces
 - on every storey (*Fig. 11b*) or
 - in some places (*Fig. 11c*).

The most advantageous solution from the point of view of the structural forming as well as the constructing is the strengthening of the top braces. This has the advantage that the constructing works are concentrated in one place and there is no need to reconstruct the frame effect during the floor-slab strengthening, so it affords a solution to realize such strengthening which does not increase significantly the moment bearing capacity of the joints.

Fig. 11. The strengthening of the stiffening system in lateral direction

- a. cross section,
- b. the shear walls,
- c. top bracing,
- d. internal bracing

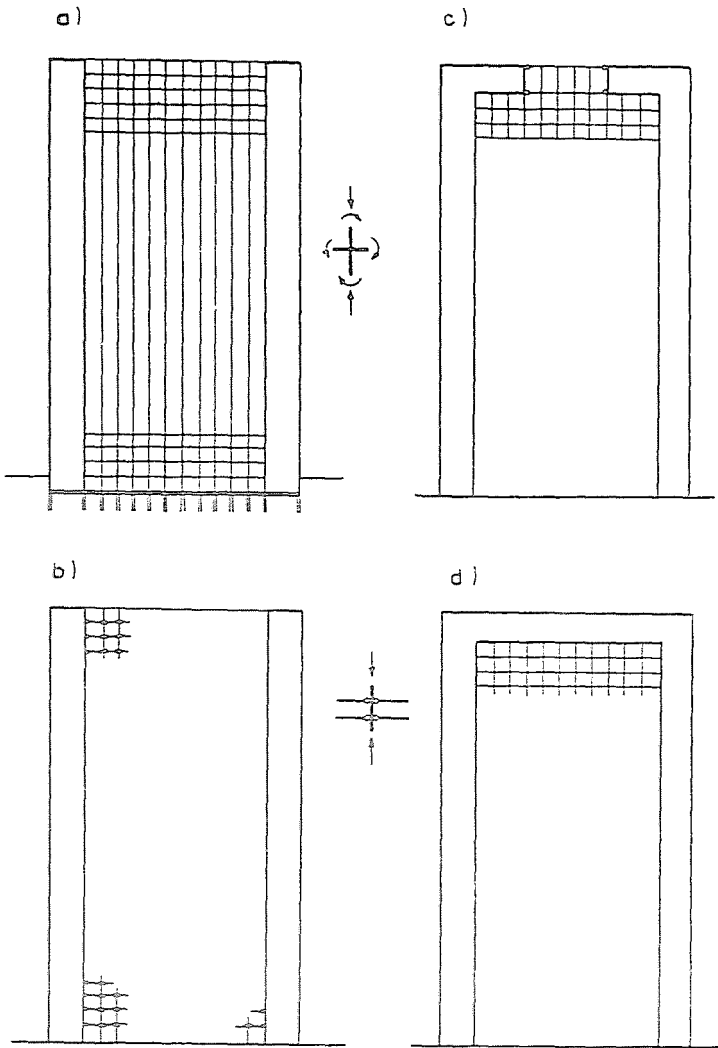
The structural shape of the stiffening system is shown in *Fig. 12*. The stiffening system is hardly sufficient almost in the case of properly operating frame effect. The possible methods of strengthening are:

- to build in new shear wall(s);
- to reconstruct the frame effect;
- to alter the statical system of the existing walls by
 - partial or
 - total top bracing.

Among these variants we suggest again the strengthening with top bracing, namely the structural forming of the top stories of the building have to be altered in any case.

Fig. 12. The strengthening of the stiffening system in longitudinal direction,
 a. the stiffening system,
 b. the shear walls with frame,
 c. partial top bracing,
 d. total top bracing
