## FATIGUE TESTS ON THE OLD STRINGERS OF THE RAILWAY BRIDGES

A. SZITTNER, L. KRISTÓF and L. KALTENBACH

Department of Steel Structures,  
Technical University, H-1521 Budapest

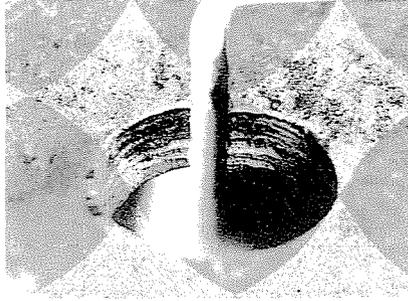
With the specimens B of a cross-sectional area reduced by the original rivet holes, the unexpected result was obtained that the lowest ‘fatigue limit’ was observed with the specimens cut out of the middle of the web plate. The cause of this phenomenon is given clearly in photo No. 3 taken of specimen GK 3. Since the original hole in the specimen has an extraordinary rough surface, it was probably processed without ‘reaming’, and this fact verifies the lower value. Since a hole of such a layout can occur anywhere, the low fatigue limit is determined by the technology used rather than by the position of the hole.

*Fig. 3.* Rough surface of rivet holes developed with high thread pitch

the final dimensions of the rivet holes should be developed by reaming after occasional boring or punching.

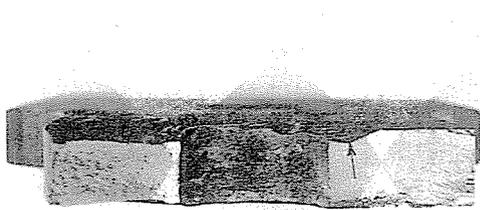
*Fig. 4.* Fatigue-failure started from a surface deficiency

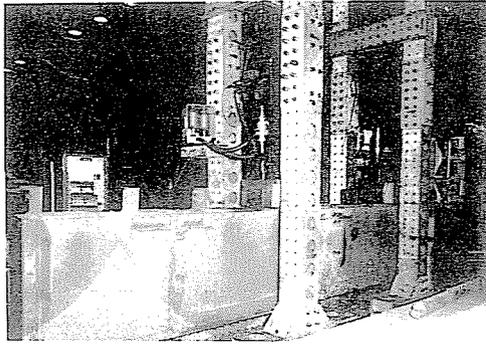
*Fig. 5.* Structural fatigue loading of the stringer of the Southern Railway Bridge in laboratory

During the experiment conducted in a proper way, neither fatigue failure nor any sign of it could be observed.
