EXAMINATIONS FOR THE DETERMINATION OF LOAD-CARRYING CAPACITY OF THE BRIDGE OVER THE SEBES-KÖRÖS AT VÉSZTŐ

GY. SZABÓ

Department of Steel Structures
Technical University, H-1521 Budapest

Abstract

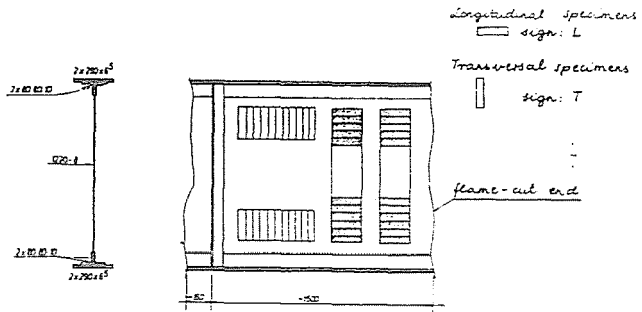
Fig. 1.

A possibility was offered for cutting out specimens from about 1.5 m long part of the flood-plain structure destined to be demolished due to the bad corrosion damage of the flange-plates.

Owing to the fact that the flanges were corroded to a very great extent, the tests were performed, first of all, on the samples cut out of the web. The arrangement of cuts is illustrated in *Fig. 1*.

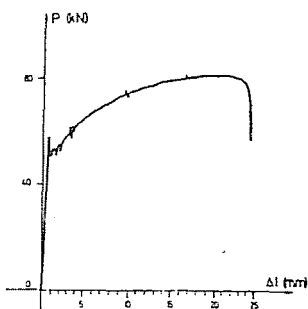
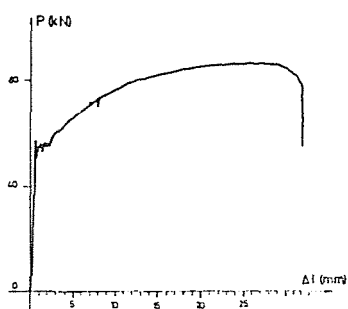
After the completion of fatigue test, flat specimens were processed cut out from the stringer and then the most important characteristics were determined (see *Fig. 5*). The values measured on the two specimens were yielded as follows:

The yield-point was slightly lower than the values measured on the web of the flood-plain bridge, however the other results were in fact identical.

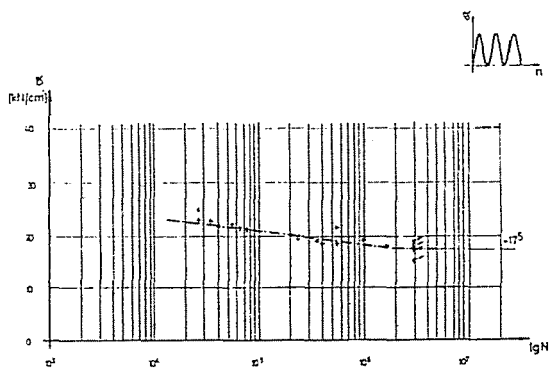
Fig. 6. Fatigue results of flat specimens

The results of the tests are shown in *Figs. 6, 7, 8 and 9*. In addition to the numerical results obtained, the following conclusions can be inferred from the tests:

1. There is no considerable difference between the results obtained with the specimens of longitudinal- and transverse directions.
2. The previous fatigue has no detectable effect on the cycle-number required for failure. The same can be claimed for the specimens which did not suffer failure on the first stress-level chosen under the influence of cycle- number $3 \cdot 10^6$.
3. Somewhat greater standard deviation is yielded in comparison to the steel materials used nowadays.

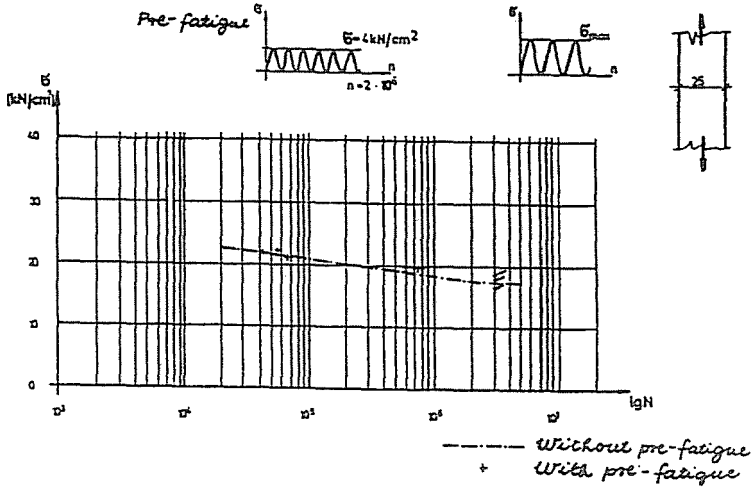
Fig. 8. Fatigue results of specimens subject to previous fatigue

Nine flat-shaped specimens were subject to previous fatigue process on $\sigma = 40 \text{ N/mm}^2$, then they were subject to the test mentioned above.

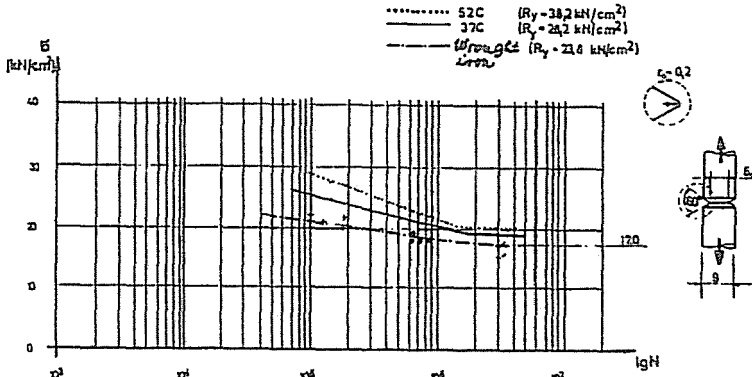
Fig. 9. Fatigue results of notched specimens with circular cross section

For the purpose of a more accurate comparison with the materials used nowadays, the results obtained with the notched specimens of a circular cross-section can serve, as shown in *Fig. 9* since the identical circumstances of the tests can be created technically with these specimens.

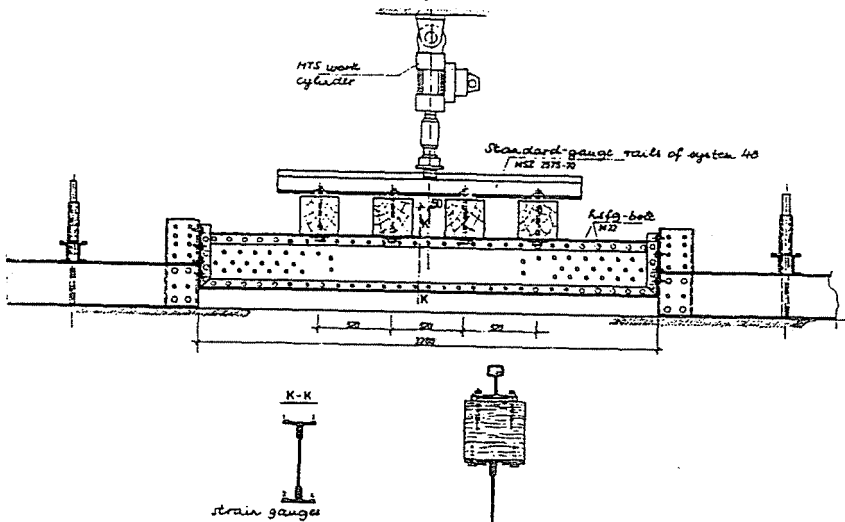
Fig. 10.

According to the original scheme of mounting, pieces of the sleepers, and the normal-gauge rails of type '48' were mounted on the stringer. The fatigue-load was applied by a work-cylinder positioned in the middle of the stringer. The layout can be seen in *Fig. 10*.

The failure occurred on one of the flange angles on the tension side. The crack prior to failure started from two places. In both places, the cracking started from a rivet-hole, one of them was the flame-widened place of a removed rivet, the other one was a flange-rivet in its original state. The crack propagation across the full cross-section of the flange angle occurred

in the cross-section of the above mentioned flange-rivet. The crack was initiated on the web, too, it was propagating in about 5 - 6 mm length above the leg of the flange in a way well observable to the naked eye. This state of the stringer was considered a failure.

In the case of a load of 180 kN, the failure occurred after a cycle-number $n = 1.200.000$ on one of the bottom flange angle in tension.
