# ANALYSIS OF THE FALL-DOWN OF THE BRIDGE OVER THE HERNÁD AT GESZTELY

P. PLATTHY

Department of Steel Structures  
Technical University, H-1521 Budapest

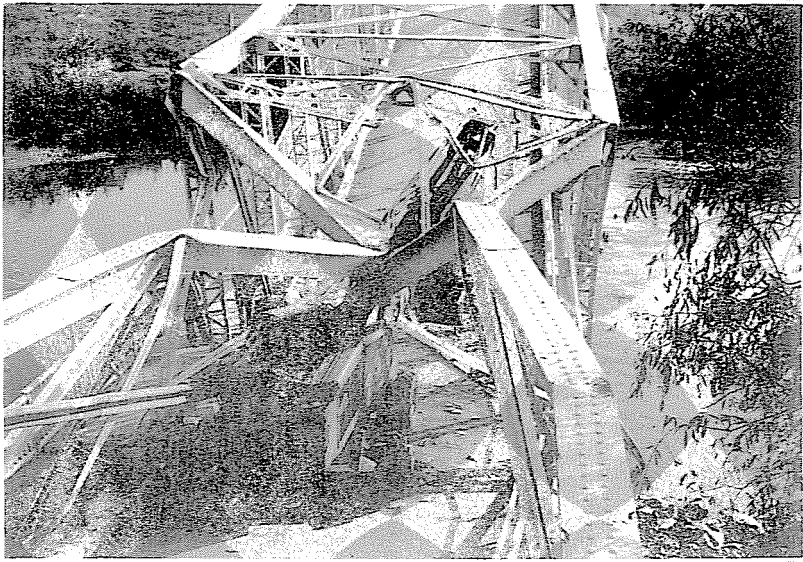
*Fig. 1.*

- a) The collapsed bridge was an old type trough structure, designed with the use of principles not applied any more in today's practice, and constructed with riveted trussed main girders (*Figs. 1 and 2*).

- d) The main girders of the bridge were subject to repair and repainting in the course of rebuilding of the floor structure.
- e) the time of the on-site inquiry, only the excavator was left behind on the bridge, by the lorry was hauled away in the meantime. The excavator could not be removed without demolishing the structure, because the structural material got entangled in the jib of it. It could be stated unambiguously that the jib got caught in the first transverse bracing of the upper wind brace and, as a result, the upper chord was contracted by the tensile force arisen in transverse bracing (*Fig. 1*).

As it could be stated also in the course of the on-site inquiry, the jib of the trailed excavator got caught in the upper transverse bracing and, as a result, the contraction of the upper chords was brought about by a force  $Q$  (*Fig. 1*). It is problematic what magnitude of tensile force  $Q_t$  could take an effect eliminating the resistance (load-carrying capacity) of the chord.

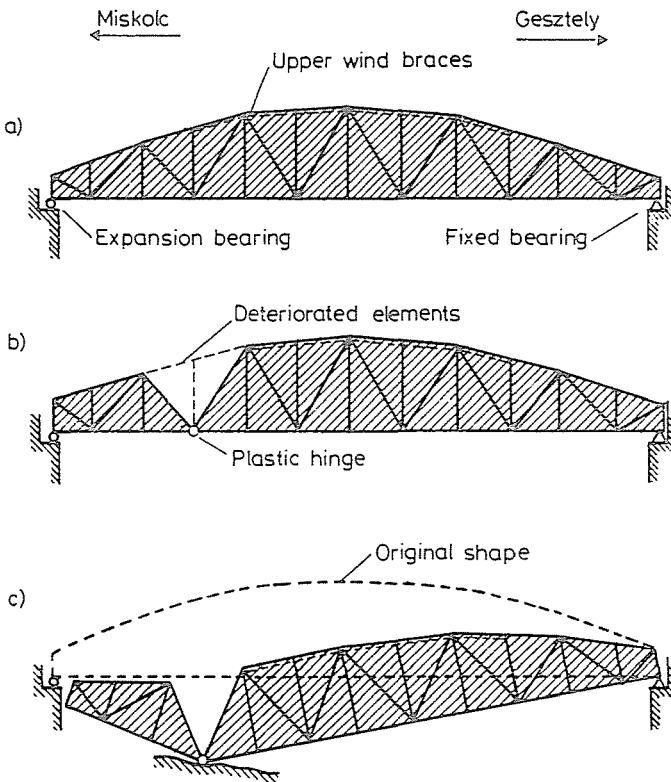
*Fig. 3.*

- a) The lorry hauling an excavator entering the bridge from the direction of Miskolc (Onga) overpassed the cross-sectional area at the fourth post of the trussed main girder where the transverse bracing of the upper wind brace was laid out (*Fig. 3a*) while the jib of the trailed excavator got caught in this transverse bracing. By the effect of impact, the transverse bracing deflected the upper chords of the main girder together with the posts assembled from their original plane (contraction), as it can be seen in *Fig. 1*.

effect of deadweight and the weight of the hauled vehicle — lost their load-carrying capacity (they underwent plastic buckling) and so did the posts, too. Consequently, the elements (bars) traced in dashed line in *Fig. 3b* did not work any more. This involved the consequence that, in this place, both the joint of the bottom chord, and the floor structure were overloaded, which — in turn — led to the development of a plastic hinge (as indicated in *Fig. 3b*).

- c) The structure becoming a kinematic chain (unstable bar chain) due to the plastic hinge collapsed slowly under the influence of the loading weights (deadweight, lorry, excavator), the girder end at the bearing-support came off the abutment, and the section of the bottom chord to which a change in direction was brought about due to the plastic hinge was leaning on the bottom of the river bed (*Fig. 3c*). In this position, the structure — as pieces of 2 two-support beams — was held in equilibrium.

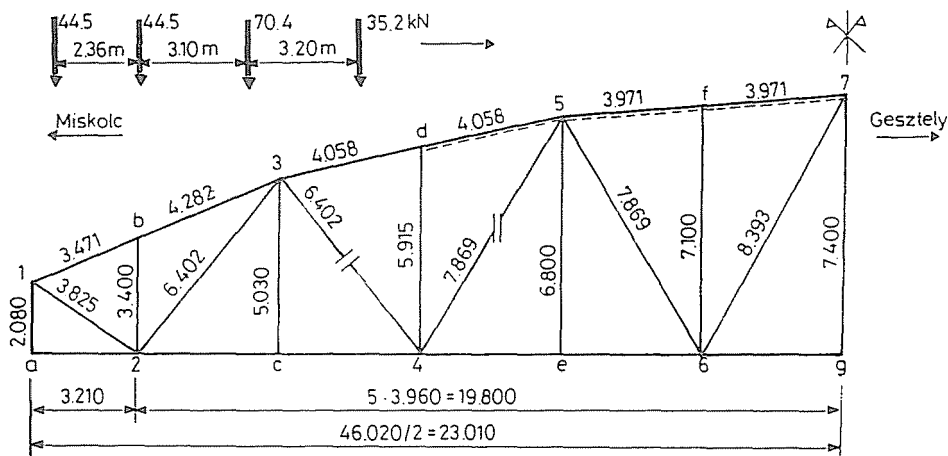
Fig. 4.

while the data of the vehicle passing through at the time of collapse, as well as the network of the main girder are shown in *Fig. 4*.

According to force-theory calculations, the maximum calculated compressive stress arisen in the upper chord No 3-5 of main importance with respect to the failure of the structure — if load 'C' is taken into consideration — was yielded as:

These stresses are essentially smaller than it could have been permitted for the given structure on the basis of the slenderness of the bar, or the rigidity of frame, respectively. Thus, e. g. the permissible stress for a bar of symbol 5-d on the basis of slenderness would have been:

Consequently, the failure of the bridge could not have occurred due to the loss of stability in the case of a normal service.

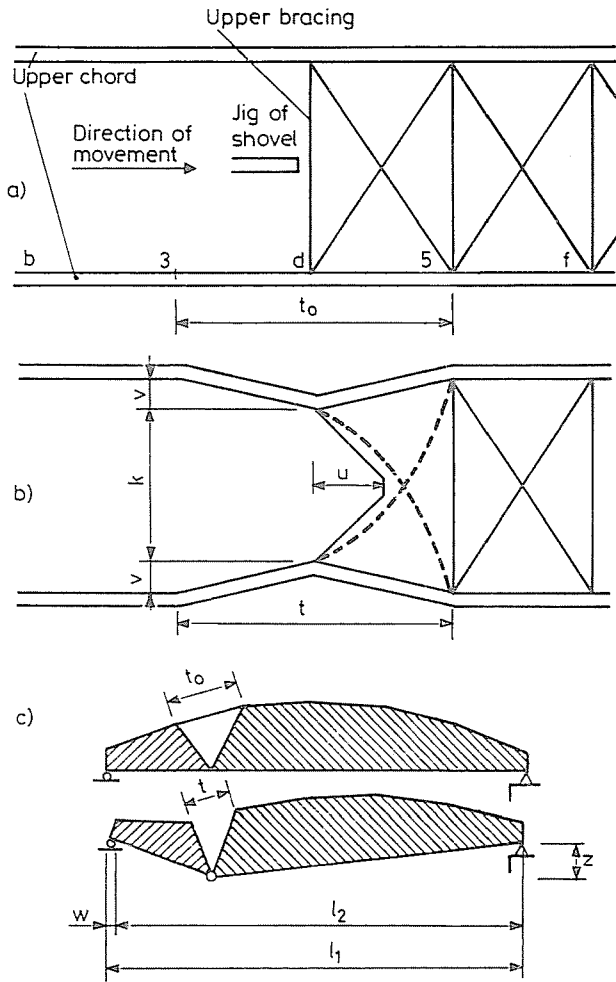
Fig. 5.

*Figs 5a* and *5b* show the top view of the structure in the state prior to failure, and its state during the failure process, respectively.

In *Fig. 5c*, the side elevation of the structure (main girder) can be seen in the state prior to failure, and during the failure process, respectively.

The geometrical data indicated in *Fig. 5* ( $t_0$ ,  $t$ ,  $l_1$ ,  $l_2$ ,  $k$ ,  $v$ ,  $u$ ,  $w$ ,  $z$ ) are correlated with each other. If the change in length of the elements is disregarded (elongation, compression), then the relationships can be determined relatively in a simple way, and the motion of the structure during failure (kinematics of the developed mechanism) can be described or examined mathematically.

well as the dimensions of the structure are taken into consideration, and an ideally elastic-plastic material is assumed, as well as a theory of the second-order is used, then the relationship between contracting force ' $Q$ ' and transverse displacement ' $e$ ' (in Fig. 5b, the displacement indicated by ' $v$ ') can be determined for the two extreme cases, particularly with respect to:

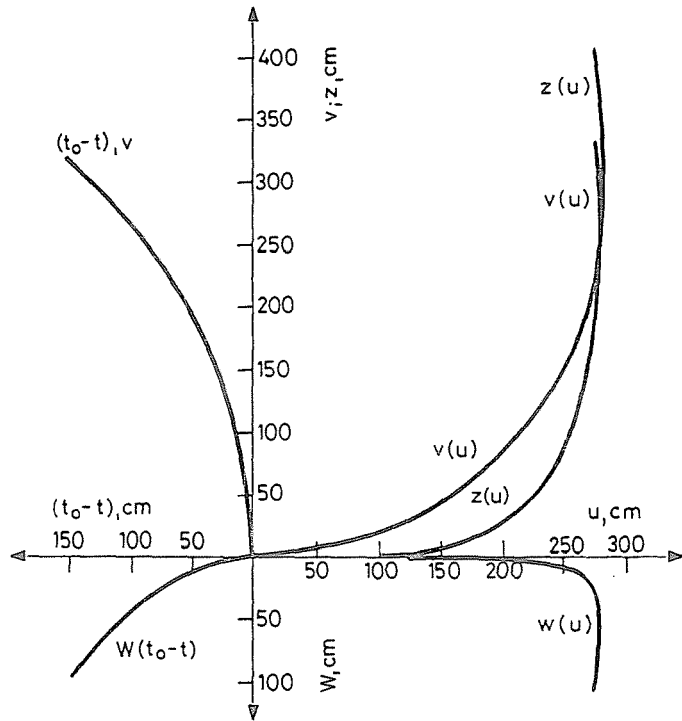
Fig. 6.

It is reasonable to examine the behaviour of the mechanism as a function of the vertical displacement ( $z$ ) of the plastic hinge brought about on the bottom chord. The data calculated in this way are contained in *Table 1* and *Fig. 6*, respectively.

The results obtained by means of the simplified kinematic model are in harmony with the state experienced during the on-site inquiry. Thus, e. g. the end towards the bearing support of the bridge had to fall from the abutment.

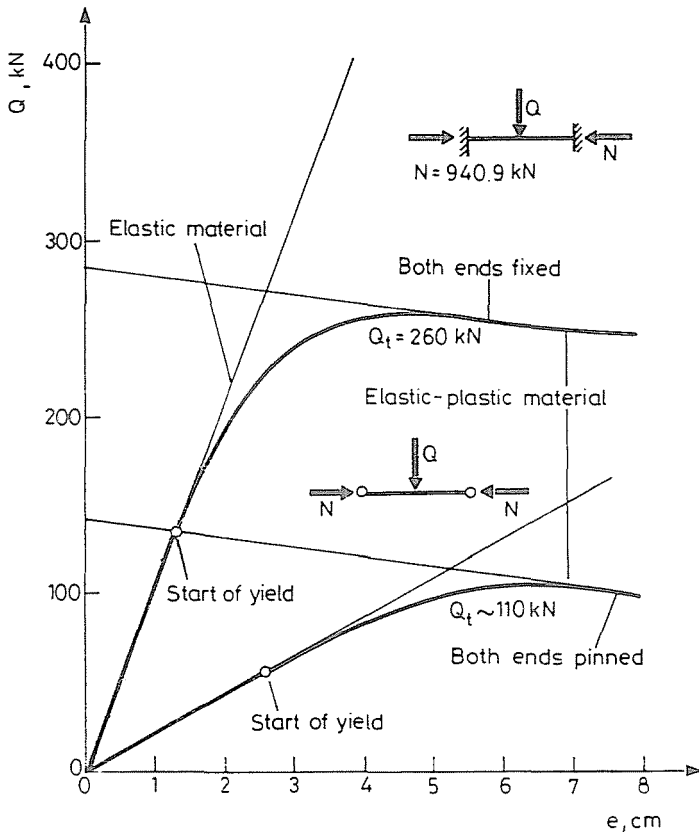
The results of the approximate calculations of this type performed by means of stability functions stipulated in MSZ 15024/4-85 are shown in Fig. 7. Since the reality is closer to the case of the clamped bar (the intermediate post, too, reinforces the chord to some extent, though it is not too considerable according to the numerical examinations), on the basis of Fig. 7, it can be accepted as an approximation that the stability of chord 3-5 occurred by the effect of transverse tensile force:
