# INVESTIGATION OF A SLOPE SLIDE ON THE MOTORWAY M-3\*

J. FARKAS—L. NAGY

Department of Geotechnique, Technical University, Budapest

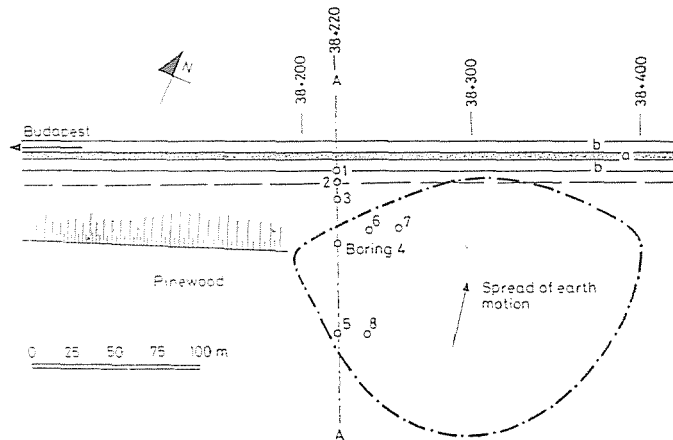
The original hillside sloped 16—18 percent to the north-west; the envisaged slope of the borrow pit was 20 to 26 percent. During earth excavation on 13 April 1978, several thousand cubic metres of earth over an area of 200 m × 130 m slid down toward the motorway. Fortunately, the lower part of the slip surface intersected the slope surface at the edge of the parking lane, thus, the pavement structure was not damaged, only the premixed cement stabilization pavement of the parking lane got damaged along 20 m length and 1 metre width. During the excavation of the slid earth masses and the

slope reconstruction, repeated, seemingly continuous motions took place, the slip surface gradually "receded". The layout of the damaged area is depicted in Fig. 1.

Fig. 1. Layout of the landslide a — central reserve; b — pavement

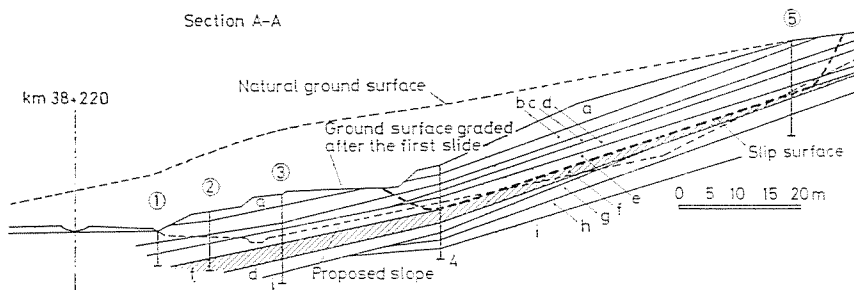
After the surface earth masses started to slide (in March and April 1978) UVATERV surveyed the situation and drilled prospect holes in three sections. Data obtained by boring permitted to map the stratification of the hillside sections. A characteristic section (A—A) taken at the location shown in Fig. 1 is represented in Fig. 2 indicating also the slip surface of the receding surface movement subsequent to the terrain correction following the first slope failure.

Below the ground level of the terrain correction subsequent to the first slope failure, yellow, grayish yellow and red clay strata with lens-like deposits of sandy slime and loam were found in thicknesses growing (0–7.3 m) towards the hill. Beneath, all over the area of sliding, yellow, grayish yellow clay 1.0 to 2.5 m thick is found underlain by gray clay, silty fine sand and clay strata.

Fig. 2. Section A—A of the area of landslide. a — yellow limy clay; b — yellow lean clay; c — red fat clay with sand veins; d — silty fine sand; e — yellow clay; f — fat gray clay; g — yellow gray fat clay; h — yellow fine sandy clay; i — yellow silt

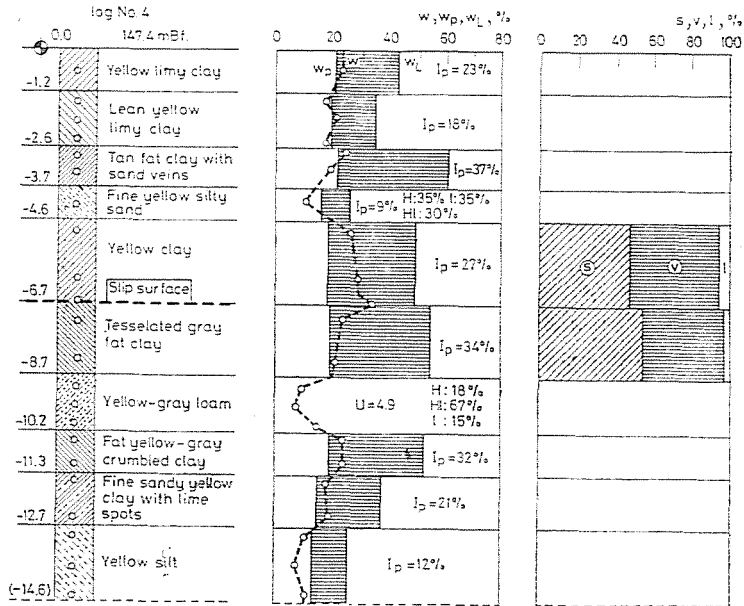
A typical boring log with soil physical characteristics is shown in Fig. 3. Already in the first site inspection the slip surface was deemed likely to have developed on the interface between the gray fat clay and the overlying yellow clay. Consequently, at the foot of the slide, where the gray fat clay approached the soil surface, large undisturbed soil samples of a cross section of 50 cm × 50 cm were taken from open ditches around the seemingly critical interface. Exploration trenches exhibited a thin light yellow (whitish) plastic clay strip 0.5 to 1.0 cm thick ( $w_L = 79$  to 83 percent;  $I_p = 45$  to 53 percent,  $w = 33$  to

Fig. 3. Section of boring No. 4 and physical characteristics of explored soils

36 percent) separating the layers of gray rich clay and yellow clay, of course unobservable in the course of borings.

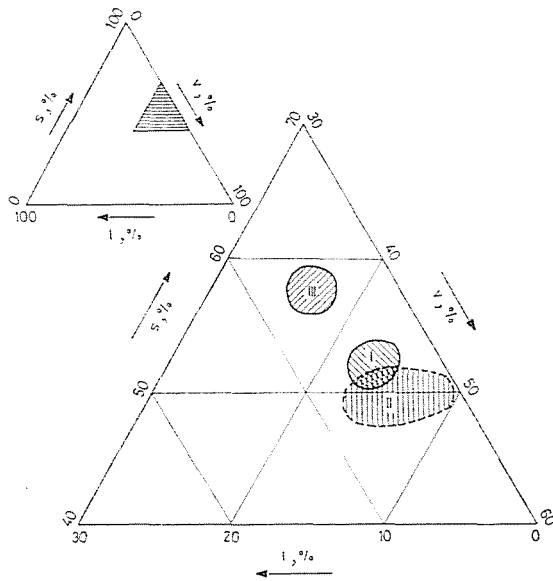
The physical characteristics of the typical soils found near the slip surface and those of the soil samples taken from the interface (the light yellow clay) have been compiled in Table 1. The phase composition of the tested soils is represented in the triangle diagram of Fig. 4.

**Fig. 4.** Phase compositions of soils around the slip surface

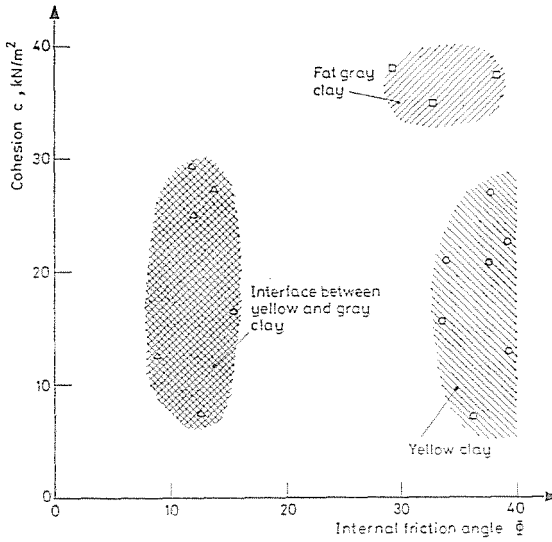
The shear strength parameters of the soil below and above the slip surface and of the interface samples are presented in Fig. 5. It is interesting to see the relatively low value of the internal friction angle of interface samples contain-

Fig. 5. Shear strength parameter ranges

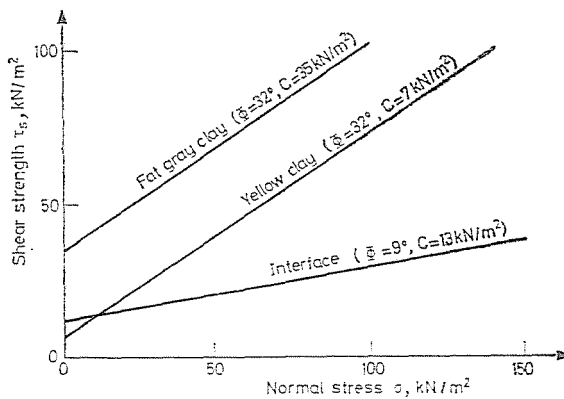
ing also the slip surface. The *Coulomb* lines showing the direct shear strength values are seen in Fig. 6.

Fig. 6. Coulomb lines of soils near the slip surface

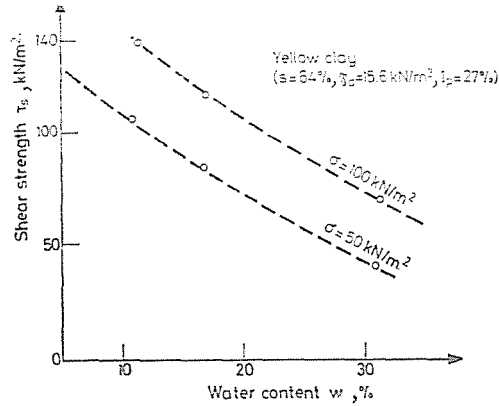
The influence of the water content on the shear strength of clays has been investigated. The relationship for the case of the yellow clay above the slip surface is represented in Fig. 7 as an example.

Fig. 7. Shear strength vs. water content

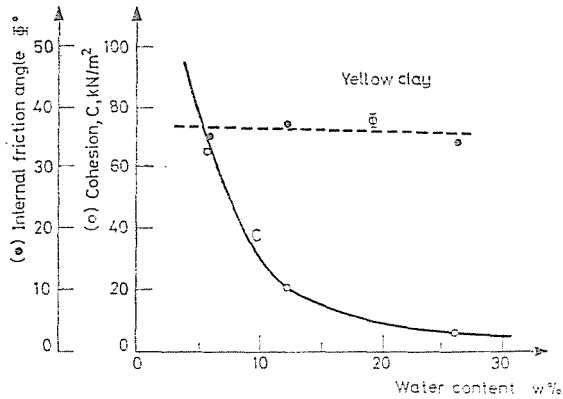
Results of consolidated undrained direct shear tests showed the increase in water content to significantly reduce the strength. The value of the friction angle practically was little dependent on the water content, the cohesion, however, the other shear strength parameter, decreased exponentially with increasing water content (Fig. 8).

Fig. 8. Shear strength parameters vs. water content

This fact also is a hint that seasonal waters reduce the shear strength. (Of course, it would be premature to draw a general conclusion on the interdependence between the shear strength parameters and water content from the obtained test results.) In this area a continuous water table was found 6 to 13 m deep under the ground surface graded after the first slide.

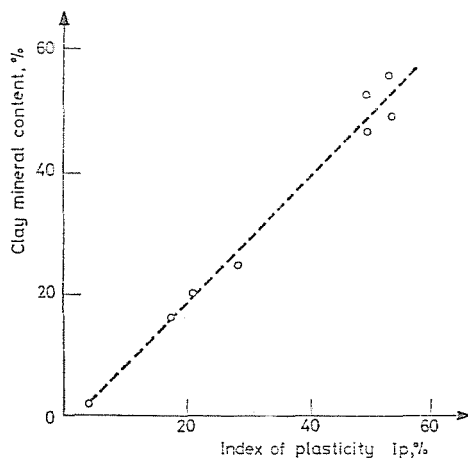
The plasticity of the clays is due almost exclusively to the interaction between water and the clay fraction. For a given mineralogical composition of the clay fraction, the plasticity index is proportional to the clay content; but the coefficient of proportionality much depends on the mineralogical composition. The relationship between the plasticity index and the clay mineral content for soils in the slope failure region found by the authors has been plotted in Fig. 9.

*Fig. 9. Plasticity index vs. clay mineral content*

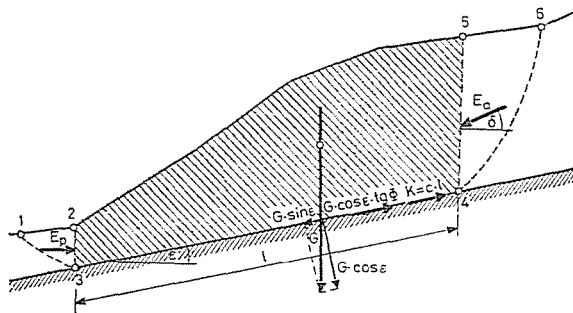
The scheme of balance tests is shown in Fig. 10. The equilibrium condition of the earth mass confined by the combined slip surface and the ground surface was investigated. Dividing the earth mass into three parts, the forces acting on block 2345 were to be determined. The active forces which caused the slide were: the component of load  $G$  along the slope and the active earth pressure acting on surface 45. The highest possible value of the forces resisting the movement is the sum of the passive earth pressure acting on surface 23 and of the frictional and cohesion forces to be mobilized on slip surface 34. Accordingly, the safety factor becomes:

Fig. 10. Scheme of the balance analysis

Safety factors  $\nu_{\min}$  obtained at sections of  $38 + 220 \text{ km}$  and  $38 + 240 \text{ km}$  were 0.39 and 0.83, respectively.

The variation of the safety factor  $\nu$  upon breaking up the original ground surface was examined at sections of  $38 + 220$  and  $38 + 240 \text{ km}$ . The extreme values are found in Table 5. According to the calculations, the safety factor dropped below  $\nu = 1$  during the excavation hence the landslide is the consequence of the excavation.

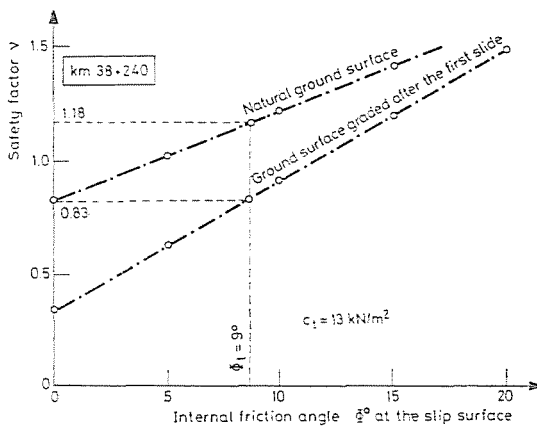
Also the effect of the variation of the shear strength parameters is of interest. Assuming the value of the cohesion on the sliding plane to be constant ( $c = 13 \text{ kN/m}^2$ ), the safety factor varies as a function of the internal friction angle as seen in Fig. 11. Selecting the angle of internal friction as constant ( $\Phi = 9^\circ$ ), the safety factor and the cohesion at the section of  $38 + 240 \text{ km}$  are related as represented in Fig. 12.

Fig. 11. Safety factor vs. internal friction angle

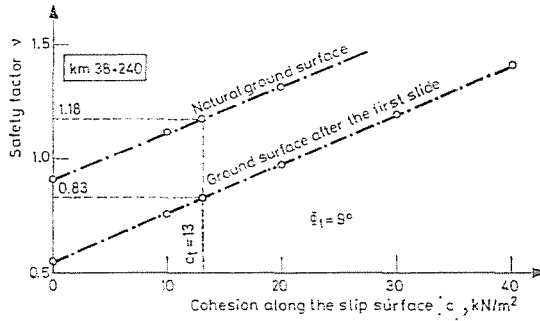
Fig. 12. Safety factor vs. cohesion

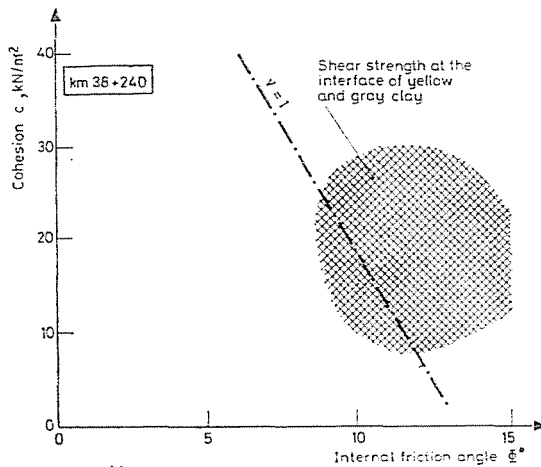
At last, the pairs of values  $(c, \Phi)$  associated with the limit state of equilibrium  $v = 1$  have been determined to be aligned on the line shown in Fig. 13 together with the range of shear strength parameters on the yellow clay — fat gray clay interface. The straight line  $v = 1$  intersects the range of available shear strength parameters, pointing to the imperative of movement where and how it occurred.

Fig. 13. Correlation between shear strength parameters at ultimate equilibrium indicating the range of actual shear strength parameters at the interface between yellow and gray clays

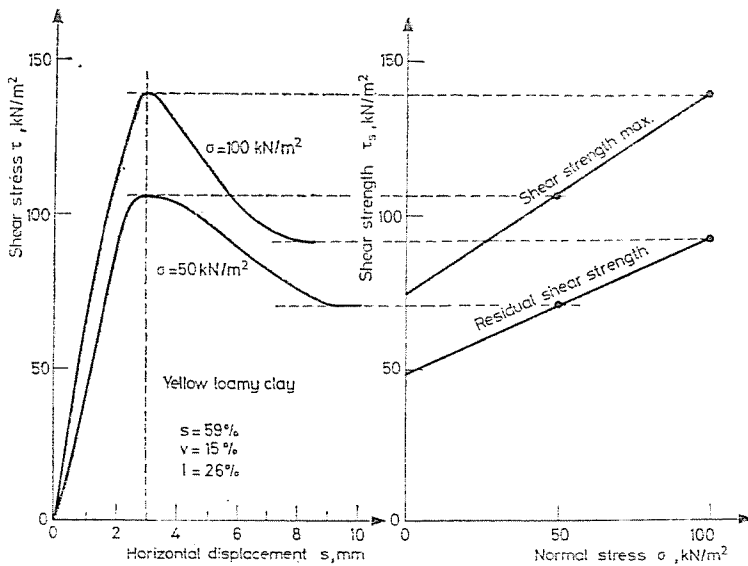
The residual shear strength was determined in direct shear tests on samples taken at the site of slope failure from yellow, sandy marl clay. The samples were tested in shear applying different normal stresses, then, following each shear test, the samples were pushed back into their original position and the test was repeated twice or three times. Typical test results are seen in Fig. 14. The clay stiffness caused significant differences between the peak value and the ultimate (residual) value on the curve of shear deformations. Beyond the peak value of the shear strength, shear displacements exceeding the ultimate deformation are only opposed by a minor shear resistance. Namely, on the one hand, the orientation of the flat, scale-like clay particles will change, their former irregular position will be more regular, reducing the shear resistance; on the other hand, variation of the deviator stresses due to the action of shear stresses during the displacement elicits neutral stresses (with axial rotation), further reducing the shear strength.

Thus, at or beyond critical shear displacements, the value of the shear strength will be reduced, reducing the safety factor to below  $\nu = 1$ . Thereby, the movement will be fast and accelerated and becomes very significant, until

Fig. 14. Characteristic shear displacements of the yellow clay marl; peak and final shear strength values
