GEOTECHNICAL ANALYSIS OF AN EMBANKMENT BASE FAILURE

I. KABAI

Department of Geotechnique, Technical University, Budapest

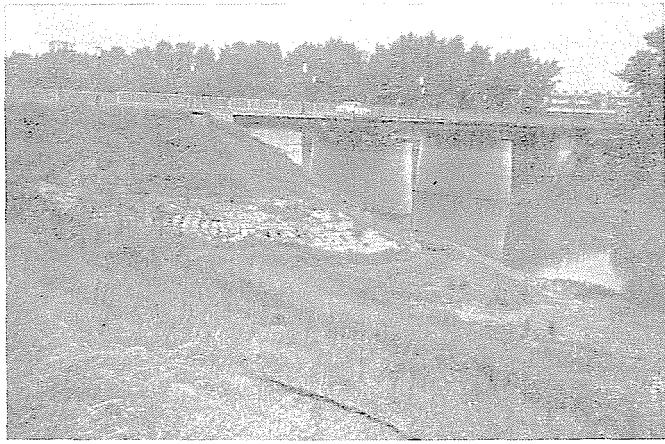
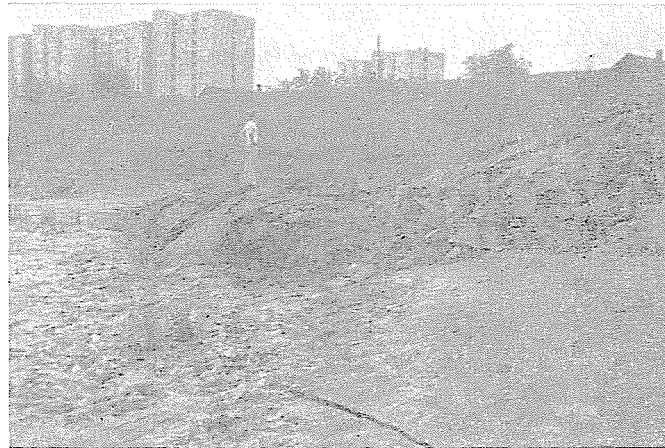
On October 23, 1975 a base failure occurred in a section of the embankment after withdrawal of the flood. Photograph of the base failure is seen in *Fig. 2*.

Fig. 2. The July 23, 1975 base failure: a — spot of the base failure; b — surface upheaval before the embankment foot

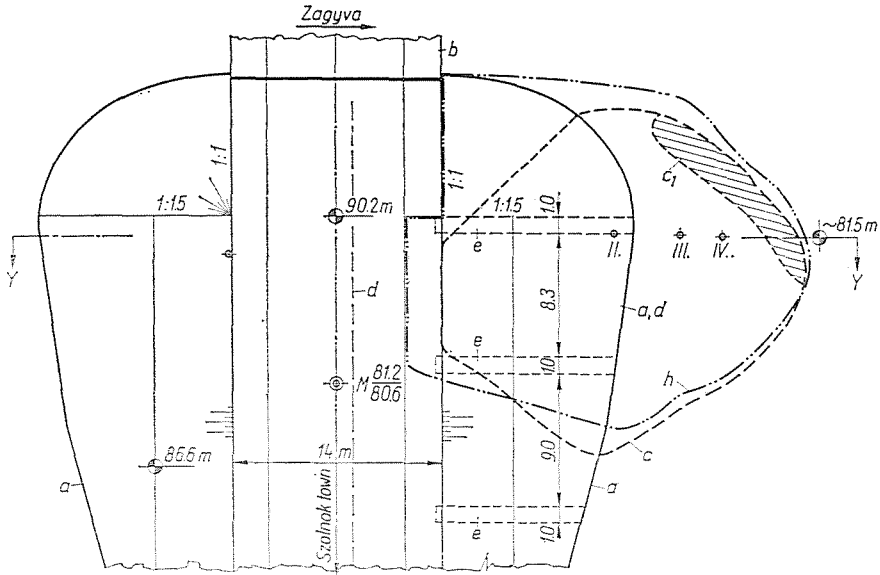
Fig. 3. Lay-out sketch for the failed embankment section: a — embankment constructed in 1958; b — the new reinforced concrete bridge; c — boundary of the base failure, July 24, 1975; c₁ — surface upheaval; d — boundary of the reconstructed embankment section; e — buttress drains; h — boundary of the repeated base failure after reconstruction (May 31, 1977); M. I, II; III; IV — boreholes

It became evident from the construction data that the old embankment leading to the wooden bridge was not pulled down under the new section of the embankment in 1958.

After the base failure the design seen in *Figs 3* and *5* was carried out. (In *Fig. 5* also the boundary lines of the two discussed base failures are plotted.) It was tried to reinforce the failed embankment section, reconstructed according to *Figs 3* and *5*, by buttress drains. The buttress drains were subsequently constructed in braced trenches inside the completed embankment.

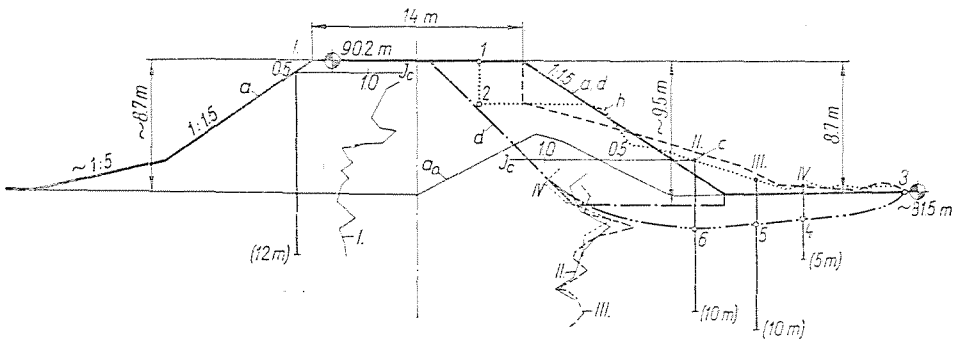
Fig. 4. Elevation Y—Y of failed embankment section: a₀ — site and embankment before construction of the reinforced concrete bridge; 2, 3, 4, 5, 6 — the points of sliding surface (other symbols see in Fig. 3)

Course of the base failure repeated after reconstruction could be approximately established from the surface form and the relative consistency data shown in Fig. 4. (See soil mass outlined by points 1, 2, 6, 5, 4 and 3 in Fig. 4.)

The displacement boundary line in Fig. 4 can be replaced approximately by a circular arch between points 2, 6, 5, 4 and 3 as shown in Fig. 16.

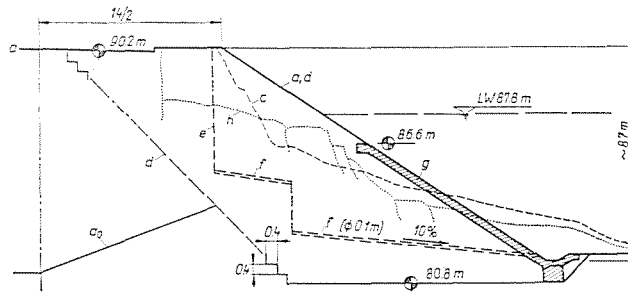
Fig. 5. Proposal for reconstruction of the 1975 base failure: *f* — earthenware tubes; *g* — quarry stone masonry facing; LW — flood level maximum (other symbols see in *Figs 3* and *4*)

From the discussed test results it became obvious that the stability of the slope reconstructed according to the design shown in Figs 3 and 5 was still very low. Outlets of the drains and of the earthenware tubes did not only lead out the water, but in case of inundation they led it in, likely to contribute to the decrease of shearing strength. Test results in Figs 13 and 14 proved that the soil absorbed quickly water, a small water content change and swelling markedly reduced the shearing strength. At the same time the embankment material got rid slowly and with difficulty of the absorbed water. Shearing strength began to diminish along the boundary surfaces of the buttress drains.

For quick drainage of the water seeping into the embankment, earthenware tubes were placed at the invert of the drains leading to the open air.

The jointed quarrystone facing of the slope was again raised to the 86.6m elevation.

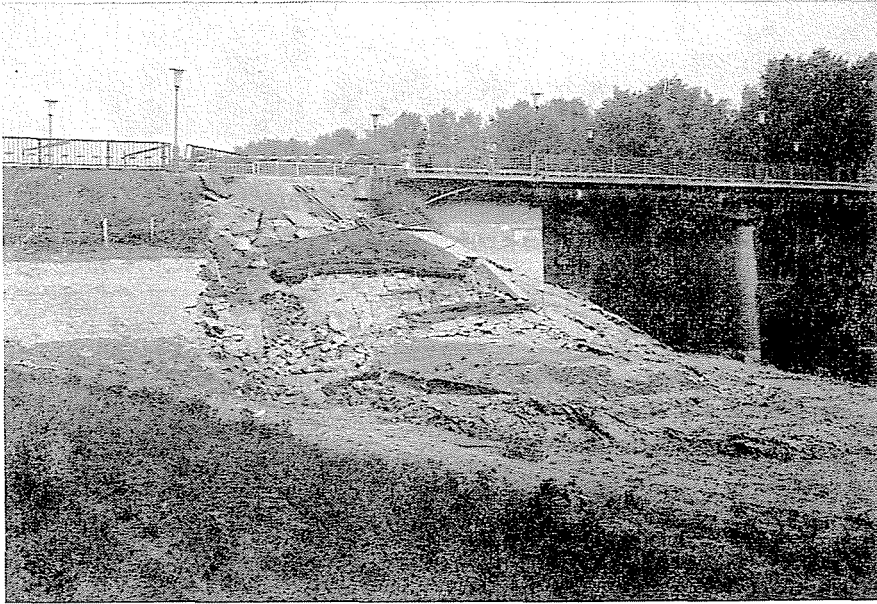
The flood lasted long and the water level only sunk to ~ 80.0 to 81.0 m after May 10, 1977. At this time the water level was already ~ 0.5 to 1.0 m below the lowest point of the embankment foot. Following this a base failure under the embankment occurred on May 24. *Fig. 6* is a photograph made of the base failure on May 31.

At the time the picture was taken, water was seeping at the foot of the embankment from the remoulded and dilated material at several places. In the *Y — Y* section of the base failure at the farthest points from the embankment, still a very slow movement was observed. (During one or two hours the surface heaved by some ~ 5 to 6 cm and a crack of ~ 2 to 3 mm appeared.) After these precedences, the Department of Geotechnique undertook analysis of the base failure causes.

Fig. 6. Photograph of the May 24, 1977 base failure

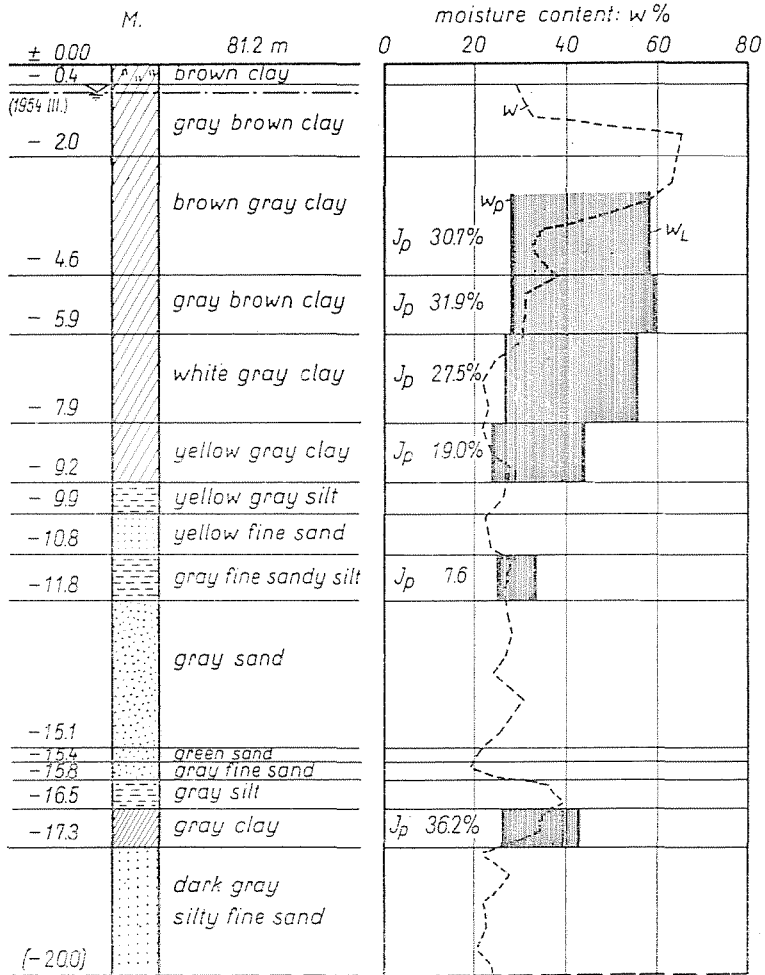
Fig. 7. Borehole section M (March 1954)

Typical subsoil conditions of the site are shown by the borehole section in *Fig. 7*. The location of boring *M* shown in *Fig. 7* is seen in *Fig. 3*.

In boring *M*, the ground water level was ~ 0.6 m below the ground level before the construction, in March 1954.

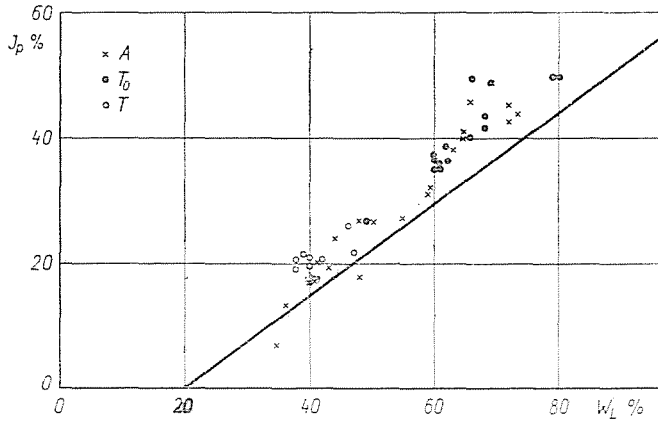
area material of the *Zagyva* River. This is clearly seen from the distribution of data related to the fill and subsoil in Fig. 8. The 1975 reconstruction of the failed section applied, however, a mosaic-structured clay of medium plasticity.

Fig. 8. Consistency limits of the tested soils. *A* — samples of the subsoil; *T*₀ — samples of the old embankment constructed in 1958; *T* — filling material used in the reconstruction of the 1975 base failure

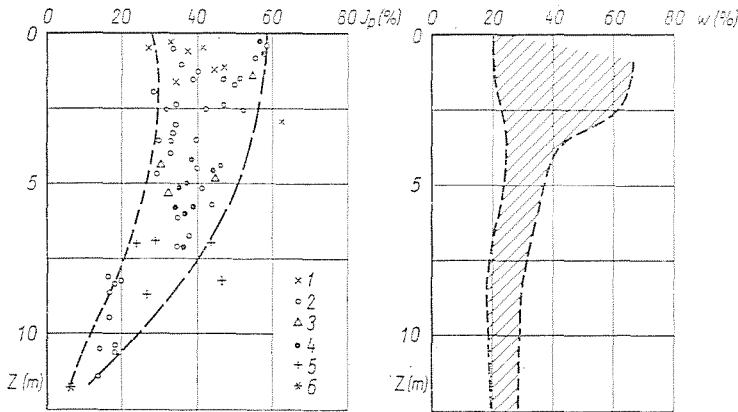
Changes in plasticity index and water content of the subsoil have been plotted in Fig. 9. These results also proved that properties of the soft fat clay of mosaic structure ~3 to 4 m thick were rather unfavourable for an embankment foundation, already before the construction.

Fig. 9. Changes with depth of the plasticity index and the water content: 1 — yellow, drab clay; 2 — gray, green-gray rust-marbled clay; 3 — brown, olive-drab clay; 4 — dark gray, black clay; 5 — white, white-gray clay; 6 — drab sandy silt

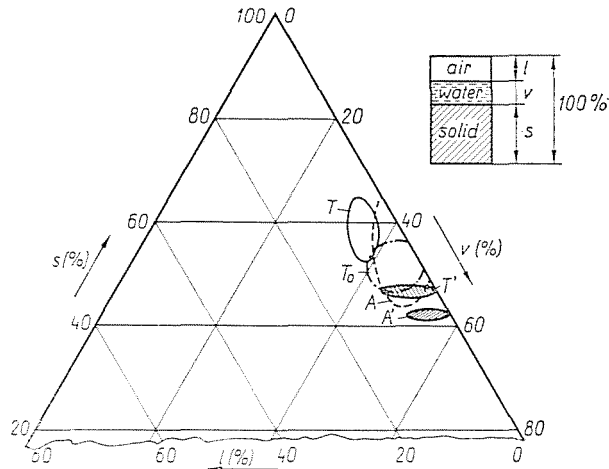
Changes in phase composition of the different soil types are seen in Fig. 10.

Fig. 10. Phase composition of the soils A' , T' — saturated dilated subsoil and embankment material (other symbols see in Fig. 8)

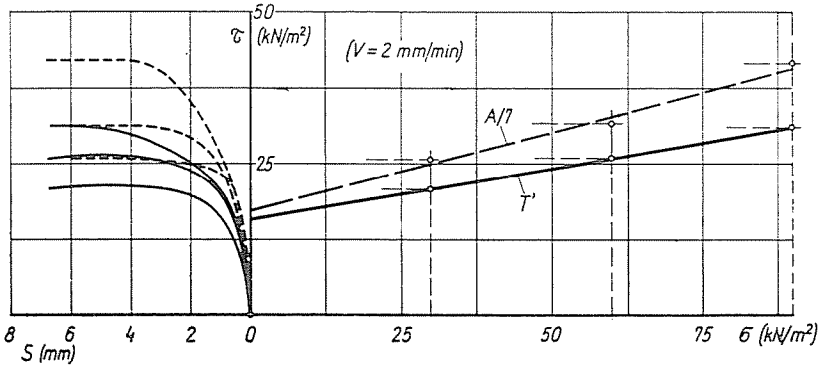
Two typical results of the direct shearing tests have been plotted in Fig. 11.

Fig. 11 Typical strength results of subsoil and embankment material (symbols 7, T' are those in Table 1 and in Fig. 8)

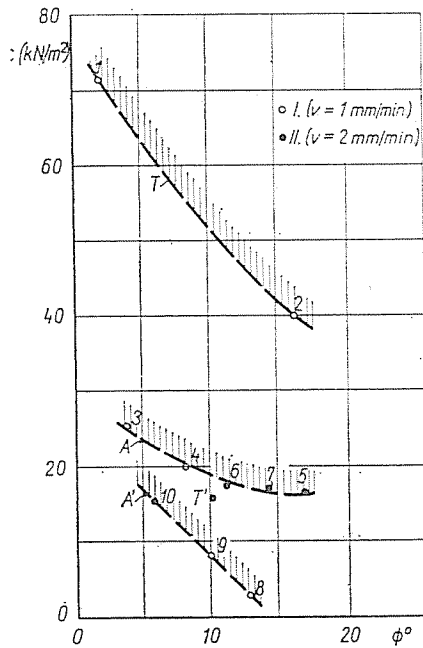
Fig. 12. Shearing strength parameters of the analyzed soils; I — triaxial compression; II — direct shearing tests (other symbols see in Table 1 and Fig. 8)

The test results prove that the shearing strength of the subsoil is very low, the cohesion in the case of $\Phi \approx 0$ being as low as $c \approx 25$ to 35 kN/m².

The values obtained from the equilibrium analysis ($\Phi = 0$, $c = 20.3$ to 20.8 kN/m^2) are in an apparent contradiction to data of actual soils A , A' and T' in *Fig. 12*.

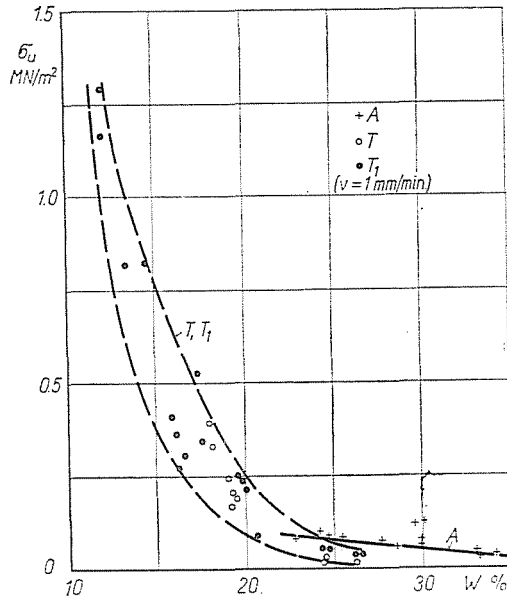
Fig. 13. Unconfined compressive strength vs. water content. T_1 — Filling material samples for Proctor tests (Symbols A , T see in Fig. 8)

Fig. 13 shows the change of unconfined compressive strength of the subsoil A and the embankment material T as a function of water content.

Strength of the embankment material used for the reconstruction was very sensitive to water; with increasing water content its unconfined compressive strength abruptly diminished.

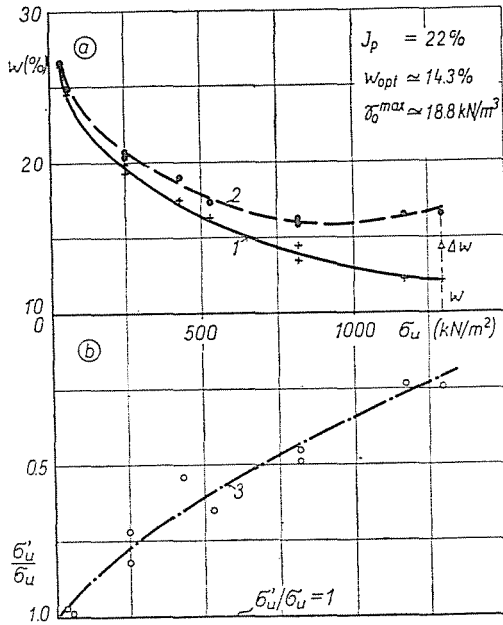
Fig. 14. Unconfined compressive strength vs. water content

The results have been plotted in Fig. 14. Line 1 in Fig 14a shows the relationship between the initial water content w and the unconfined compressive strength σ_u . In the same figure the rate of water content increase Δw is shown by line 2. Fig. 14b indicates the rate of strength decrease (σ'_u/σ_u) upon water absorption. The figure also shows the data of the *Proctor* test.

Data in Fig. 14 show a small increase in water content to be accompanied by an important drop of the unconfined compressive strength because it caused also movement of the solid skeleton (see KÉZDI, 1976).

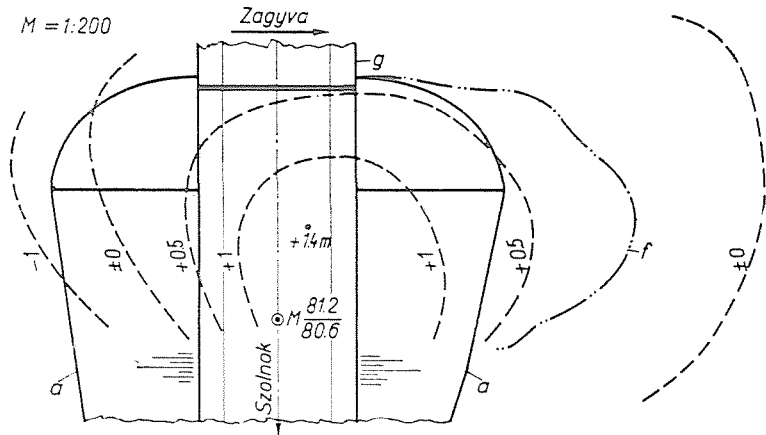
Fig. 15. Isohypsies of the ground water level for the low river water level following base failure according to measurements in summer and autumn 1976 and 1977

The maximum water level change was ~ 2 m. Data in *Fig. 15* illustrate changes of probable pressure conditions of the site against conditions before construction. The isohypsies refer to the period after the base failure, when the water seeped from the broken embankment material through cracks into the open, at a low river water level.

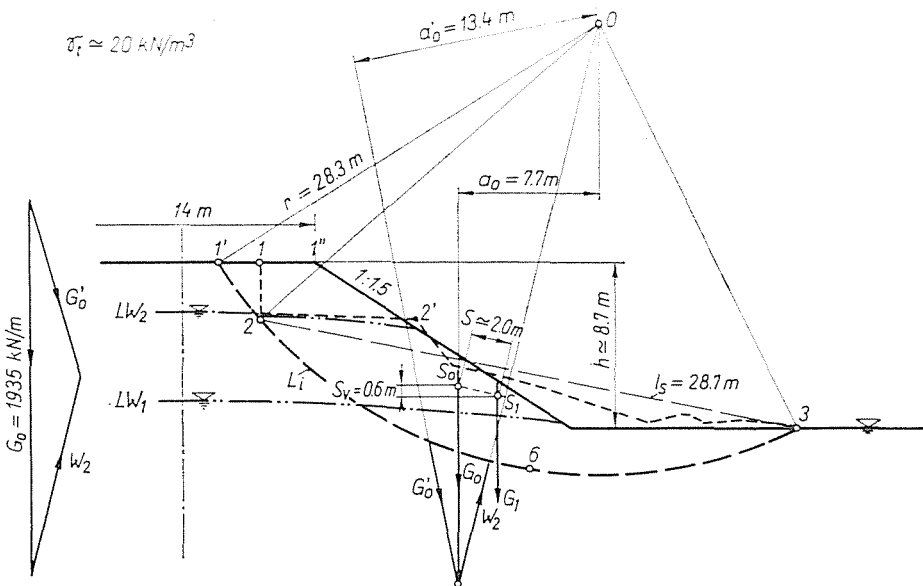
Fig. 16. Stability analysis of slope and computation data

Particulars of the computation principle are shown in *Fig. 16* for the soil mass limited by points 1, 1'', 3, 2 both reckoning with, and omitting water pressure. For convenience, lines 2, 3 indicate only the resultants of water pressure.

The resultant water pressure acting on the sliding surface was obtained by plotting drawdown surfaces LW₁ and LW₂ in *Fig. 16*. LW₁ was assumed according to data in *Fig. 15*. LW₂ involved the following assumptions:

at the beginning of the base failure. In the new situation following the base failure, for $\nu = 1$, $c \approx 15.2 \text{ kN/m}^2$ giving the average safety against further movement:

$$\nu = 20.5/15.2 \approx 1.35.$$
