**ARCHAISM AND UP-TO-DATENESS VALUE-ADDED
REFURBISHMENT OF WINDOWS ON A HISTORIC BUILDING
KÁROLYI PALACE, BUDAPEST**

László SZABÓ and Ferenc ZEPKÓ

Abstract

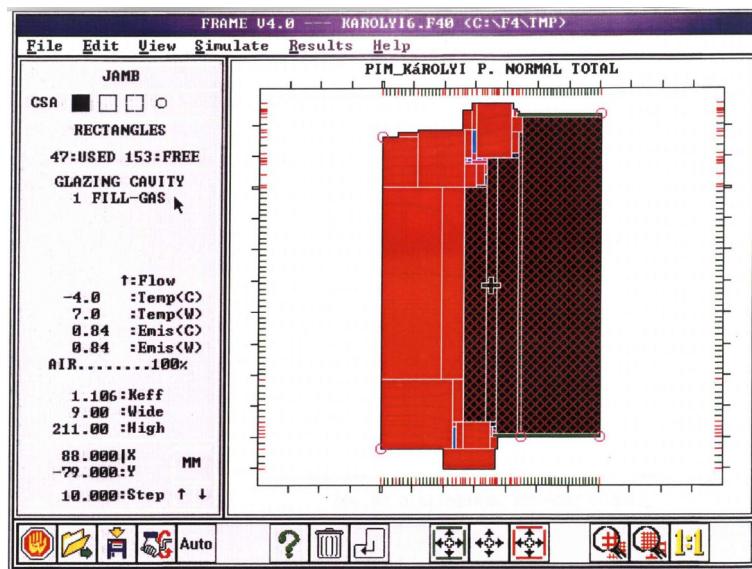
- c) *Replacing the outside frame and leaf with a new individual structure, built of profiles matching the original windows in appearance, incorporating insulating glass* would not hurt the historic appearance, and is up-to-date in technical performance (e.g. thermal and acoustic insulation, withstanding striking rain), answering today's demands in energetics, noise reduction and other requirements, with moderate additional costs. The calculated average U-value of this structure is 1.9 W/m²K.

The thermal analysis was carried out using *Frame4plus*, a software of 2-dimensional final differential numeric method (Figs. 2, 3 and 4).

Fig. 2. Analysis of thermal insulation: Alternative c) – structural model

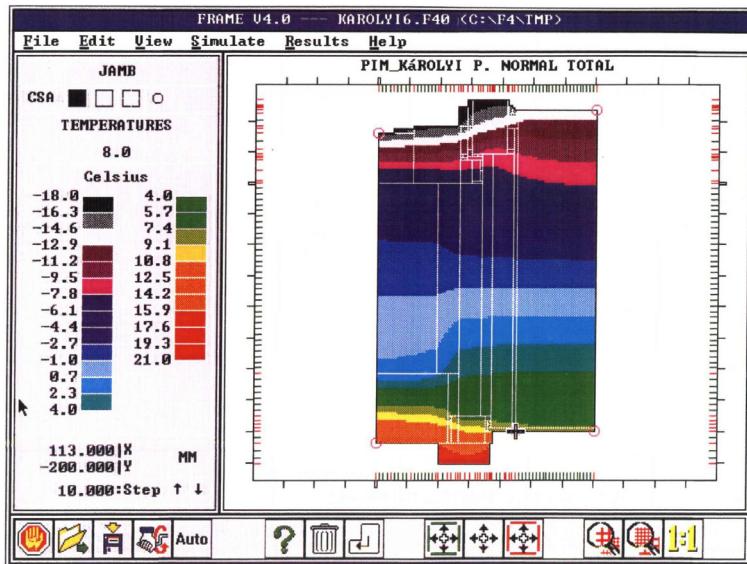
Fig. 3. Analysis of thermal insulation: Alternative c) – temperature distribution

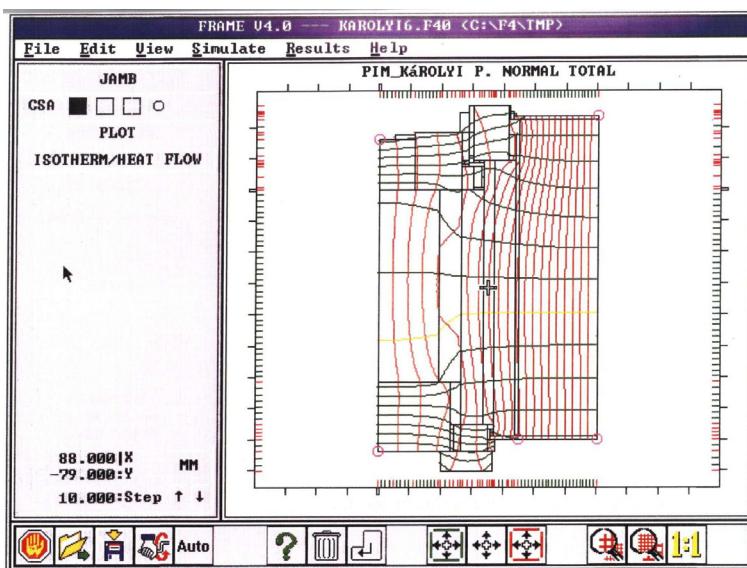
Fig. 4. Analysis of thermal insulation: Alternative c) – isotherms and heat flow

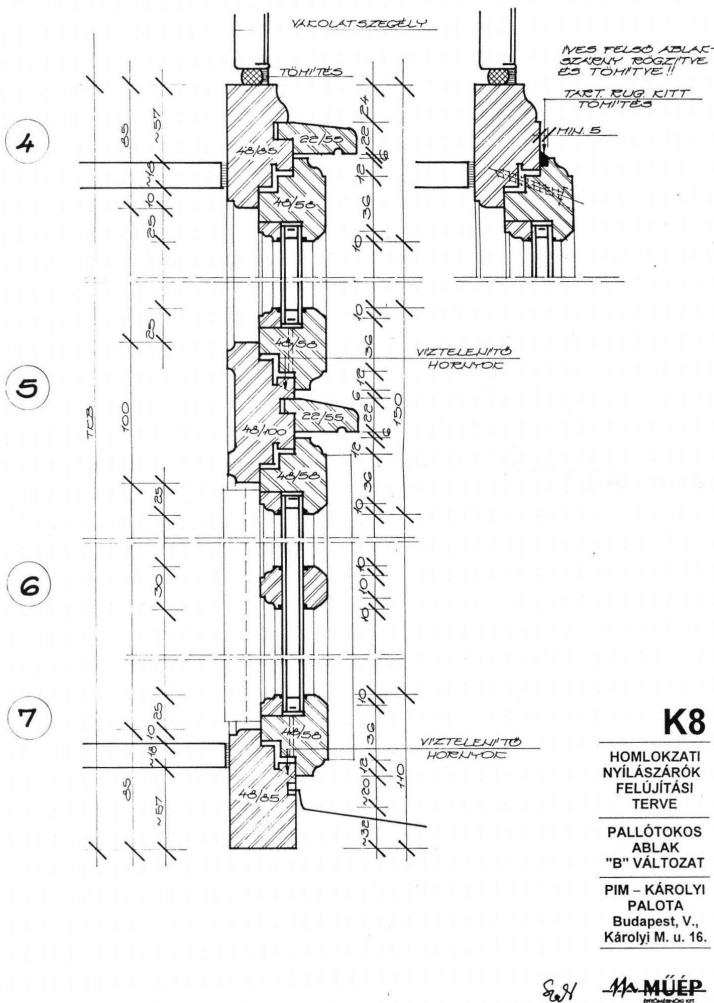
Fig. 5. Individual profile system for IG unit, with authentic appearance, resulting in value added reconstruction

Having had the decision the shop-drawings were worked out (*Fig. 5*) and manufacturing the frames and leaves of 158 windows, individual in dimensions and belonging to 9 type classes, started.

The structure was made with *triple connection* between frame and leaf, sealed with *foam rubber strip* at the middle one, with the required *ventilating (de-watering)* holes drilled both on frame and leaf, with *silicone seal* on both sides of the insulating glass. The divided leafs were glazed by *one insulating glass unit* for higher stiffness, providing the authentic appearance with external *division profiles* on both sides of the IG unit.

The *insulating glass* composition is 3-8-3 mm (of annealed clear float), using a spacer non-metallic in colour and surface: the black *TREMCO Swiggle®* spacer. This spacer is hardly visible and therefore recommended for historic applications in several European countries.

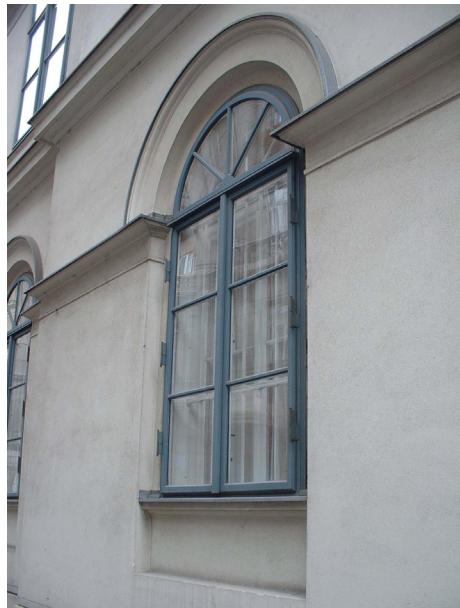
The manufacturing and construction took place in 1996–97. The authors have lately checked the technical status of the windows, after 7 years in operation, and were informed about proper functioning (*Fig. 6*). These technical performances can be kept in even longer terms with carefully planned and executed maintenance.

Fig. 6. The window manufactured according to *Fig. 5* drawings in 2004 (age: 7 years)
