## LANDSLIDE – ANALYSIS AND STABILIZATION

Miklós KOVÁCS and Zoltán CZAP

### Abstract

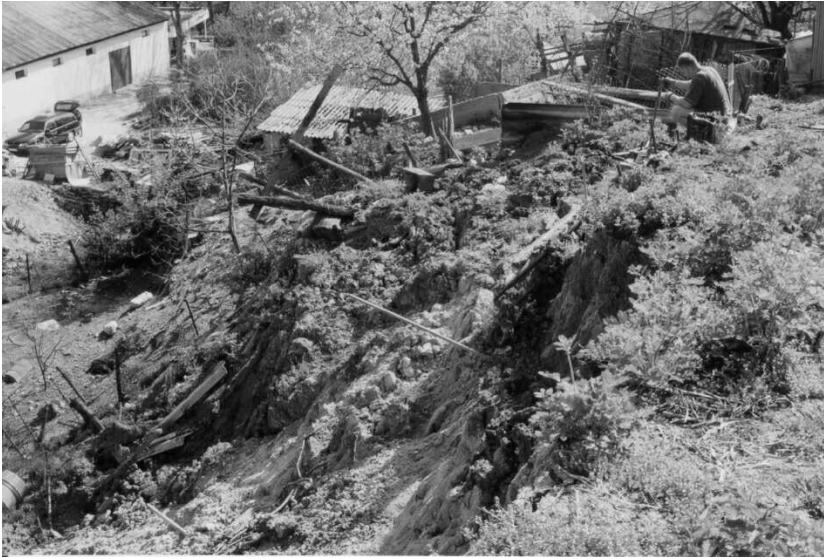
Extensive surface movement occurred on the spring of year 2002 in the internal district of a peripheral town near to Budapest. Five buildings were directly and further five buildings indirectly involved in the disaster, beside the damage caused to the communication and utility lines. The movement encompassed a 100 m long and 60 m wide hillside above a 15 m deeper lying shore. The initially slow creep turned suddenly into a several metre deep and forward directed sliding, what, in an attenuating manner continued for weeks. On the first week, the rate surpassed 20 cm in both directions (see *Fig. 1* and *Fig. 2*).

*Fig. 1.* The crown of the landslide

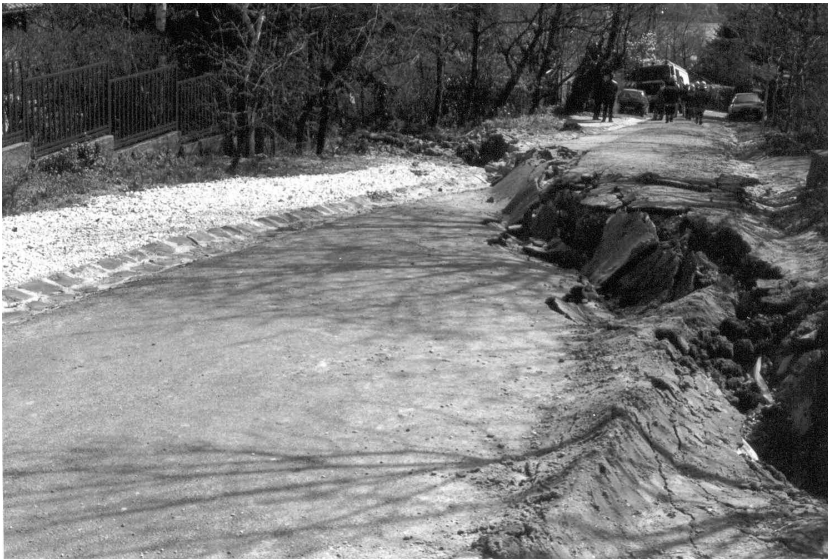
*Fig. 2.* The toe of the landslide

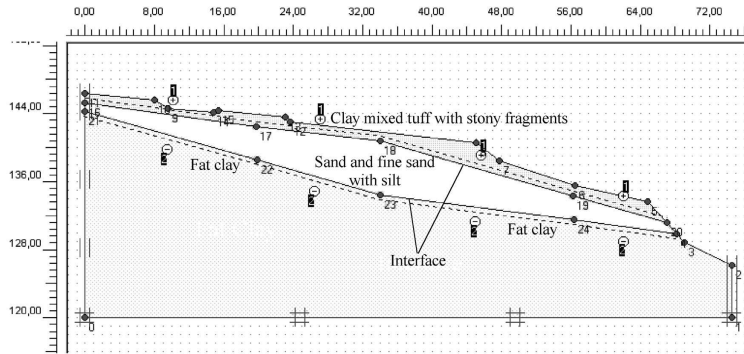
Longitudinal soil profiles were plotted on the basis of the borings placed in rows in the direction of the movement. Such a geotechnical model for the calculation can be seen in *Fig. 3*. Properly visible is the sliding surface on the top of the clay.

The condition for the movement was produced by the shearing resistance depriving seeping groundwater on this outward slanting surface. The outward leaning layers of the soil mass over the moulded and wet clayey surface slid first slowly, then (supported by the leakage from the that time already broken water mains) abruptly in the downward direction of the slopes at the shore.

Fig. 3. The geotechnical model for the calculation

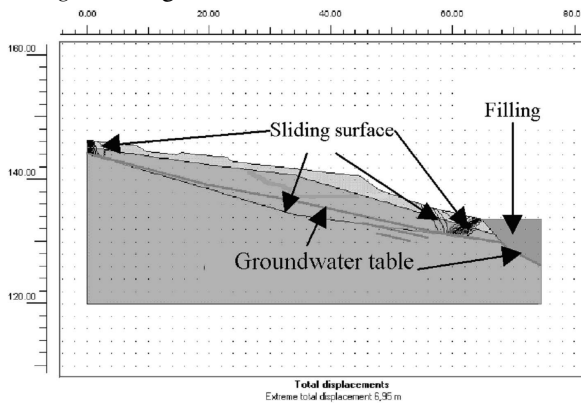
Fig. 4. Failure mechanism

Core of the first solution was to eliminate (or at least to diminish) the destructive impact of seeping groundwater movements, whereby the shear parameters may not attain (or go below) the critical value on the sliding surface. The concept was that the soaking of the critical surface will cease through the help of proper drainage, therefore the originally acceptable shear parameters of the clay will prevail and, in the meantime, also the pushing forces from the water flow will lose their influence. Horizontally bored 'Ramney-wells' were proposed which (through the 'tentacles') could collect the seeping water in the shafts. Sketch of the actually completed and efficiently operating drainage system is presented in *Fig. 4*.

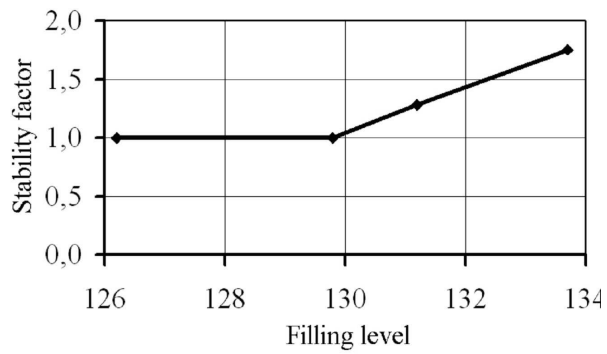
Fig. 5. The stability factor

The second concept of retaining the moving earth mass with a retaining wall and refilling the gorge to some level was discarded by the parties, though it was demonstrated by the presented computerized finite element programme that the balancing load may withstand the pressures (*Fig. 5* explains).
