DIKE BREACHES IN THE CARPATHIAN BASIN

László NAGY

Abstract

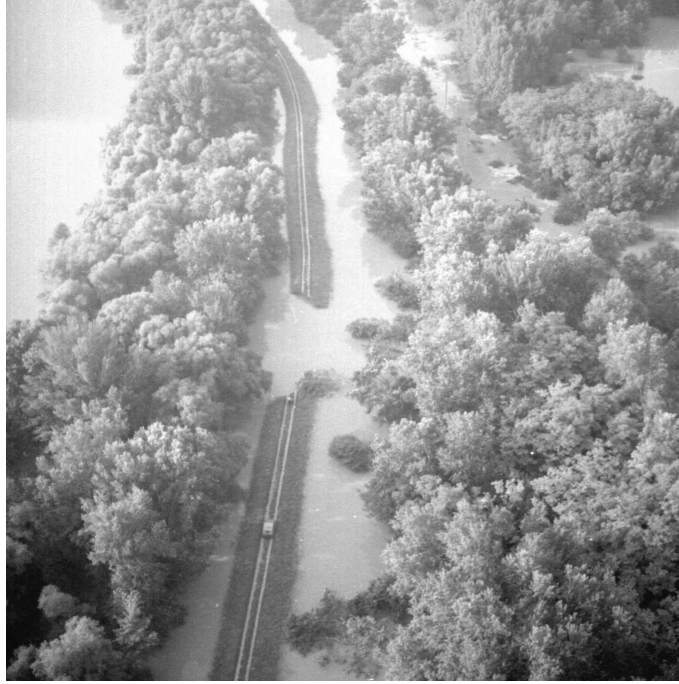
Fig. 1. Surány in 09. August 1991. (Hungary)

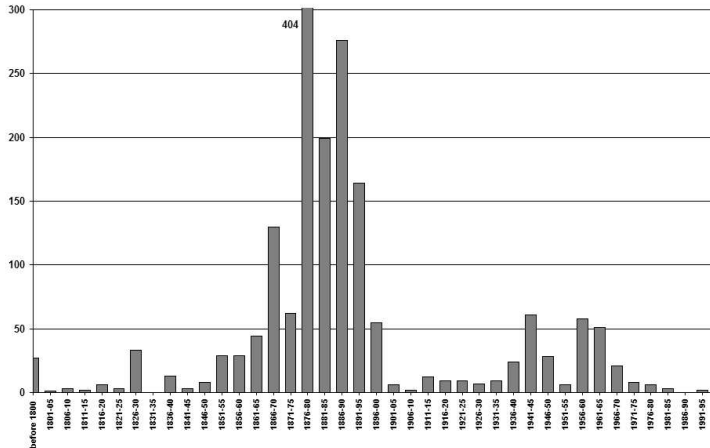
- At the time of closure (end of the year 2000) the review contains information on more than 2200 failures in the Carpathian Basin. The number for the present territory of Hungary is 1174. The number of failures per five-year periods demonstrates clearly that the large-scale flood control project launched in 1845 was not fully successful up to the turn of the century (*Fig. 2*).

Fig. 2. Five years distribution of dike failures

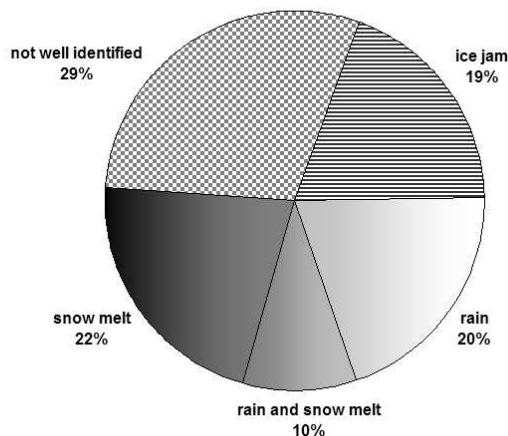
In the Carpathian Basin high level water is caused by three things: ice jam on the plain section of river Danube, heavy rainfall on the smaller rivers and on the upper sections of larger rivers, and snowmelt in spring. The largest floods become when the snowmelt appears with a heavy rainfall. The distribution of the flood origin can be seen in Fig. 3 [8]:

Fig. 3. Distribution of flood origin

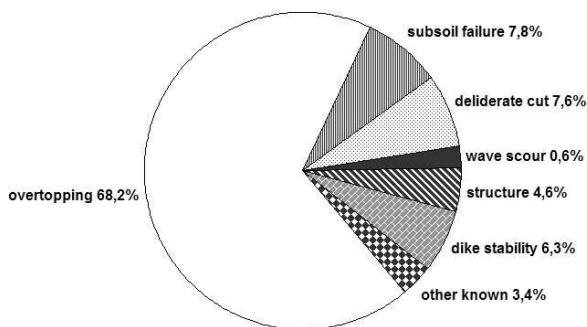
The failure mechanism is known in 525 cases, that is 29% of the total [8]. The distribution of those known is illustrated in *Fig. 4*.

Fig. 4. Distribution of failure mechanism

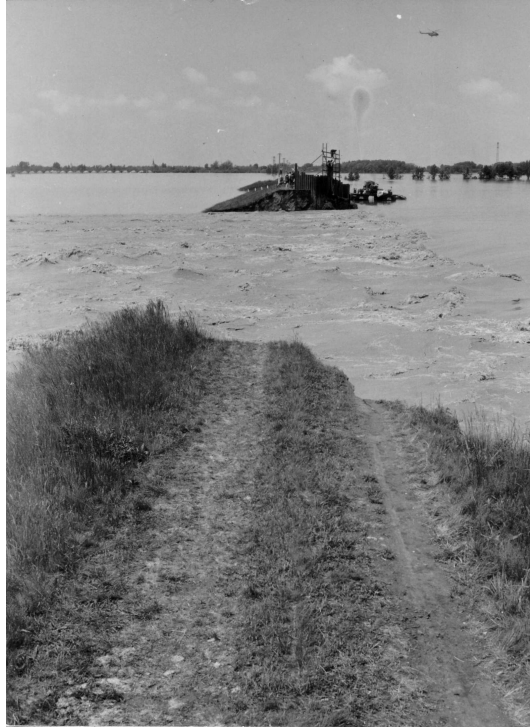
Fig. 5. 1970 Szamos left bank at Tunyogmatolcs (Hungary)
