DEGREE OF DETERIORATION DUE TO FIRE IN LARGE CONCRETE HALLS

Éva MAJOROS and György L. BALÁZS

Abstract

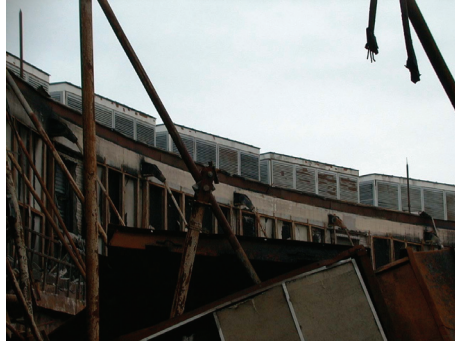
The most intensive fire effect was experienced at the arena's roof, which tumbled thereupon. Presumable reason of tumbling was the relatively fast melting of the lead cast at the cable heads (Fig. 7). In case of appropriate technological solution the tumbling would probably have happened much later.

Fig. 7. Destroyed cable heads [4]

Presumably the roof of the BS crushed as a result of a contestable structural solution. Under high temperature, the cable heads, which were cast with lead in the foundation castings after the smelting of the lead slid out the castings. Presumably, in case of the appropriate technical solution, the crushing would have occurred much later. Lack of dilatation or its improper emplacement contributed largely to the damaging of the two other store-buildings. In the course of deciding upon the use of a certain structure, the possibility of the influence of an incidental fire should by all means be taken into consideration. Special attention must be paid to the selection of the appropriate materials and structures.

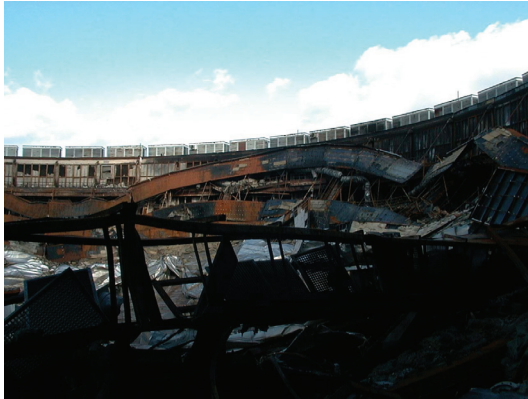
Under the influence of the fire the geometric shape of the upper reinforced concrete flange did not change. In the case of the lower steel ring, a deformation of several cm-s could be measured. The inside steel pillars remained almost vertical [4] (*Fig. 8*).

Fig. 8. The steel rings deformed [4]

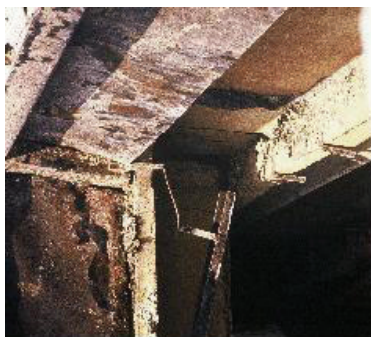
Fig. 9. Angular displacement of the tail of the principal beam

In the western part the edge beams of the ground floor ceiling got severely damaged. The short cantilevers of the two middle main beams on the supporting points of the roof slabs were cracked and their inclination exceeded by 1-2 cm that of the undamaged beams. In the main beam a spatial torsion deflection was also experienced besides the strength decrease of the concrete (*Fig. 9*). The cracks setting off in an angle of 45° downward from the fork-formed stanchion referred to torsion. The two extreme main beams, apart from the necessary surface repairing, did not require any strengthening.

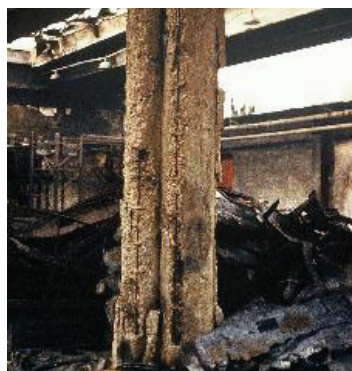
The concrete in the pillars directly exposed to the fire got burnt more deeply than the line of the main reinforcement; it could be separated by hand. The corners of the pillars supporting the main beam were cracked off.

Fig. 10. Burnt pillar
