## STABILITY OF THE ELEVATED RIVER BANK AT RÁCALMÁS

József FARKAS, Zoltán CZAP and Tamás VARSÁNYI

### Abstract

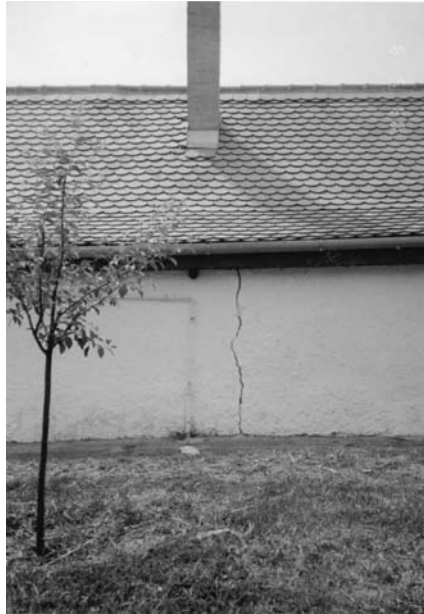
The uppermost one of cracks was observable in a distance of about 100 m from the bank-line of the Danube along the street parallel with the river. 6 dwelling houses were damaged in the moving area. There was a house in the case of which the pavement next to the building came out of place in an extent of more than 10 cm from the building (*Fig. 4*). On both of banks of the low water mark river bed of the Little Branch of the Danube (in the area corresponding to the length of the dredged river bed and the surface motion in the elevated river bank) ‘fresh’ sliding movements were happening (*Fig. 5*). Fortunately, the motion slowed down in the course of the droughty spring in lack of precipitation, and the dry hot summer and stopped providing time in such a way for protecting.

*Fig. 1.* Fracture on the wall of a house

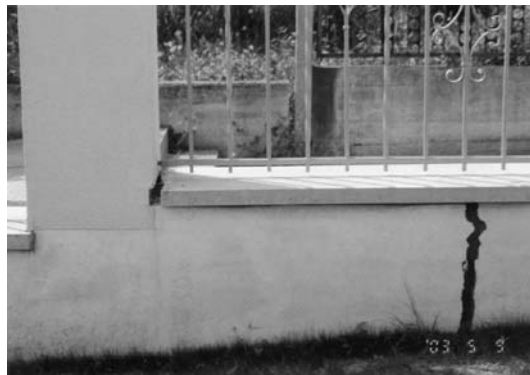
*Fig. 2.* Strongly marked fracture in the fence footing

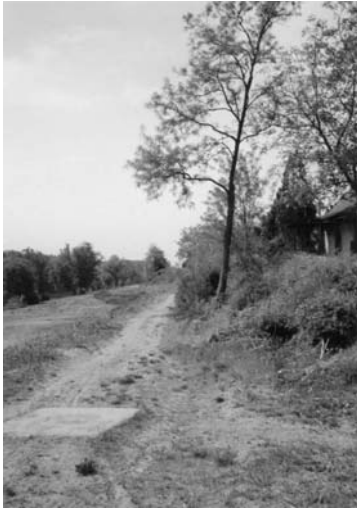
In autumn 2002 the Branch of the Danube at Rácalmás in the area reaching from the Szávó-köz up to the Bruck-köz was dredged hard in order for gravel exploitation. The river bed has been deepened down to about 2.5–3.5 m. After having dredged the bed the movements appeared, then in February 2003, following the lasting wintery thawing of the snow they were increased in a marginal zone with a length of about 200 m and a width of about 100 m. On the basis of the surface signs the motion can be considered a motion of mass sliding character, ‘expanding’, receding motion towards the hill. In the area from the hill side, in some places, inside of the moving mass, strongly marked fracture openings are to be well observed, caused by the tensile stresses, the course of which is nearly parallel with the Danube and at the edges arching towards the river; moreover, they are to be seen in the field and on the walls of the houses (*Fig. 1*) and in the fence footings (*Fig. 2*) as well. The fracture width in footing to be observed in the photo was in May 5.4 cm, at the end of August, however, 6.1 cm. The ‘cover’ of footing came also out of place. In the moving area were eight houses damaged. The fact of the sliding also became unambiguous by the tilting of the trees (*Fig. 3*) and fences.

Fig. 3. Tilting of the tree

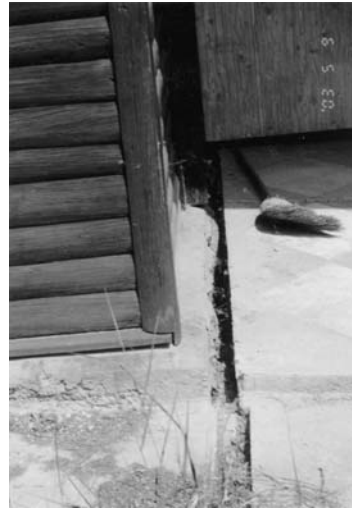
Fig. 4. Pavement next to the building came out of place

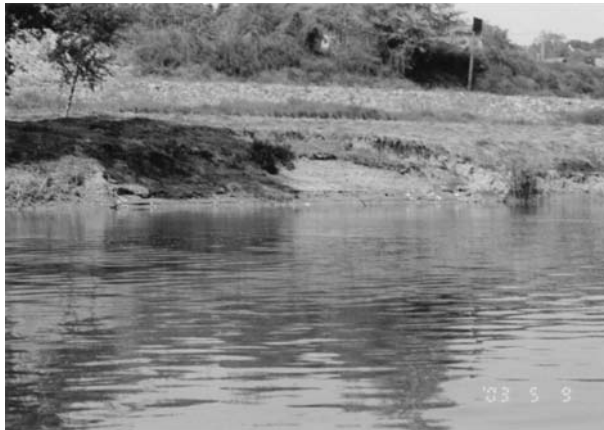
Fig. 5. Sliding movements

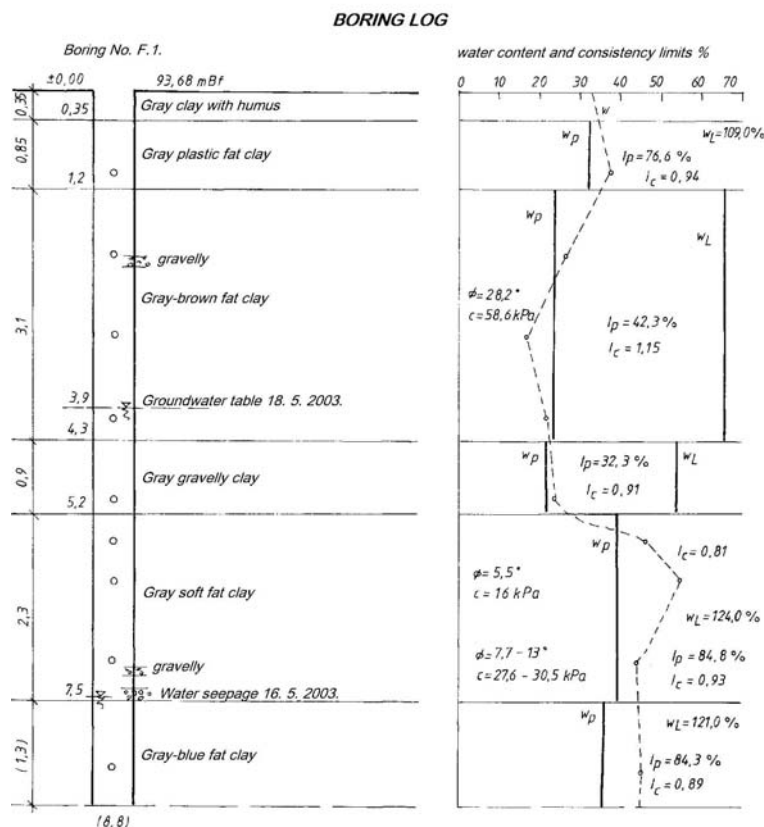
below the underground water the sludge consistency was soft. 3 drillings deepened with 5.5–8.8 m depth in the 20 m wide inundation area before the river bank area have gone thoroughly along clay. *Fig. 6* shows the soil stratification. Here, down to 7.5 m range the Pleistocene and Holocene rich clay strata ( $I_p = 32 - 85\%$ ), containing in some places chalky ‘stone dolls’, and calcareous crushed gravel. The underground water skirting these stone settlements is seeping with relatively low intensity. The lower part of this Pleistocene deposit is light gray coloured, having a loose ( $e > 1$ ), mushy consistency. Its water content is 40–55%. The creeping motion of this doughlike clay is only too conceivable for lack of passive soil resistance ‘terminated’ owing to the dredging of the river bed. We reached the grayish-blue coloured Pannonian, very rich clay, here and there with a purplish shade of colour, having the following consistency characteristics:

Fig. 6. Soil stratification

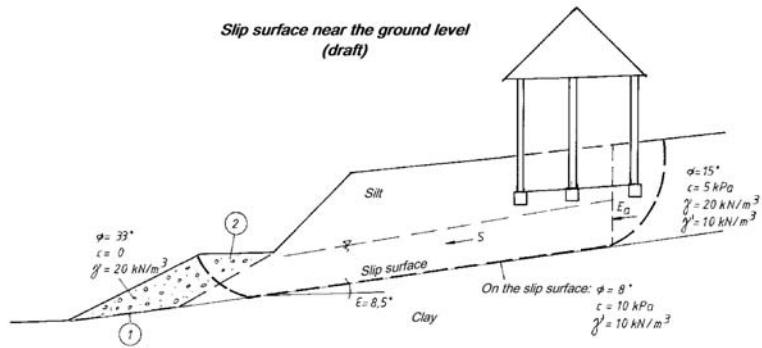
The development of the sliding plane near the surface is to be made probable according to the simplified sketch in the *Fig. 8*. The coming into existence of the sliding planes marked 1 and 2 is also conceivable.

$$\nu = \frac{T}{E_a + S + G \cdot \sin \varepsilon + G^k \sin \varepsilon} = \frac{918}{933.9} = 0.982 < 1.0,$$

In a similar way, we obtained a safety factor  $\nu = 0.93$  for the sliding plane 2; that is, the possibility of motion is even higher on this sliding plane.

Fig. 8. Slip surface

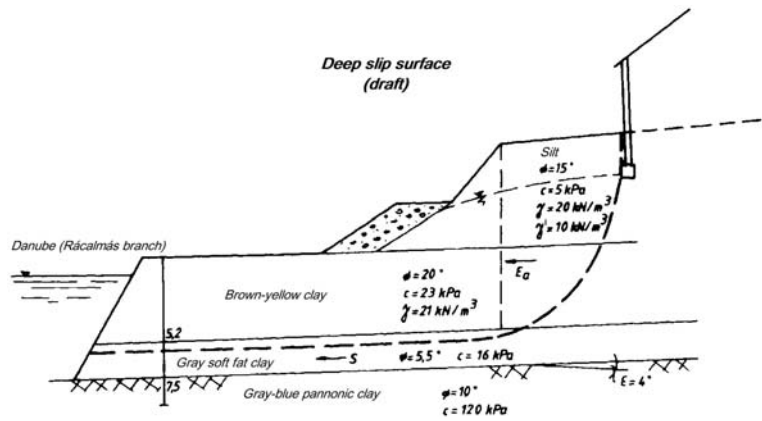
The case of the deeper sliding plane protruding up to the river bed is to be seen in the *Fig. 9*. Here:

$$\nu = \frac{1660}{1527.6} = 1.08,$$

that is little over the 1.0 value and that means that the tested soil mass can also take place on the bounds of the standstill and motion along this deeper sliding plane.

Fig. 9. Deeper sliding plane

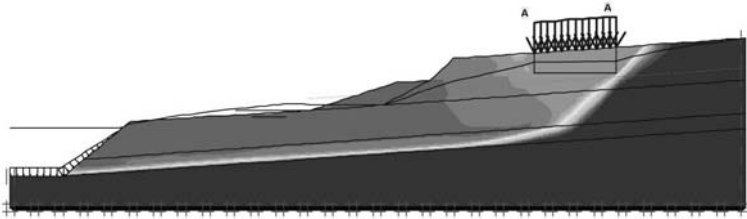
The cracking mechanism ‘according to computer’ as the result of the test is to be seen in *Fig. 11*. Consequently, the possibility of the motion is somewhat higher along the deeper sliding plane protruding up to the river bed (running counter to our mass-method calculation). The minimum safety factor obtained  $\nu = 0.946$ , that means the motion.

Fig. 11. Cracking mechanism according to computer
