Floor Slabs Which are Frightening From Underneath, But Following Minor Repair Repeatedly Durable

Tamás K. Simon

Abstract

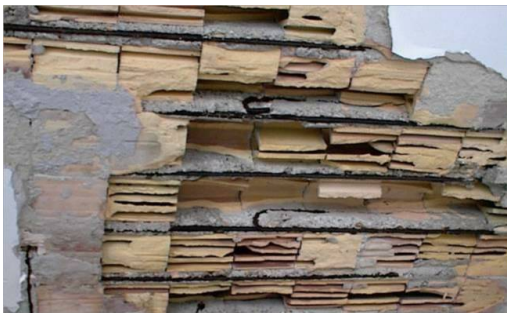
At that time the industrial activity was ceased from the building, only the offices were functioning. One morning, when the cleaning lady has finished her task and closed the door behind her of one of the offices, heard a big noise from inside. As she reopened the door the picture of the ceiling on Fig. 3. appeared for her.

Fig. 3. Appearance of the ceiling

Corrosion of the steel just in air moisture conditions would not have been so extensive, so some other factor must have played role. Indeed there was something more. Above the subjected office, during the bio industrial ages a deepfreezing room was operating. For this reason the slab could cool in such an extent that vapour precipitation occurred especially on the surface of the rebars. This circumstance has increased the rate of corrosion, which initiated the extensive failure. The bottom portion of the relatively brittle hollow ceramic elements sort of exploded downwards as a consequence.

The bottom of the slab could be repaired. Following the cleaning of the rebars the missing concrete was recouped by an appropriate concrete repair system and a false ceiling was installed. Naturally, the adequate working together capability of the accepting and new layer must have been ensured [3] during the refurbishment. The structure is well serving since. Demolition and reconstruction was unnecessary.

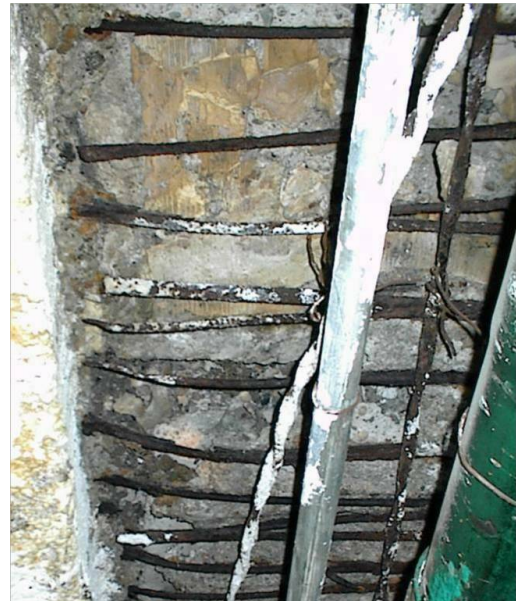
between rebars and shuttering to enable the concrete to flow around the steel and produce the necessary concrete cover on them for corrosion protection were not applied. 2. The lack or insufficient compaction produced porous concrete. In certain cases the workers deliberately threw rubbish into the shuttering possibly because of politically reasoned sabotage (Fig. 4)

Fig. 4. Unexplainable located fired ceramic pieces above reinforcement preventing concrete to envelop rebars in an RC slab

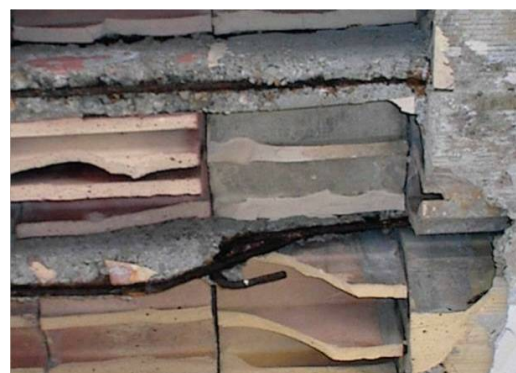
Anyone of these two circumstances is enough to allow the rebars to corrode. Even if concrete is covering the steel, since the volume of the product of the corrosion (rust) is of around eight times as much as of steel [2], the concrete cover would be strained off due to the internal tensile stresses which are born during the swelling of the embedded rebars. On Fig. 5. which is a closer picture about a small part of the failed ceiling both of these insufficiencies may be well detected.

Fig. 5. Close view of the ceiling failure

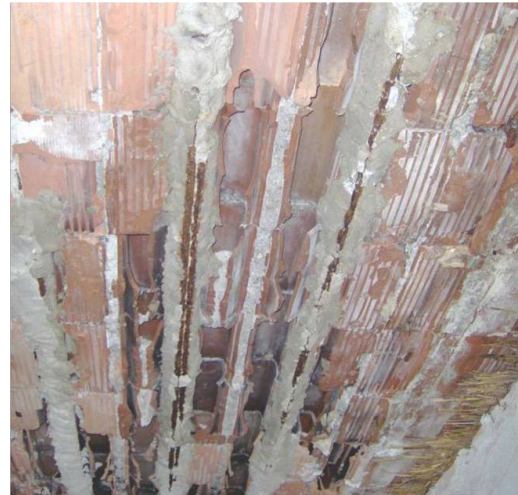
In the beginning of 2014 during the roof terrace refurbishment of a cottage house in Budapest (Hungary), most probably due to the dynamic effect of the concrete layer demolishing machinery on the slab the false ceiling at about two m² surface area has fallen from the ceiling. The until then, by the false ceiling hidden view of the bottom surface of the load bearing slab has frightened the workers. They have removed the false ceiling totally in the room and Fig. 6. shows the picture what was unfolded before the viewer. The type of ceiling was not the one described in section 2., but the system is identical, the difference is only in the shape of the hollow ceramic filling elements.

Fig. 6. Failure of bottom plane of RC slab above the false ceiling

On Fig. 7. two important factors may be detected. The first is that, only every second concrete rib is reinforced. As such the distance between the RC beams is 40 cm. This fact may also be detected on Fig. 6, where in the middle of the picture a plain concrete rib is visible. An other important factor is the obviously very small concrete cover on the rebars in the RC ribs. This shows the historically unknown importance of concrete cover at that time.

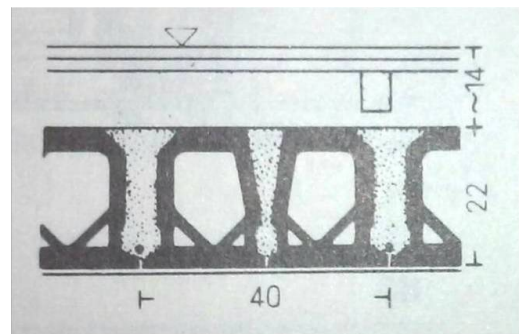
Fig. 7. Cross sectional drawing of "Ujlaki" hollow block floor

On Fig. 7 is clearly visible that, the inside of the broken ceramic blocks is black, stained by soot.

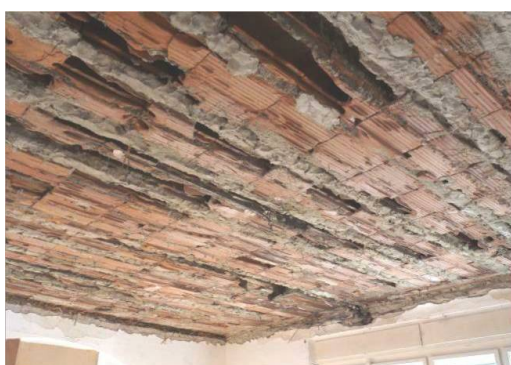
At first sight can be seen that not all, but only a relatively small part of the ceiling is harmed by the bottom plane failure. The missing pieces from the hollow blocks are randomly located, which indicates that their failure is not due to a concentrated effect like leaking roof etc. The white strips of mortar indicate that before hiding the scene with a false ceiling, the substitution of the concrete cover on the bottom rebars of the RC ribs was carried out.

Fig. 8. Underneath view of a bigger portion of the subjected "Ujlaki" hollow block floor

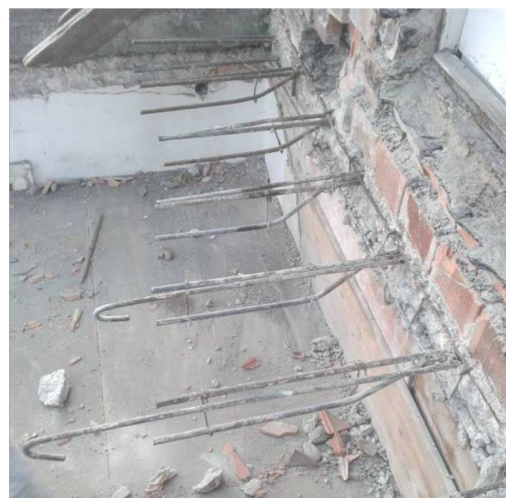
Fig. 9. Rebars which were unwrapped from the concrete of the RC ribs do not show the sign of extensive corrosion

The more or less corrosion free rebars indicate that the concrete, which was poured between the ceramic filling elements was compacted properly, it could protect the steel from corrosion through many decades. These RC ribs could have served for further decades, and from load bearing point of view there was nothing wrong with the filling elements.
