Integrated Approach for Post-fire Reinforced Concrete Structures Assessment

RESEARCH ARTICLE

On the evening of November 16, 2013, fire spread through a Reinforced Concrete industrial warehouse on the outskirts of the city of Cagliari (Italy). Due to the fire, which lasted approximately 8 hours and was extinguished principally with water, the central part of the building and its load-bearing structure were damaged.

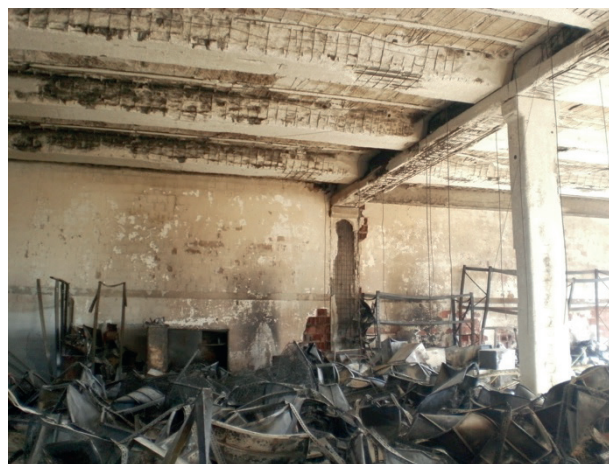
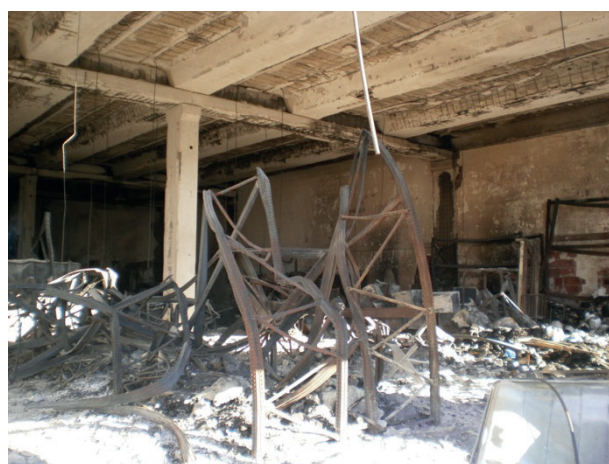
Visual examination is the simplest and cheapest technique. A trained eye can record very interesting data regarding both the residual structural safety and mechanical characteristics after a fire. In this work, initial visual examination provided a rapid survey of the damage: the central area of the ground floor was damaged by the fire, as shown in Figure 7.

Lateral columns labelled 4–6–7–9 present the most evident damage: it seems that they have been hollowed out from the fire-exposed side towards the core, probably due to convective motion generated during the fire. Concrete belonging to these columns was expelled, leaving a visible void, while reinforcements are still present although damaged. The contrast with the neighbouring fire-resistant wall is patent as well, and is depicted in both Figure 7 and Figure 9, where it is easy to note that column 6 is severely hollowed-out. On the contrary, perimeter columns 1–2–3–10–11–12 were less exposed to the fire, and negligible visible damage was recorded.

Central columns 8–5 present a completely different situation: the superficially-burned plaster exhibits great characteristic roughness, and its colour tends towards greyish white. Spalling of concrete occurs infrequently in these elements.

Fig. 7 Overview of the fire-damaged area.

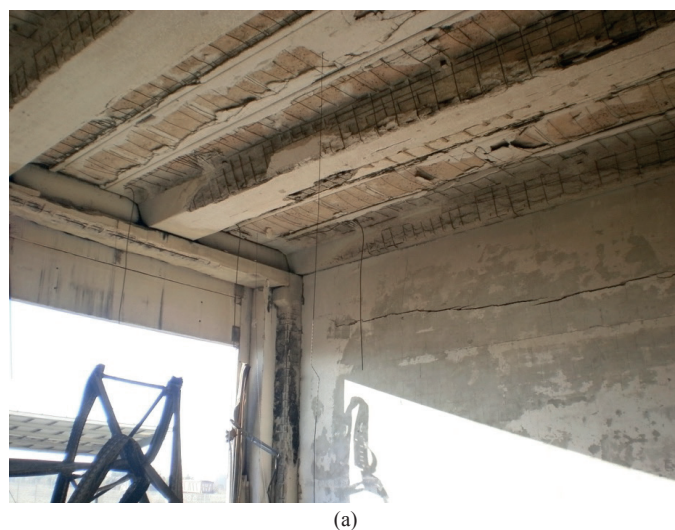
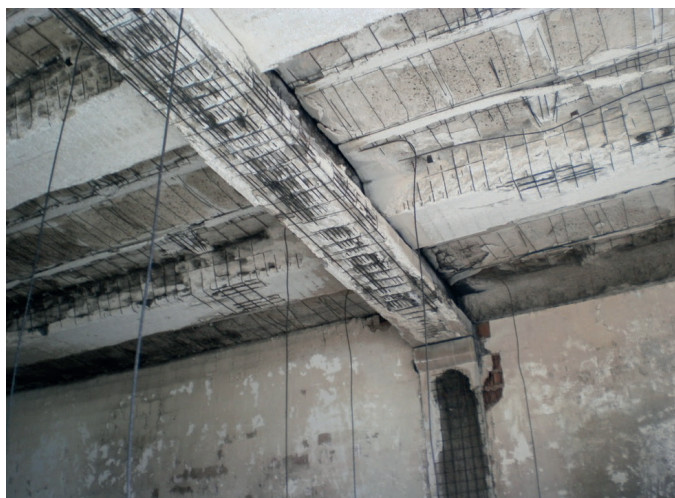
In Figure 9b, the situation of beam T6 and corresponding longitudinal beams is reported. The latter are visibly damaged as well: in most of these omega-shaped beams, concrete spalling is present in broad areas. Thus, in this case as well, there are areas in which prestressing tendons have lost their principal effect, becoming ordinary reinforcements. The other heavily-damaged longitudinal beams are labelled L4–L5–L8–L9 in Figure 8. As reported in the previous paragraph, the fire-resistant lateral partition wall guarantees a fire protection class equal to REI 120.

Actually, it separates the fire area from other areas, providing sufficient thermal insulation. The left wall (referring to Figure 8) was heavily damaged, with many cracks and incumbent collapse, as shown in Figure 9a. The right wall, shown in Figure 7 and Figure 9b, has lost part of its plaster, but there are no visible cracks.

Fig. 9 Lateral cladding cracks (a), T-shaped beams, girders and lateral column damage (b).

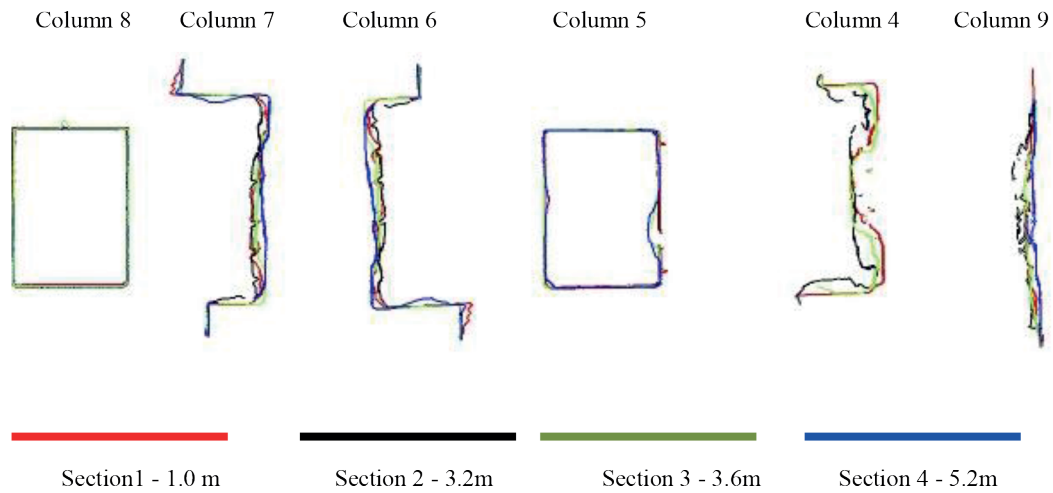
Only columns 4 and 6 show a SD x higher than 10 mm, while in all other cases, it is unlikely to find values greater than 5 mm. These centre-of-gravity position variations represent a small fraction of column height, in addition, as stated previously, they are probably due to local damage of the cross-section and not to real displacement of the column, see Figure 13. Furthermore, after a complete section restoration with new concrete, variations will be reduced to completely negligible values.

Fig. 13 Fire-exposed side of column cross-sections at different heights, recorded by means of a laser scanner.

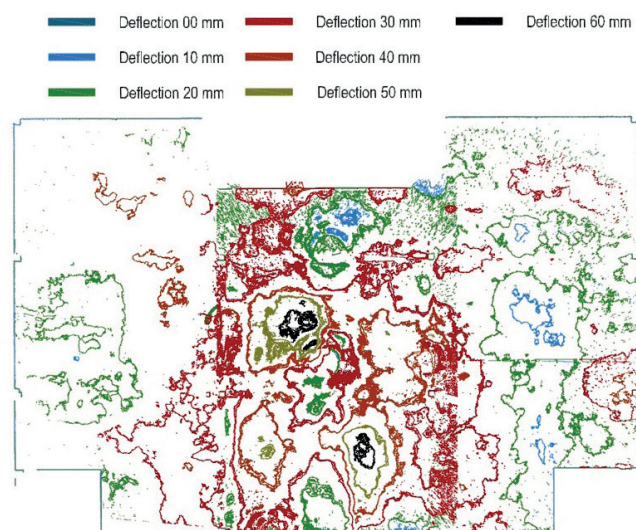
First-floor slab deflection was also investigated by means of a Laser Scanner, and results are reported in Figure 15. The maximum deflection of 60 mm is indicated by the black lines located on the left side and in the bottom part of the fire area. Both of them correspond to a midspan beam point.

Despite the high value of maximum deflection (60 mm), there are no visible cracks in the extrados, and the only other sign of the fire is the floor discolouration.

It is interesting to point out that Figure 15 can also represent a synthetic map of structural fire damage; indeed, it highlights the most deformed area, corresponding to beams T5, L4 and L5.

Fig. 15 First-floor slab deflection.

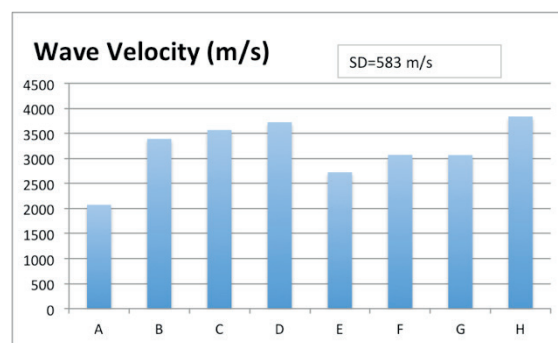
From the data reported in Figure 17, it is clear that the most highly damaged area corresponds to left points A and E, which present the lowest speed (2000–2400 m/s). Indeed, it is well known (see [21]) that damage significantly reduces the speed of sonic pulses. On the other hand, points H and D present the highest speed value (3800 m/s) and are located in a corner of the slab, near the stairwell. The latter points were probably less exposed to the fire and consequently reached lower temperatures than the ones (points A and E) located in the centre of the slab.

Fig. 17 First-floor slab Sonic Test chart results.

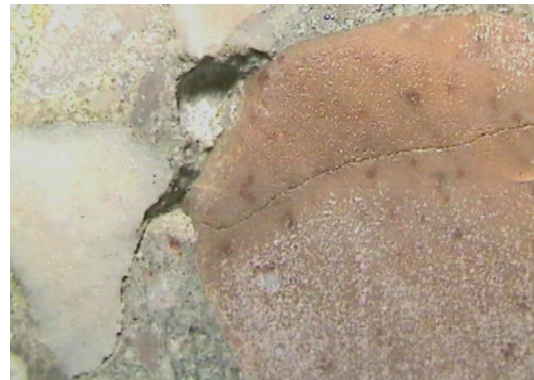
Fig. 18 Cracks around the perimeter of aggregates and inside the reddish aggregate (sample label: Beam 3).

On the contrary, the fire-damaged concrete (e.g. COL 4, COL 5, COL 9, BEAMS 8-9 and BEAM 3, see Table 9), is characterized by surface pulverisation, intense whitening, selective erosion and deformation. Microfracturing is widespread: fractures cut the aggregates or develop inside the transition zone (see Figure 18).

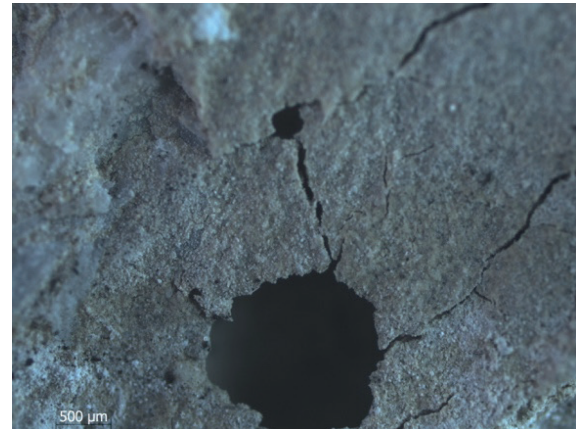
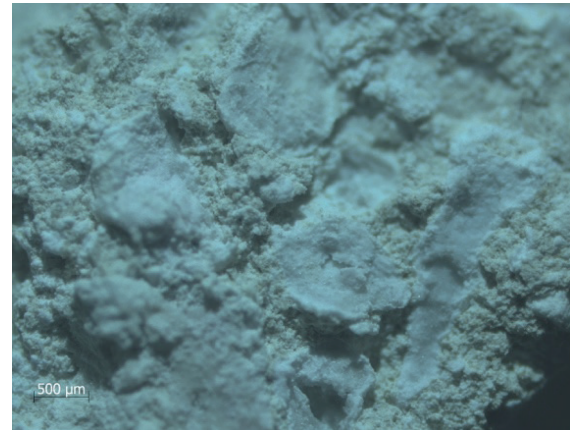
Fig. 20 Microphotos of damaged concrete surface in RL mode: (a) microcracks radiating from a macropore, cement matrix altered in colour, COL 4a Sp a; (d) pulverization and whitening (Beams 8-9 a133), see Table 9.

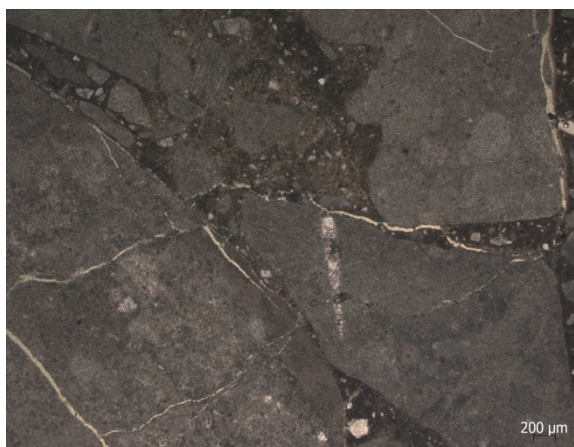
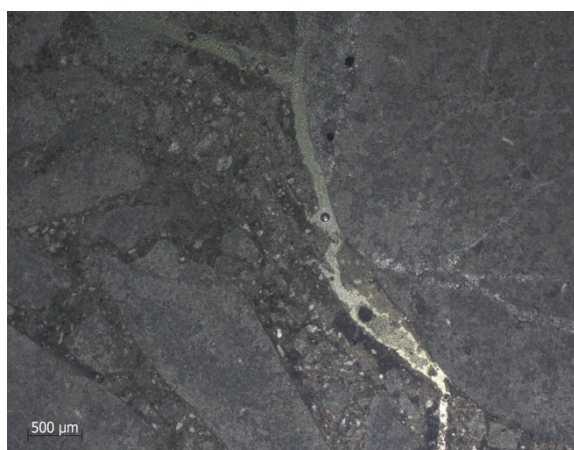
Fig. 21 Microphotos of damaged concrete surface in PPTL mode: microcracks involving the transition zone and cutting the aggregates, sample COL 5B(a); interfacial cracks, sample COL 4A(b), see Table 9.

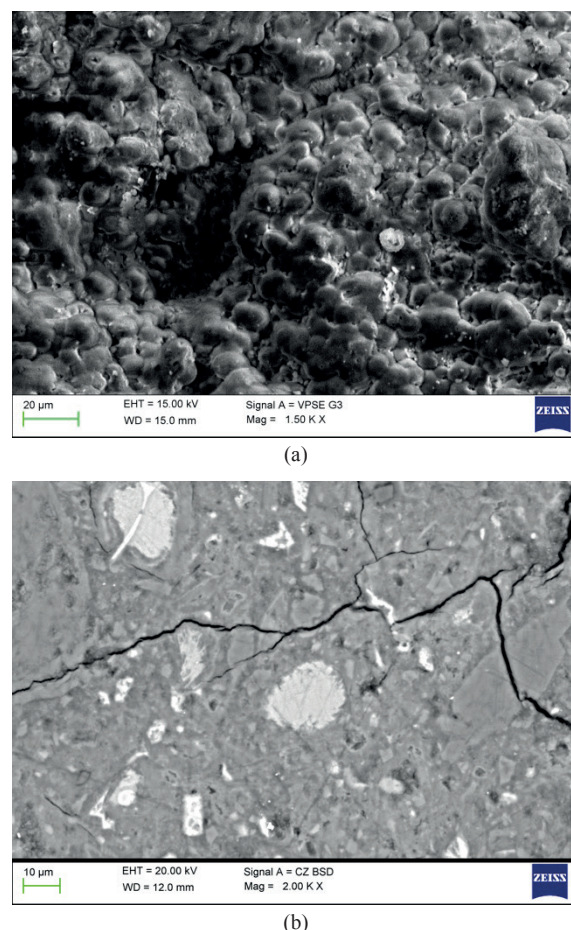
Fig. 23 SEM image of the top of high-damage sample: (a) micrometric globular formations, COL 4A; (b) microfracturing affecting cement matrix, transition zone and aggregates, COL 5B, see Table 9.
