# Analysis of solder joint failures arisen during the soldering process

Bálint Balogh / Gábor Harsányi / Róbert Kovács / Csaba Nagynémedi / Bence Papp

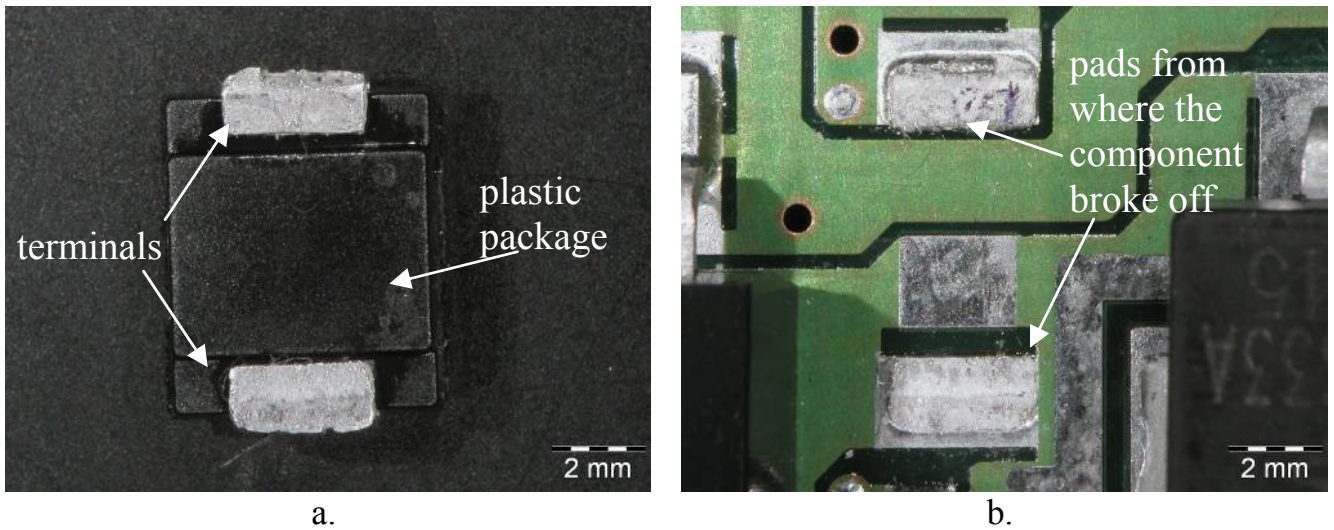
**Fig. 1.** X-ray micrographs of a step motor  
 a.) without tilted detector the pin and the coil can be seen  
 b.) with tilted detector a solder ball behind the coil can be observed (the dot in

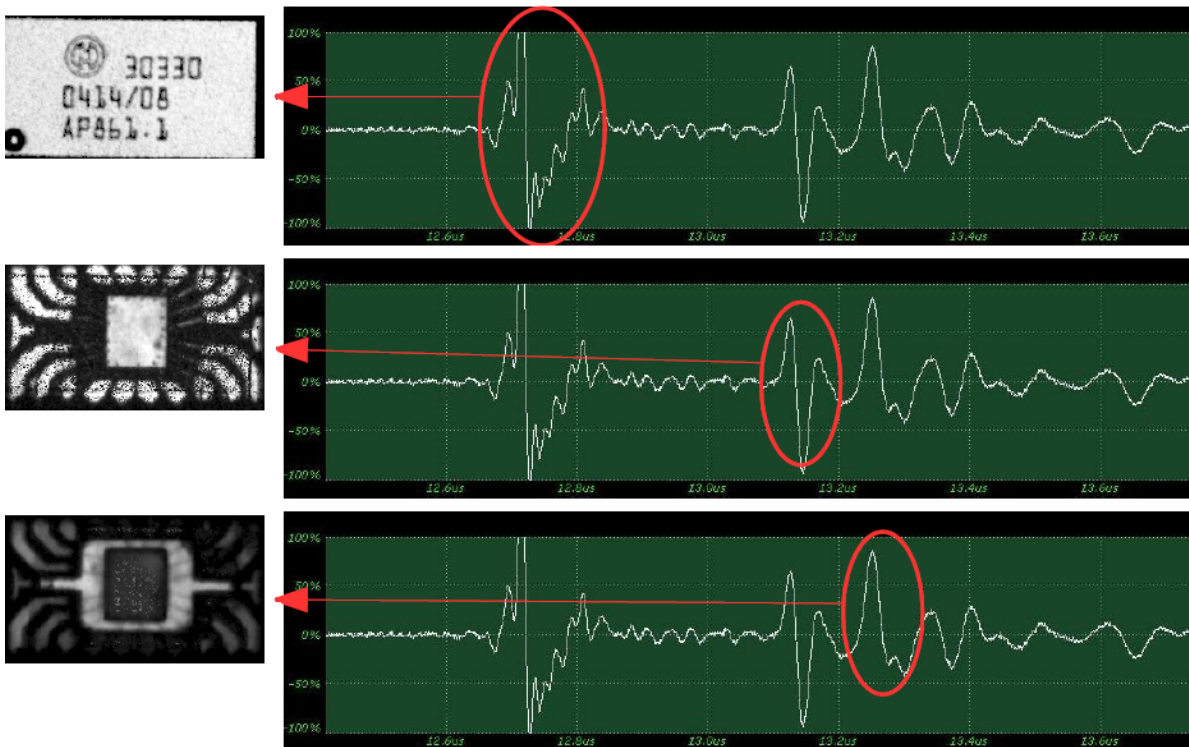
**Fig. 2.** Spectacular and interpretable C-scan images can be produced from different depth of the sample by choosing adequate time gates or windows of the

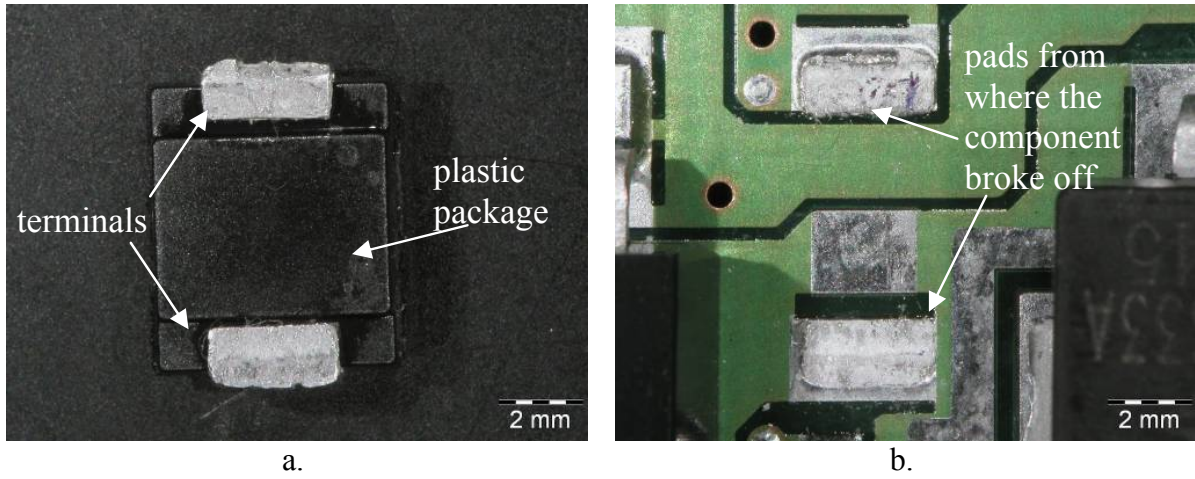
**Fig. 3.** a. Broken off SMD diode; b. Corresponding pads on the PCB

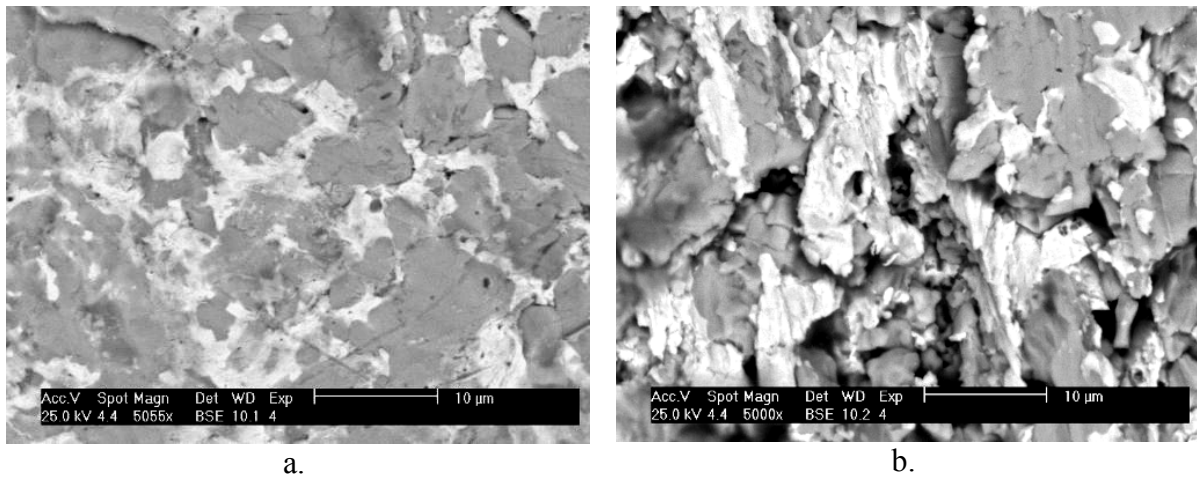
**Fig. 4.** High magnification back scattered electron micrograph of the even (a) and the rough (b) fracture surfaces of the solder joint.

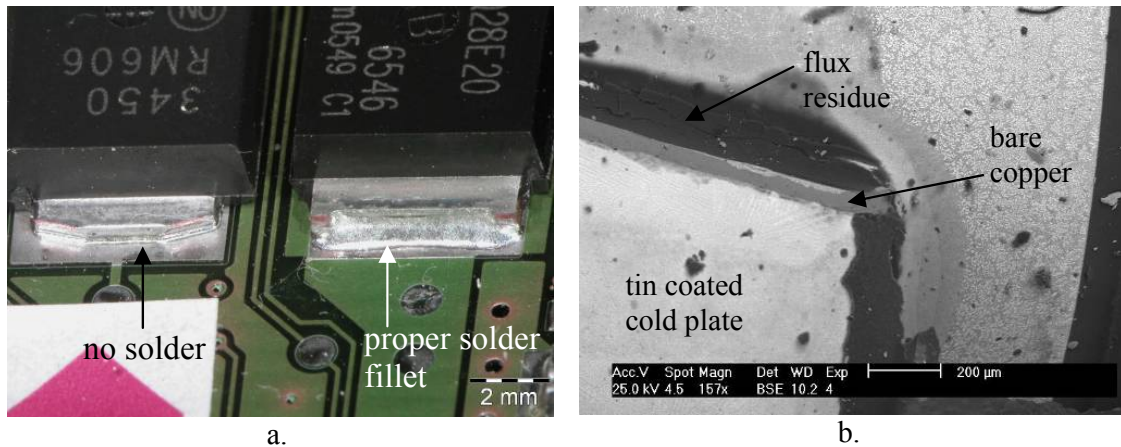
**Fig. 5.** Wetting problem of a FET cold plate.

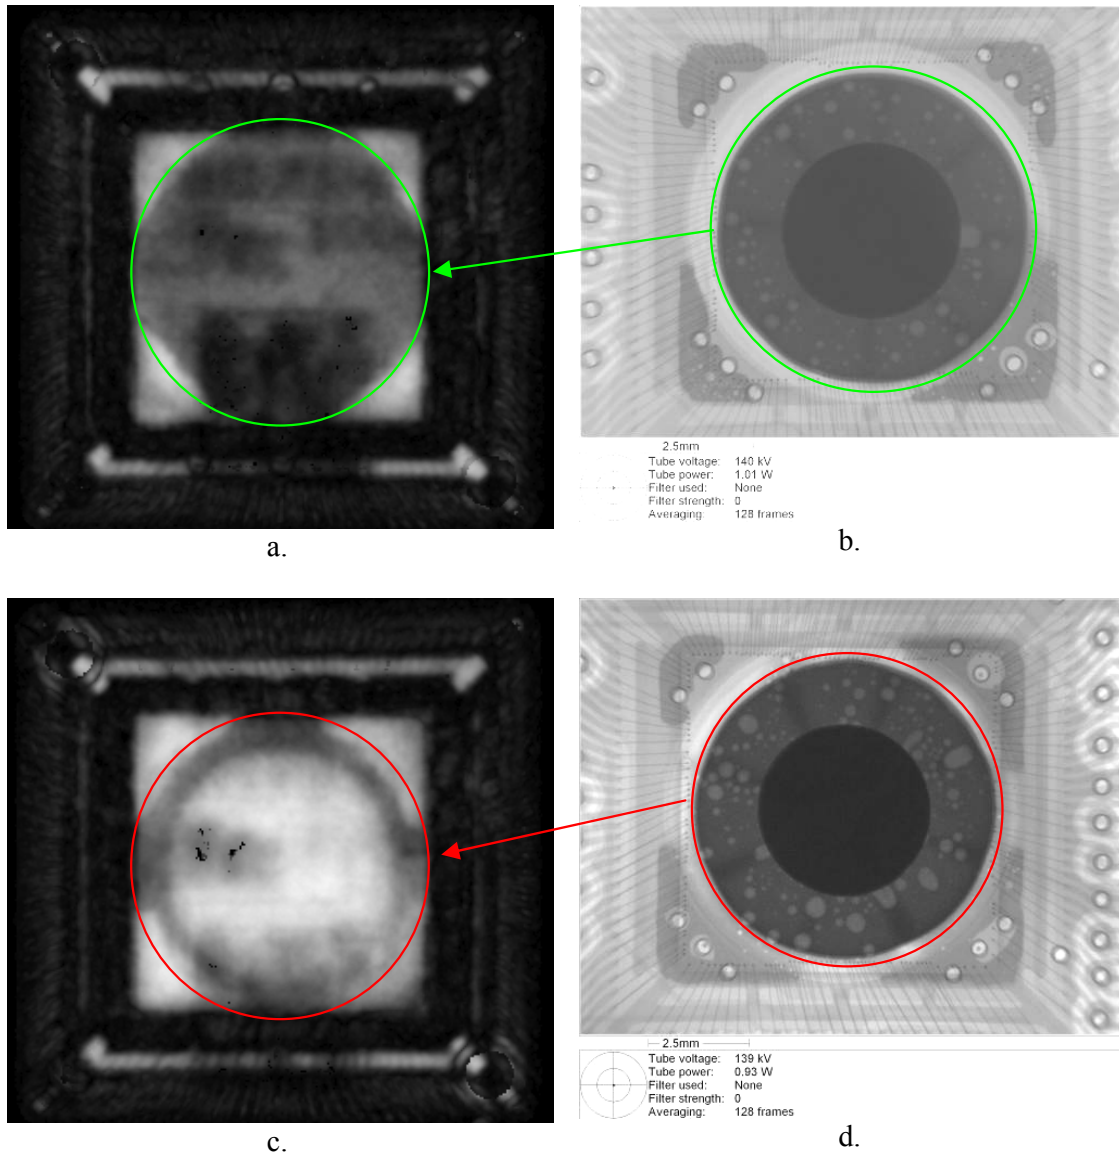
**Fig. 6.** Comparison of X-ray and acoustic micro imaging.  
 a. SAM micrograph – good sample, no delamination;  
 b. X-ray micrograph – good sample

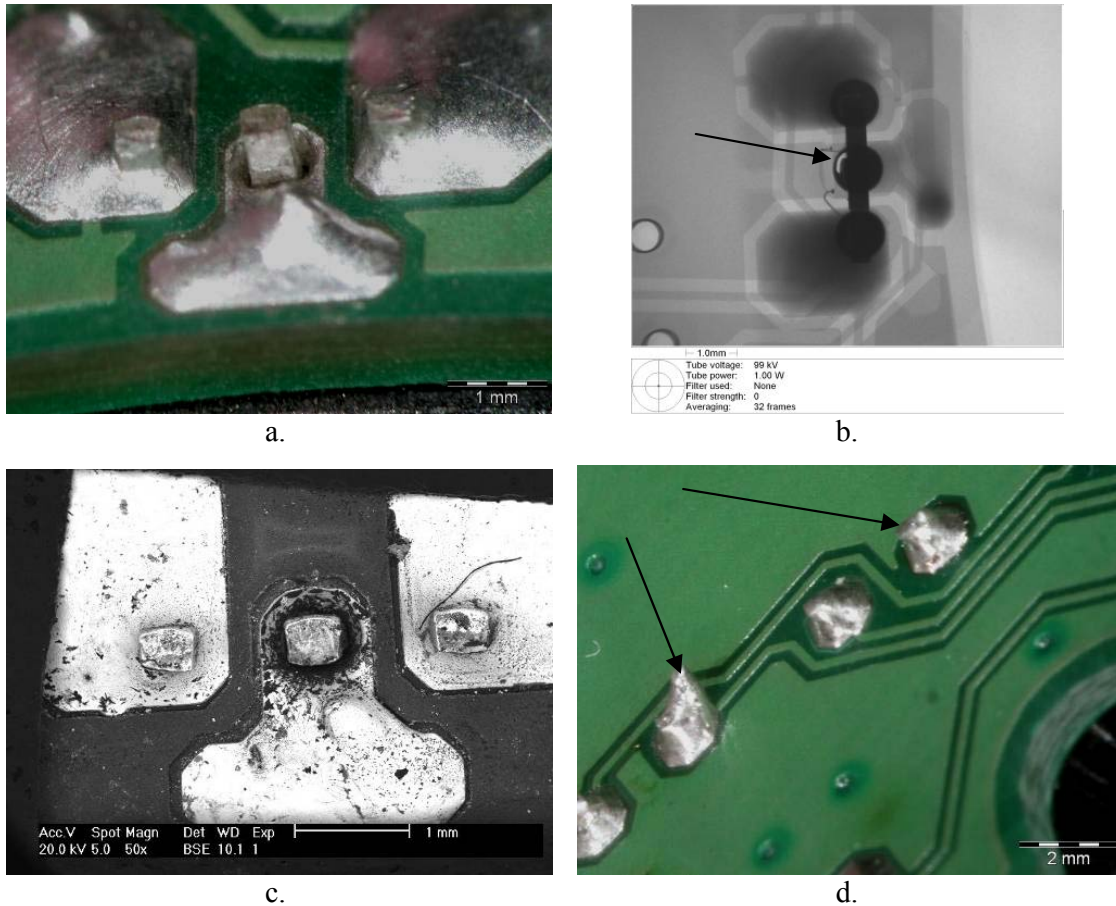
**Fig. 7.** a. Optical microscopic image of the non-wetted pin; b. X-ray micrograph, the solder did not completely fill the via; c. SEM micrograph, high
