The Condition of Immovable Cultural Heritage outside the Urban Context in Vojvodina: the Case Study of the Spitzer Villa in Beočin

Viktorija Aladžić^{1*}

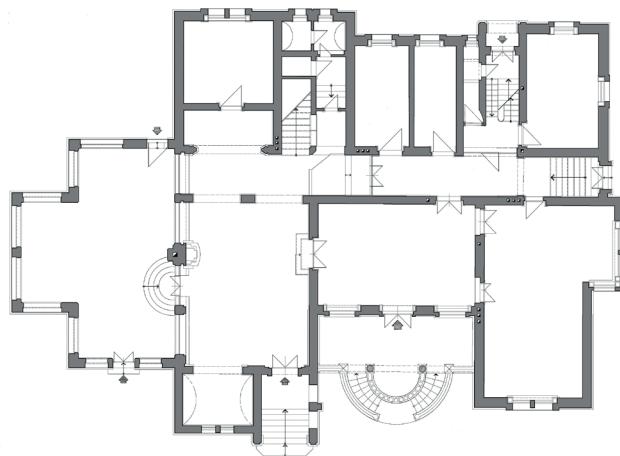
Fig. 1 Spitzer Villa – ground floor plan (Drawing: Viktorija Aladžić 2016)

Spitzer Villa is a freestanding building, with the segmented base, cellar, ground and first floor. The building was designed in the style of historicism with Secessionist decorative details. The main entrance faces south (Fig. 2), and it is connected to a corridor in the building, extending in an east-west direction. On the west side of the corridor, there is a side entrance, while the eastern branch of the corridor leads to an indoor garden, adjacent to the large parlour (Fig. 1). Smaller lounges on the ground floor are oriented northward, while the central lounge opens onto a terrace overlooking the back garden of the villa. The parlour is also connected to this garden, via a separate exit. It is also connected to the first floor via a staircase attached to the corridor.

The central corridor connecting the rooms upstairs also extends from east to west, while its eastern end opens into a gallery, which is roofed with decorative wooden ceiling and overlooks the open space of the ground floor parlour. The Northern wing of the first floor comprises a separate apartment directly connected to a bathroom and a loggia located above the ground floor terrace, also oriented towards the back garden. The Southern side of the corridor leads to two additional bedrooms. The cellar, which is located under the major part of the ground floor, includes the kitchen, store and utility rooms.

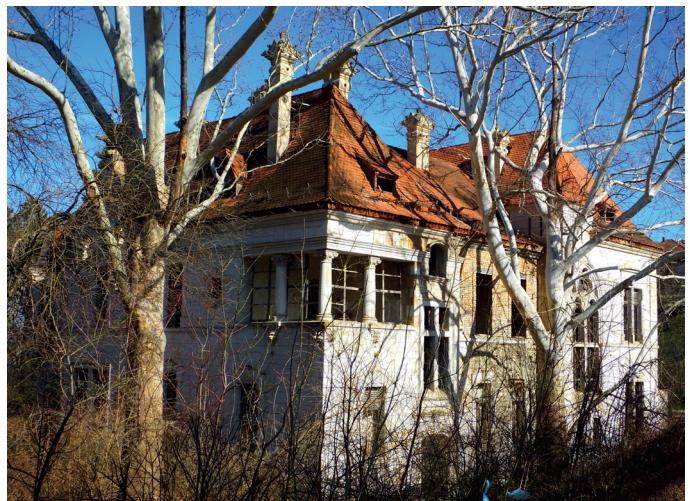
Fig. 2 Spitzer Villa – south façade before roof demolition
(Photo: Predrag Komljenović 2016)

The segmented base of the villa, with its four entrances, loggias and terrace, facilitated the concept of eye-catching façades, each different from the others. The façades have rectangular, circular and arched windows, where almost every separate light opening was conceived differently. The most representative is the three-mullioned window in stained glass located on the northern façade and providing light for the parlour (Fig. 3). On the southern façade, there is a two-mullioned window, also in stained glass, lighting the stairwell. The projecting parts of the building are covered by steep roofs, evoking the steepness of Gothic roofs, while the villa has two additional turrets.

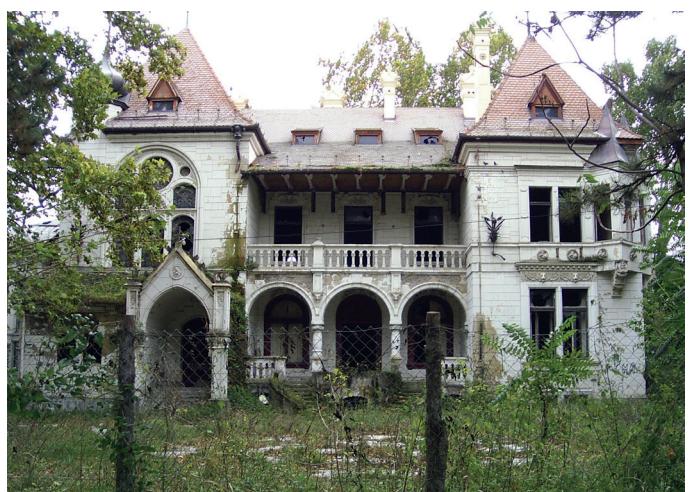
Fig. 3 Spitzer Villa – north façade (Photo: Predrag Komljenović 2004)

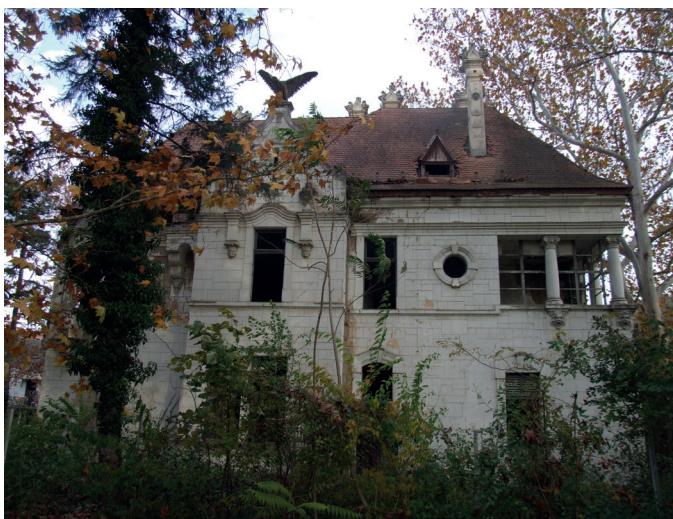
Fig. 4 Spitzer Villa – west façade (Photo: Viktorija Aladžić 2014)

The many chimneys have decorative heads, while on top of the triangular tympanum of the western façade, there is a sculpture of the Hungarian mythical Turul bird (Fig. 4). The western façade, besides regular rectangular windows, also includes a circular window and an angular loggia. The opulence of architectural details is completed with many decorative elements made of plaster and wrought iron. All these elements contribute to the daring composition and decoration, with different

historical styles being boldly combined in an original way, while additional Secessionist style details serve as embellishment. The façade comprises a multitude of sculptures with different symbolic meanings, including the heads of an owl, eagle, dragon, ram, child faces and masks.

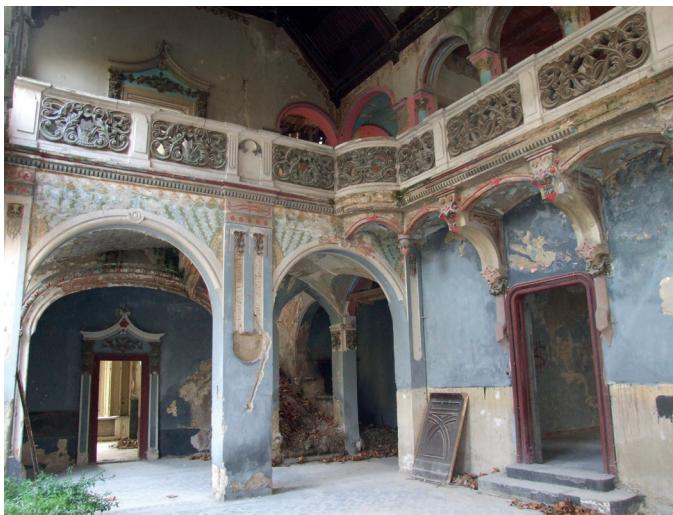
Fig. 5 Spitzer Villa – parlour interior (Photo: Viktorija Aladžić 2014)

The interior of the building is also skilfully and opulently decorated, especially the parlour area (Fig. 5). Here, the gallery fence contains elements, which are interwoven in a way almost Romanesque; oriental sinuous tympanums above the doors include a multitude of painted details, while the ornaments and stained glass are Secessionist in style. Furthermore, the hall includes a large decorative fireplace, made of Zsolnay ceramics.

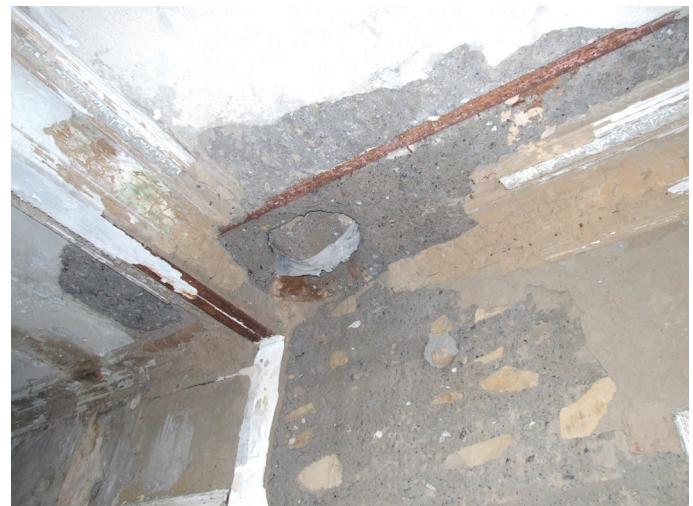
the erection of the villa as a good advertisement for his cement production, as he had invested a large amount of his capital into the business. The construction of the villa involved extensive use of concrete, both for walls and ceilings, in combination with steel girders. Cellar and ground floor walls were made of concrete and larger stone pieces, with gravel and slag as aggregates, while the first floor walls intermittently involved the use of concrete made with finer aggregates (Fig 6). The ceilings of the corridor and bathrooms were also made of fine-aggregate concrete. The walls are in places coated with brick. The roof structure is made of wood, just like the ceiling of the parlour.

Fig. 6 Spitzer Villa – concrete wall and ceiling on the second floor
(Photo: Viktorija Aladžić 2014)

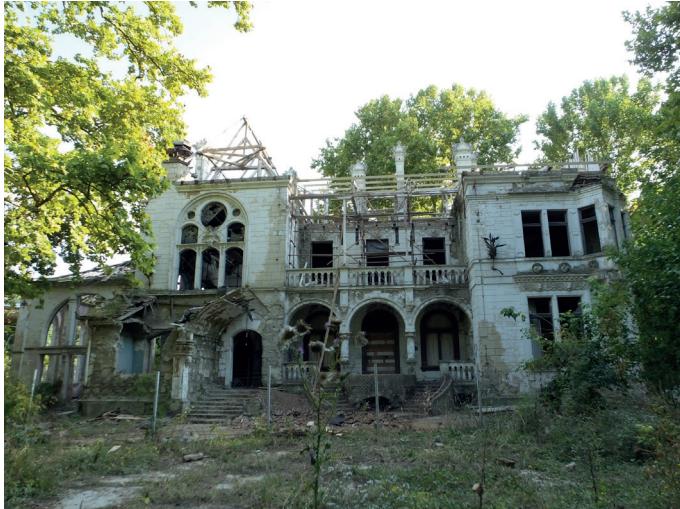
In September 2016, the Ministry of Culture and Information of the Republic of Serbia agreed to the removal of the villa's roof structure to prevent it from collapsing. On that occasion, the entire roof was disassembled, and the temporary roof structure was constructed using the material of the existing roofing (Fig. 7). During these works, three of the ten chimneys, with decorative chimney-heads, previously restored, collapsed, and are now lying in the rubble around the villa. One of the heads damaged the metal framework of the winter garden and is currently lying on the floor, beneath the damaged structure. A portion of the material and tiles removed from the roof have been stored in the villa corridor, to be used in future restoration of the original roof. The design for static repairs of the buildings is expected to be made, followed by the designs for reconstruction and conservation. The doors and windows openings were permanently boarded up. However, some of the boards have already been removed by unknown persons and trespassing is again occurring. Rubble is scattered all around, including the remains of the bitumen seals used in the roof restoration of 2000 (Fig. 8). Great piles of rubble from the collapsed roof can also be found on the floor of the upstairs rooms. The rubble also contains parts of the ornaments broken during the removal of the roof.

Fig. 7 Spitzer Villa - north façade after removal of the roof
(Photo: Predrag Komljenović 01.10. 2016)

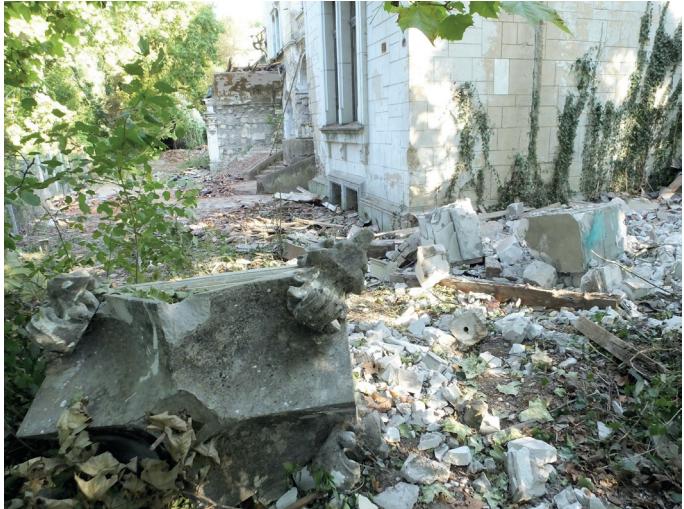
Fig. 8 Rubble around Spitzer Villa after the demolition of the roof
(Photo: Predrag Komljenović 01.10. 2016)

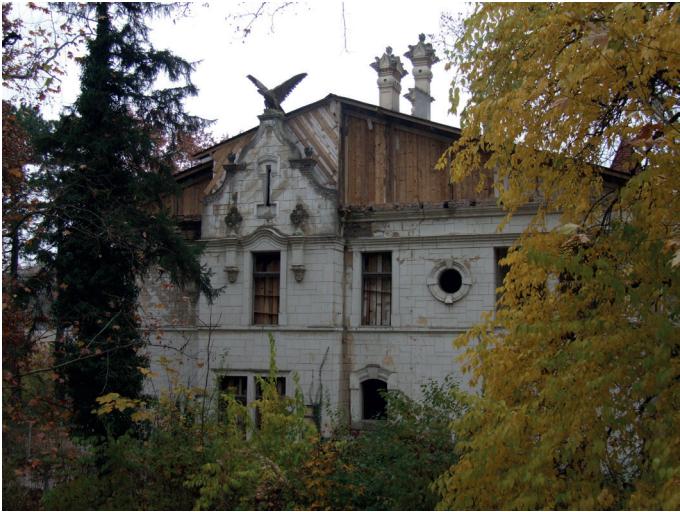
The example of the Spitzer Villa shows that none of the segments of modern heritage management were implemented in their entirety, while some of them were absent altogether (Fig. 9). The fundamental precondition for attaining good practice in heritage management is the interest of society in maintaining it. This interest must transcend passive concern and become active, where various actions would directly contribute to heritage preservation. Heritage cannot exist outside the policy and decision-making process pertaining to the future development of certain areas. Policies related to heritage creation and management must be made and implemented by policymakers, private companies, or interested individuals (Ashworth and Howard, 1999).

Fig. 9 Spitzer Villa – west façade (Photo: Viktorija Aladžić, November 2016)
