# Effect of Change on the Values of Two Historic Mosques in Manisa, Turkey

This study focuses on the value-change relationship in two historic mosques and presents a management framework that considers their common conservation problems. The case studies are the Haki Baba Mosque in Manisa centre and Kabasakal Mosque in Kırkağaç, Manisa; both have been recently restored. The literature review covers value and intervention concepts with literature and archive research specific to the case studies; this includes a comparative study with similar buildings together with site observations.

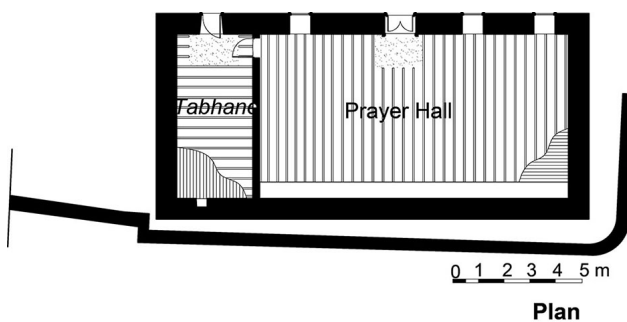
Fig. 1 Plan of Haki Baba Zaviye, restitution

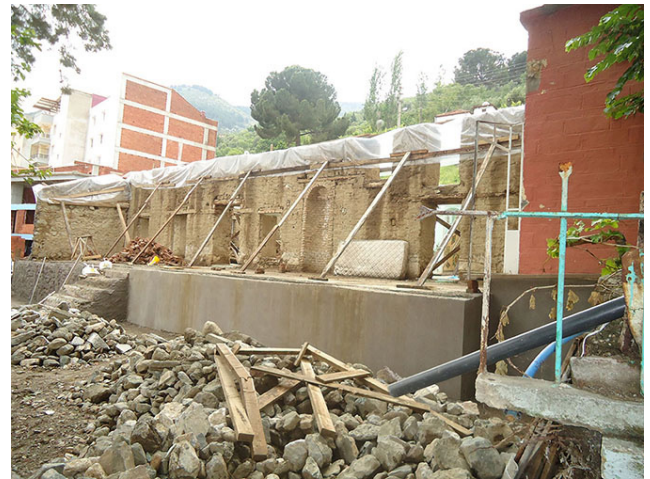
Fig. 3 Adobe mud-brick masonry walls with timber lintels, Haki Baba Mosque, during the 2014 restoration application

The mud-brick masonry walls were reinforced with a timber frame system and plastered with brick lime, giving the impression that this was the original construction technique. However, the timber posts, which were part of the flat earthen roof, were removed entirely. These interventions hinder authentic, age and documentary value. Since plan characteristics, mass characteristics, façade characteristics, construction technique and material usage were all altered throughout its life span, almost all of the architectural characteristics of the 1371 period were lost; authentic value could not be sustained.

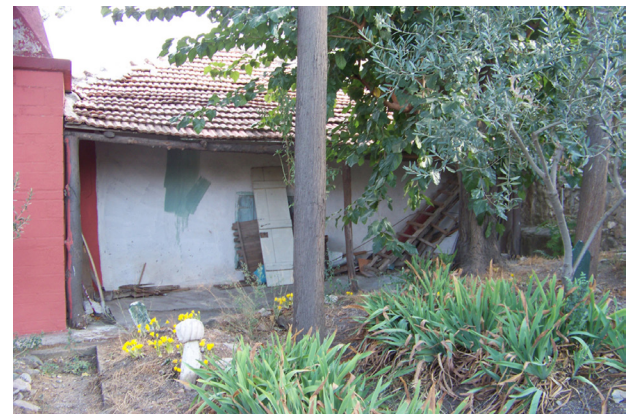
Fig. 4 Timber post remains under the eave, before restoration

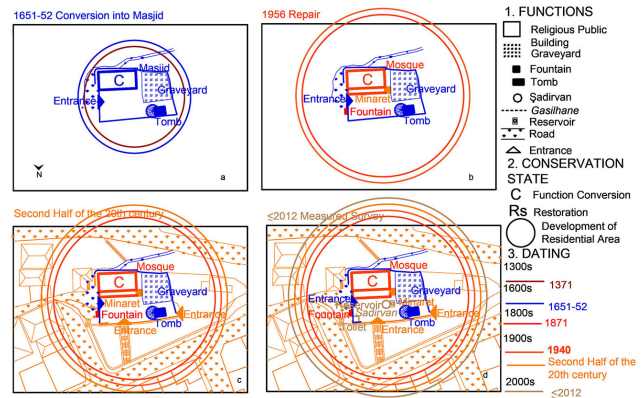
Fig. 5 Historical development of Kaynak Neighbourhood (a) 1651-52, (b) 1956, (c) second half of the 20<sup>th</sup> century, (d) ≤2012.

The case study building was initially used as a masjid from 1651-1652 (Gökçen, 1950) (Fig. 5 (a)). With the establishment of a neighbourhood in the vicinity, a route to the south of the building and a courtyard to the north were formed; access to the courtyard was from the east. Evliya Çelebi described the masjid with a hipped roof in 1671 (Dağlı et al., 2005). It is understood that the site of the masjid was damaged by magnitude seven Richter Scale earthquakes, centred around Turgutlu and Menemen districts, in 1862 and 1880 respectively (BUKÖERIRETMC, 2018).

In 1871, the fountain of Serseri Dede was constructed towards the north of the courtyard entrance (Uluçay, 1940) (Fig. 5 (b)). The residential area around the masjid was damaged by fire in 1922 (Emecen, 2003).

Conversion of the masjid into the mosque was realised in 1956, and a minaret was added (Fig. 5 (b)) (Acun, 1999). The prayer hall was also exposed to some interventions in this period: a concrete *minber* addition and new voids were added to the exterior walls.

The vicinity of the monument was filled with three to five-storied buildings with the application of the 1962 Development Plan (RDPF, 2016) (Fig. 5 (c) and Fig. 6). The courtyard walls were constructed along the designated boundary of the mosque's plot. Access from the north was provided with the addition of a flight of stairs.

In the second half of the 20<sup>th</sup> century, a new *şadırvan*, reservoir and toilet were added to the courtyard (Fig. 5 (d)) (RDPF, 2008). The courtyard was also entered from the west; from a partially collapsed section of the courtyard wall. A single, hipped roof was constructed to span both the prayer spaces and the latecomers' portico. Walls were rendered with cement, and the floors were covered with screed.

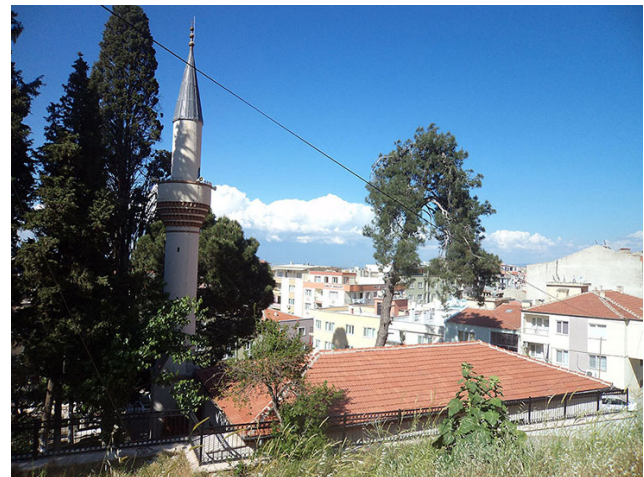
Fig. 6 Haki Baba Mosque and apartment blocks around it - view from the south

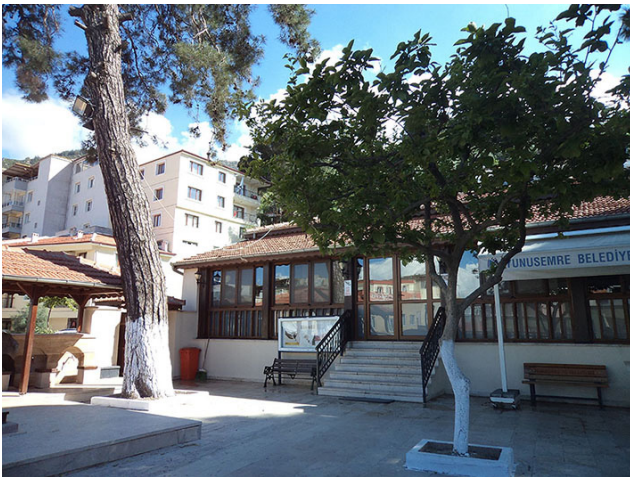
Fig. 8 Haki Baba Mosque, courtyard façade, view from the north

Conversion of the rural site into a dense urban site has harmed the picturesque value of the modestly scaled monument built for seclusion. Natural disasters have several times, demolished this urbanised area. However, the urban site was renewed on each occasion. The urban layout hinders the picturesque value together with the disproportionately sized minaret and latecomers' portico additions to

the mosque (Fig. 8). The spiritual value has mostly been sustained throughout its lifespan since the building is used for prayer, but there is no design approach guiding visitors on the seclusive qualities of the place in its origin. The community relationship with the building in terms of its periodic maintenance, for example, maintenance of the earthen roof or mud plaster, could not be sustained; these also reduce use value.

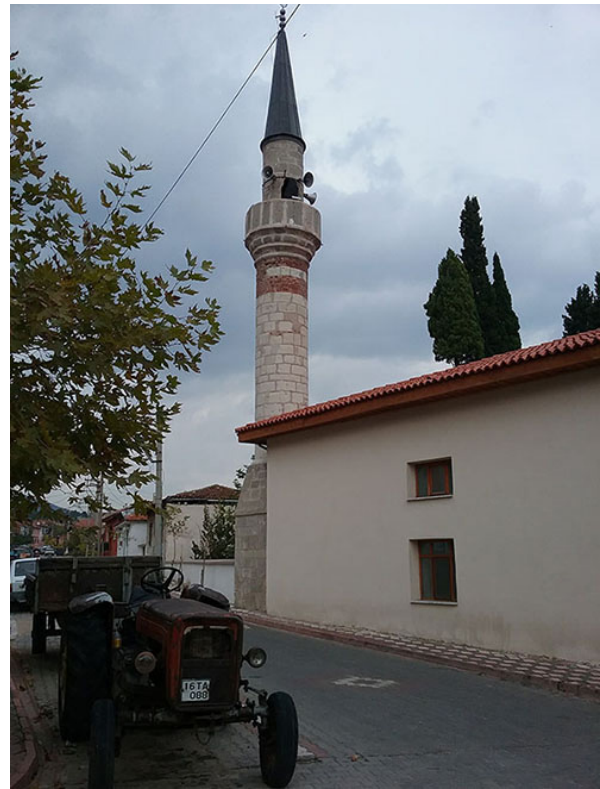
Fig. 9 Kabasakal Mosque, and road and houses surrounding it, view from the southwest

the growth of İzmir as an international trade centre, the Armenian and Greek population had also increased in its hinterland, including Kırkağaç (Ülker, 1994). The Armenian neighbourhood of Kırkağaç was established in the vicinity of Kabasakal Mosque in the 18th century. This gave way to the development of a grid layout settlement and an increasingly more urban trend (Fig. 9). The centre of Kırkağaç continued to house Turkish people.

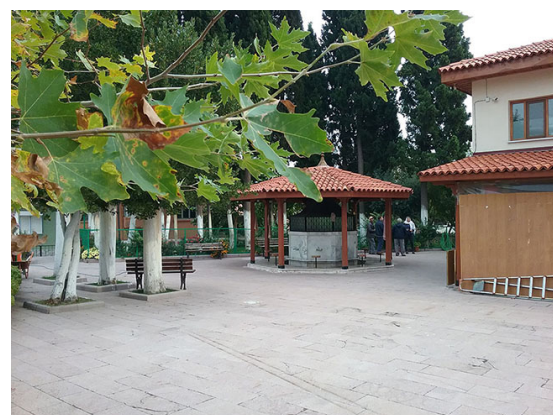
Fig. 11 Courtyard, Kabasakal Mosque, view from the northwest

In 1841, the present mosque of Kabasakal was built over the ruins of the former one (Fig. 10 (a), Fig. 10 (b) and Fig. 11). Entrance to the courtyard was from the east, south and west, with the eastern part of the courtyard hosting a graveyard. A fountain was added on the roadside, adjacent to the courtyard's western wall. Kabasakal Mosque was stone masonry, covered with an earthen roof and with narrower windows, according to a comparative study carried out with vernacular structures in the Manisa region and with similar mosques dated to late 18<sup>th</sup> and 19<sup>th</sup> centuries in Denizli, which is another historical settlement in the region (Çakmak, 1991).

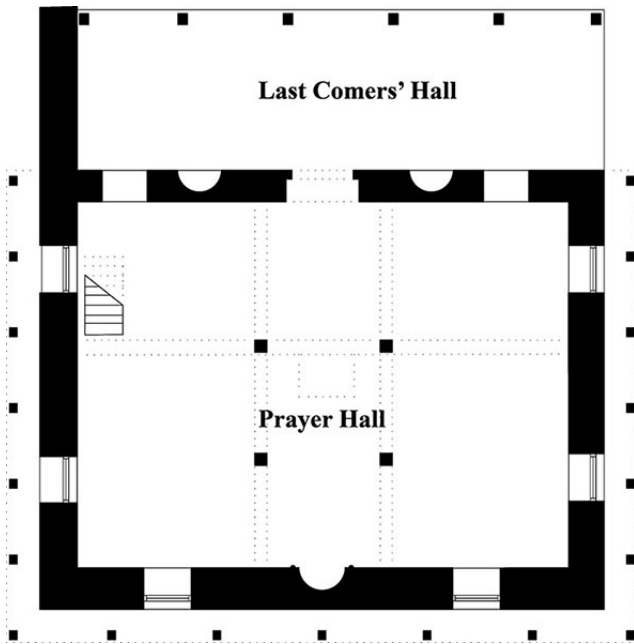
Fig. 12 Plan of Kabasakal Mosque, restitution

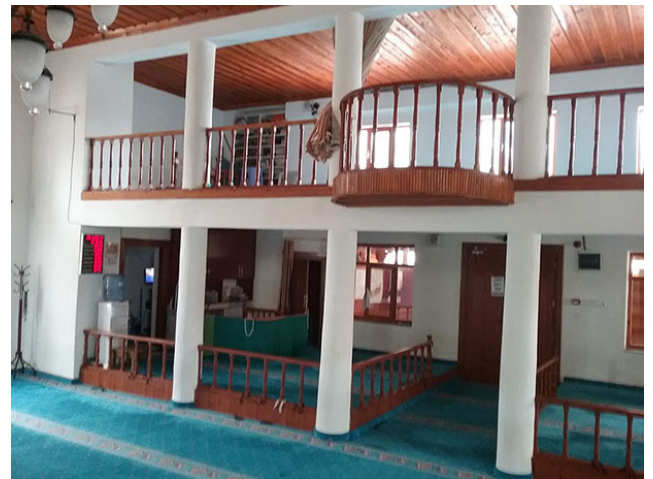
Fig. 14 Spaces and elements at the northern part of the prayer hall, Kabasakal Mosque

and additional *mahfils* for *müezzins* were provided in this enlarged part (Fig. 14). At the north-western part of the prayer hall, a stairwell replaced the stairs for the *mahfil* for women. The minaret was entered from the same stairwell. An *imam* room reached from the prayer hall with an additional door was added under the stairs. The *mihrab* niche was framed with marble ornamentation, and the timber *minber* and sermon chair were altered with marble versions.

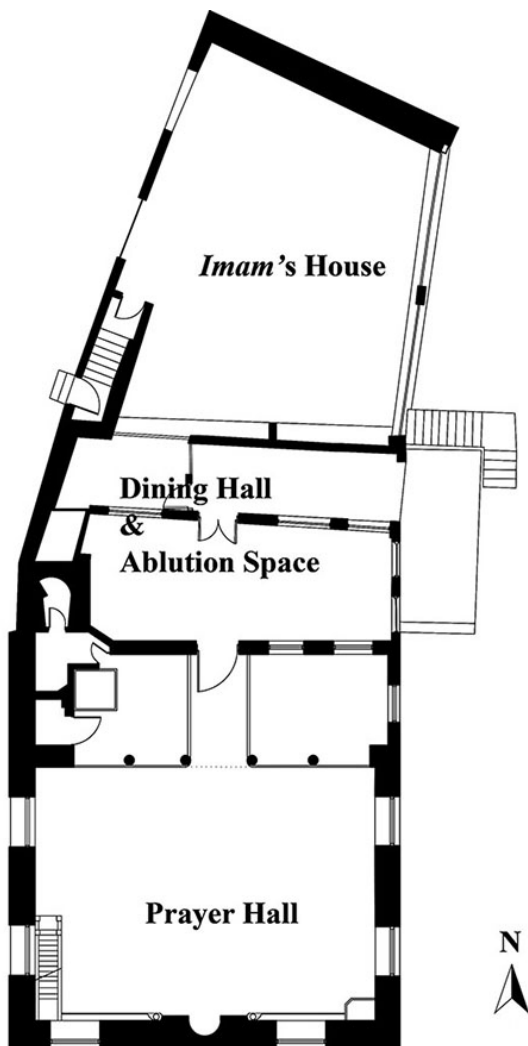
Fig. 13 Plan of Kabasakal Mosque, measured survey  
 (Revised from RDPF, 2009)

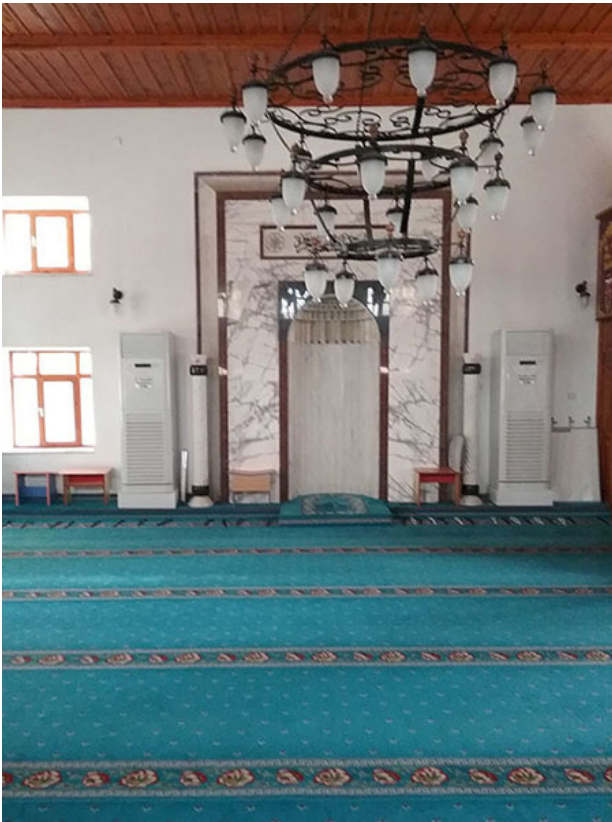
Fig. 16 New *mihrab* niche and air conditioners on its both sides, prayer hall, Kabasakal Mosque

the element alterations have harmed cultural asset values (Fig. 16). After the approval of the 2014 restoration by the related Conservation Board, an unplanned latecomers' portico disturbing the original solid-void balance of the mosque and its courtyard was added.

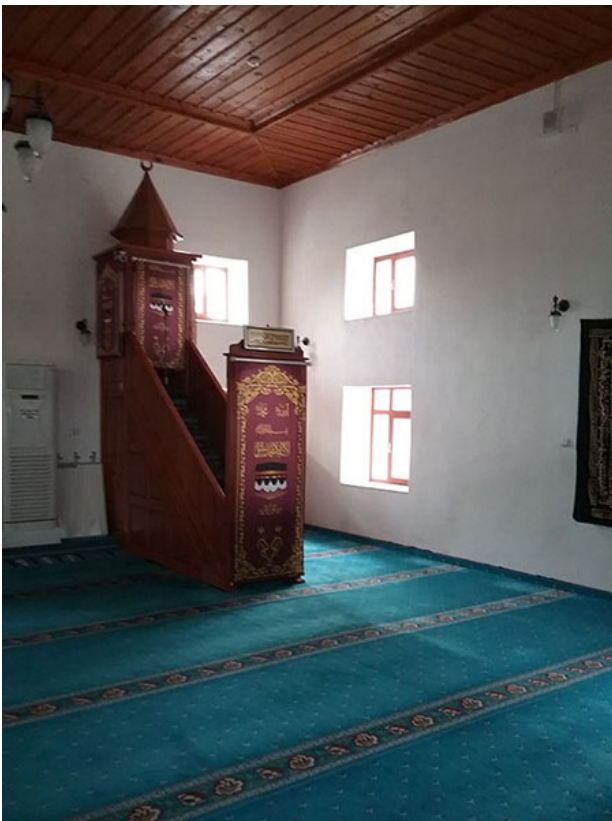
Fig. 17 New timber *minber*, prayer hall, Kabasakal Mosque

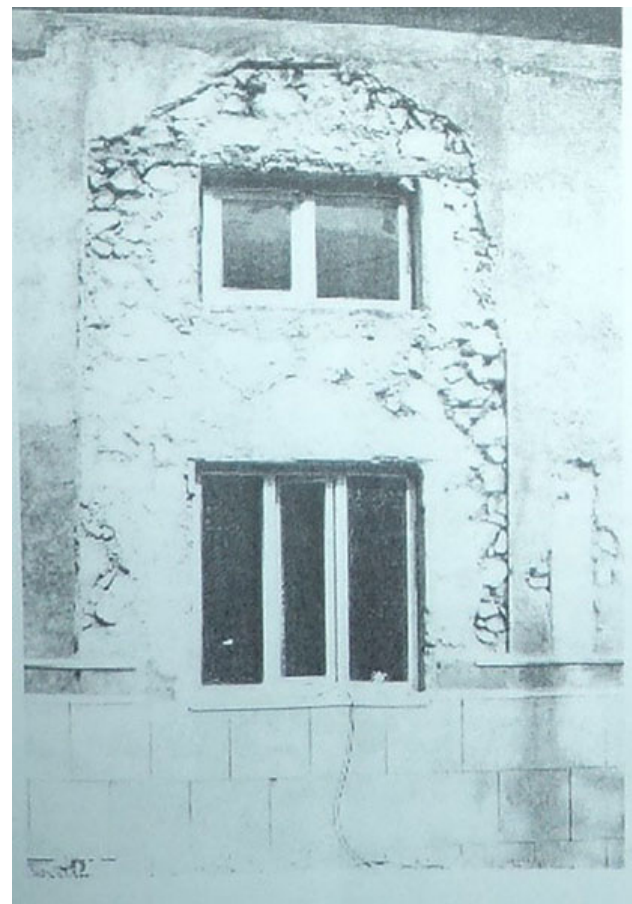
Fig. 19 Rough stone masonry wall, Kabasakal Mosque, before the 2014 restoration (RDPF, 2008)

The building documents the authentic construction technique with its walls (Fig. 19) and minaret. Cleaning the plastering at the *kaide*, *pabuç* and body of the minaret, its cornice, *şerefe* and *petek* have contributed to the presentation of its authentic qualities. However; the documentary value has been hindered since its original roof, windows, and space organisation were lost.
