Construction History and Research of the Holy Trinity Parish Church in Szigetmonostor

Ágnes Gyetvainé Balogh^{1*}

Szigetmonostor, Baroque church architecture, surveying plans from the 18th century

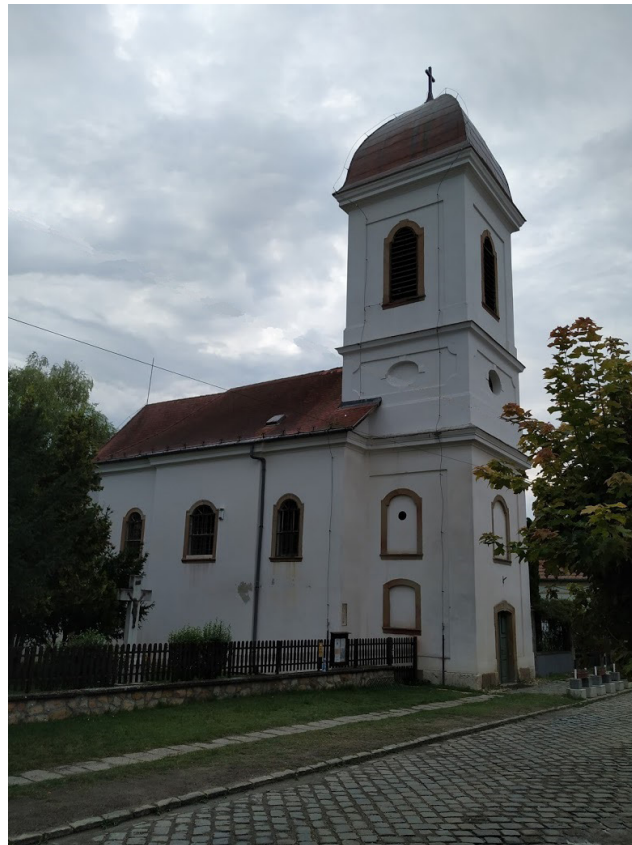
Fig. 1 The church from the South, 2020.

Szigetmonostor is a municipality in Pest County on the Szentendre Island. The Roman Catholic Church built in the honour of the Holy Trinity has been a monument since 1958 (Fig. 1).¹

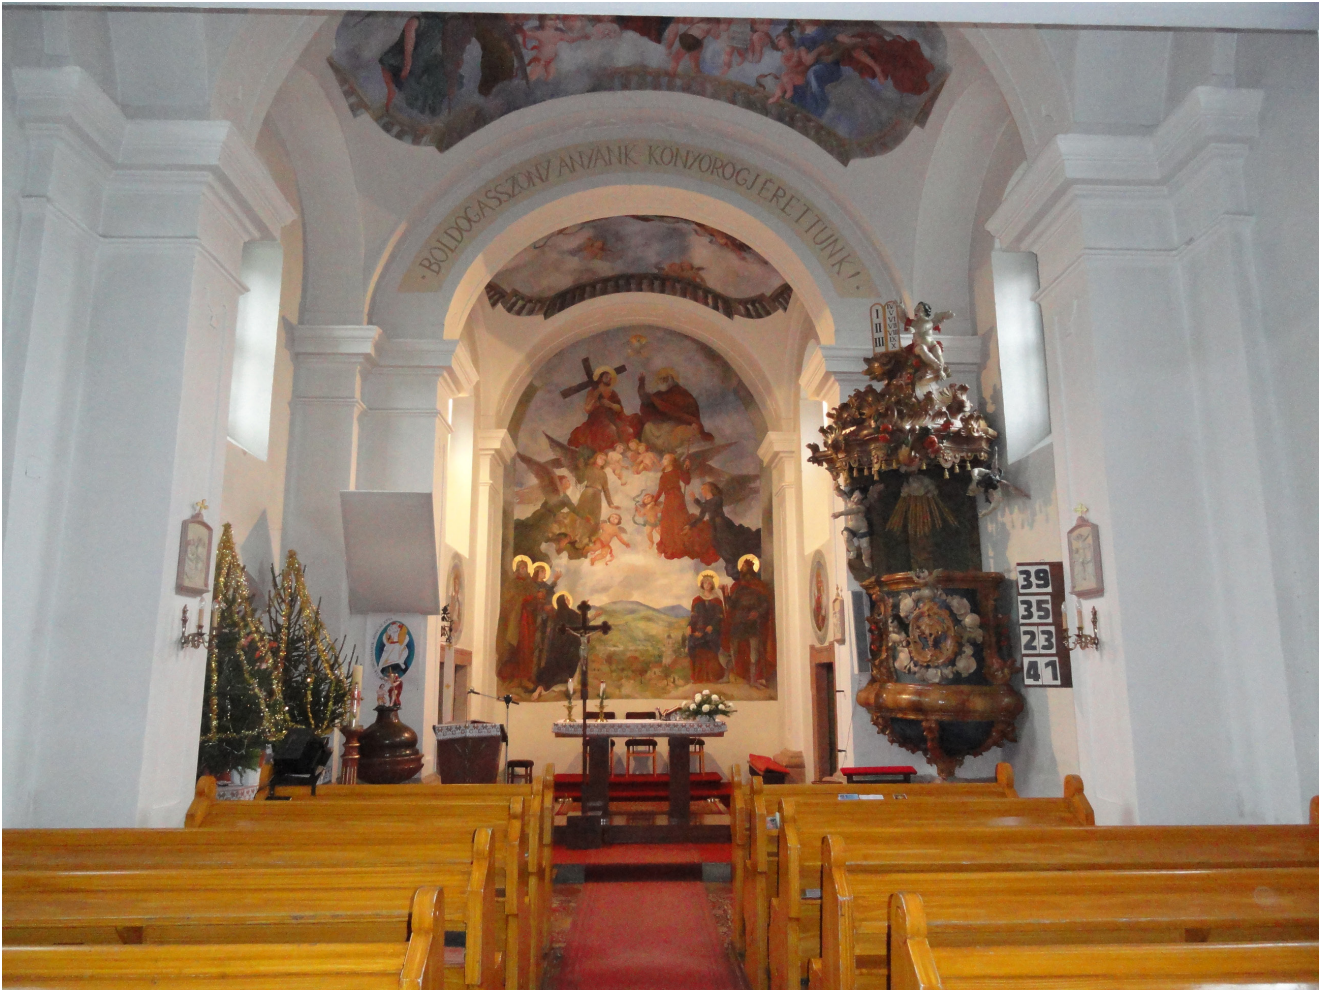
Fig. 6 The internal space of the church, 2016.

to an altar table made of artificial stone. Two late Baroque angels dating back to the 1760–1770s stand at both sides of the tabernacle (Fig. 6).

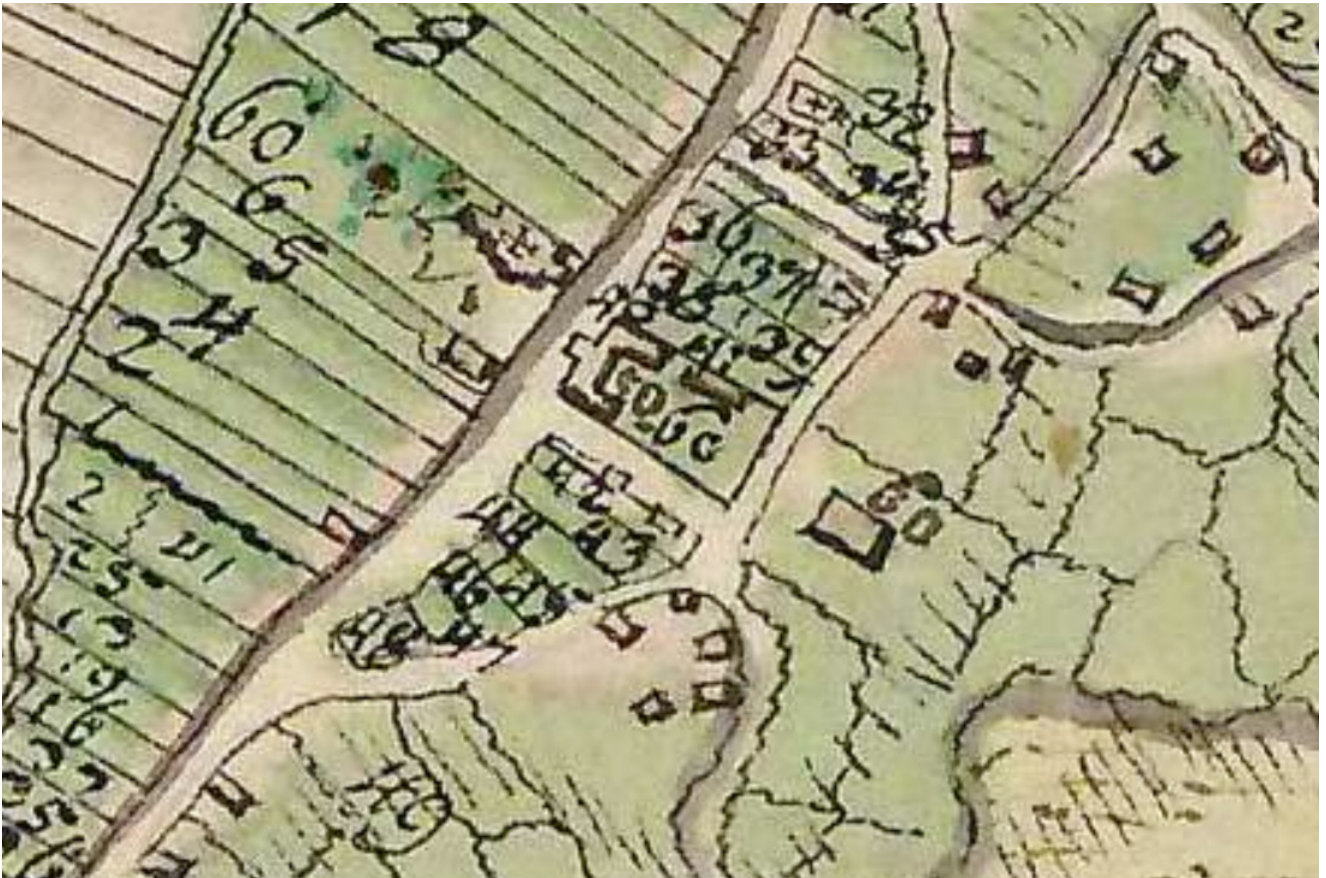
Fig. 7 In the middle the U-shape Horányi Castle opposite to the Roman Catholic church and the small teaching house. Detail from the survey map of Monostor. A. Kneidinger, 1778. (MNL OL S 11. No. 34).

After the Zichy agreement the Chamber returned Monostor from pledgee Antal Horányi back as far as at the end of 1766 (Bakács, 1963:pp.7–8, 140; L. Gál, 1988:pp.49–59, 212, 218). Following the acquisition of the manor a survey started focusing on the whole territory and building stock. Andreas Kneidinger made his map sequence about the municipalities⁴ of the late Zichy manor in the 1770s (1776–1770), providing a thorough presentation of the buildings, land allocation and street network of Monostor, too (Fig. 7).⁵

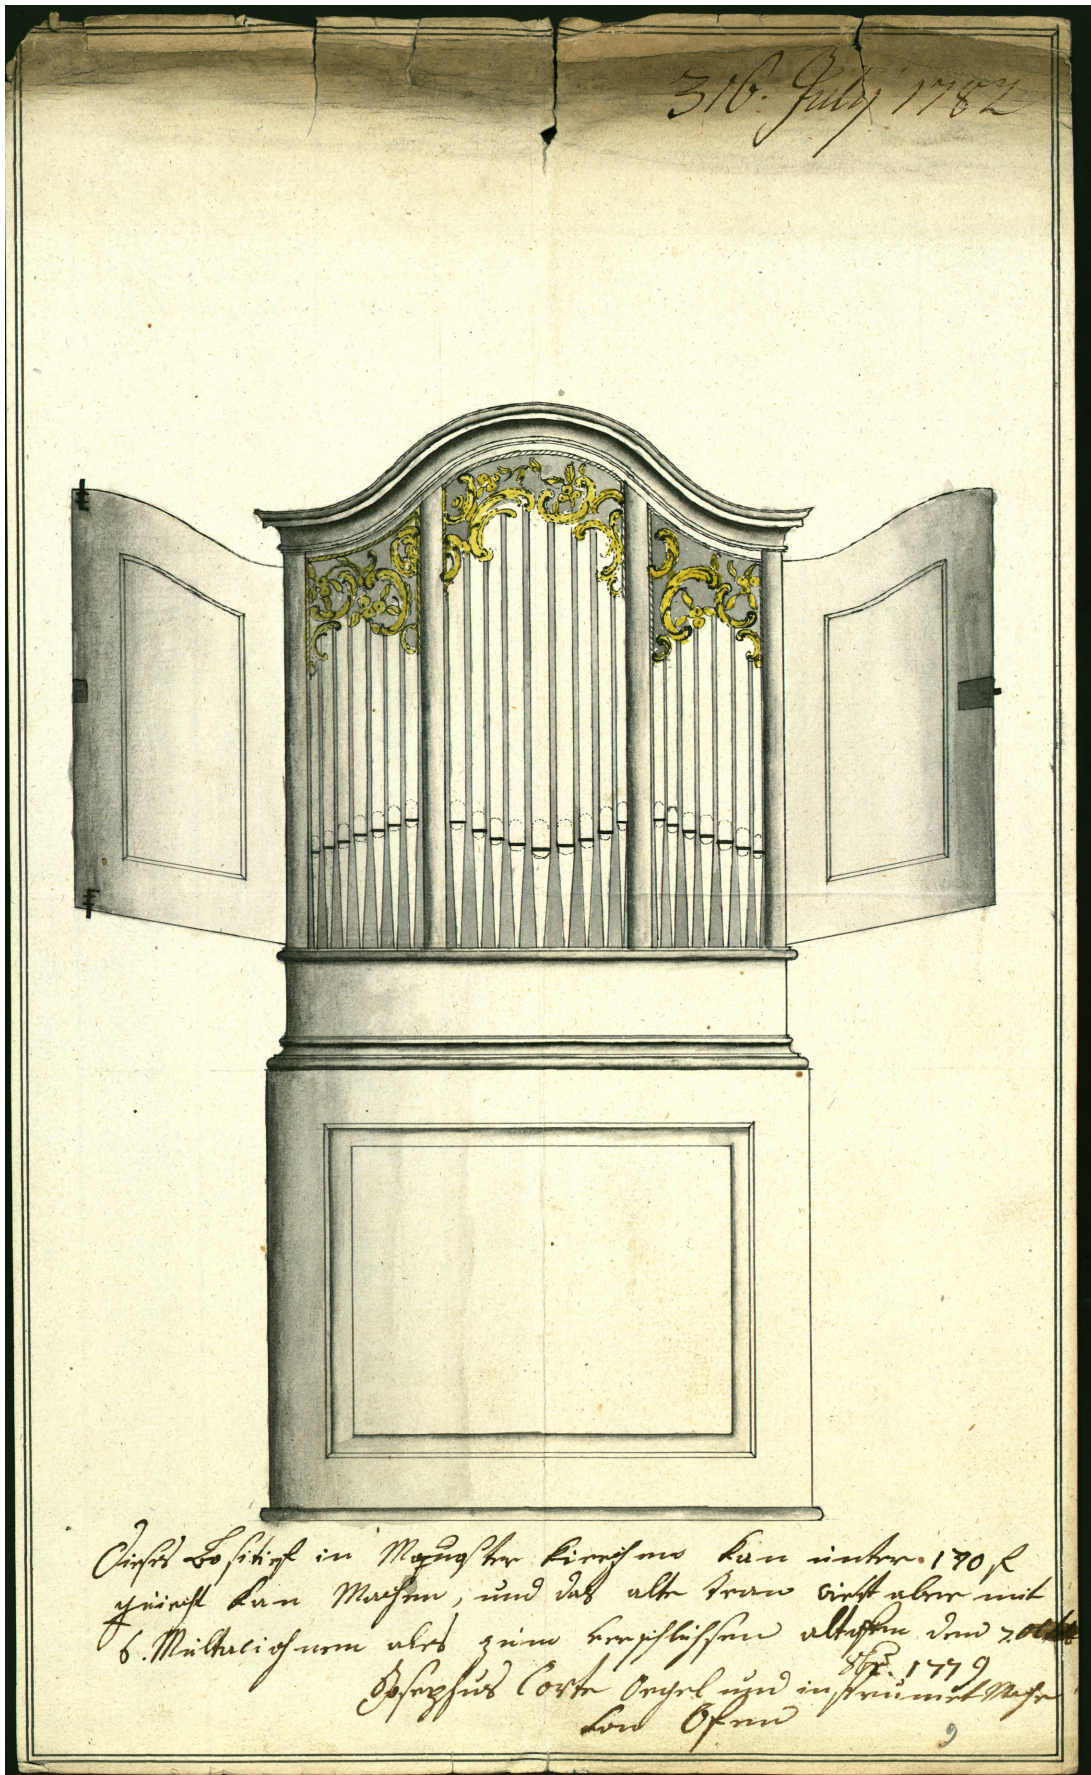
Fig. 11 Plan of the positive organ of the church in Monostor Josephus Corte, organ and musician master of Buda. Óbuda, October 1779 (MNL OL T62. No. 216/8.).

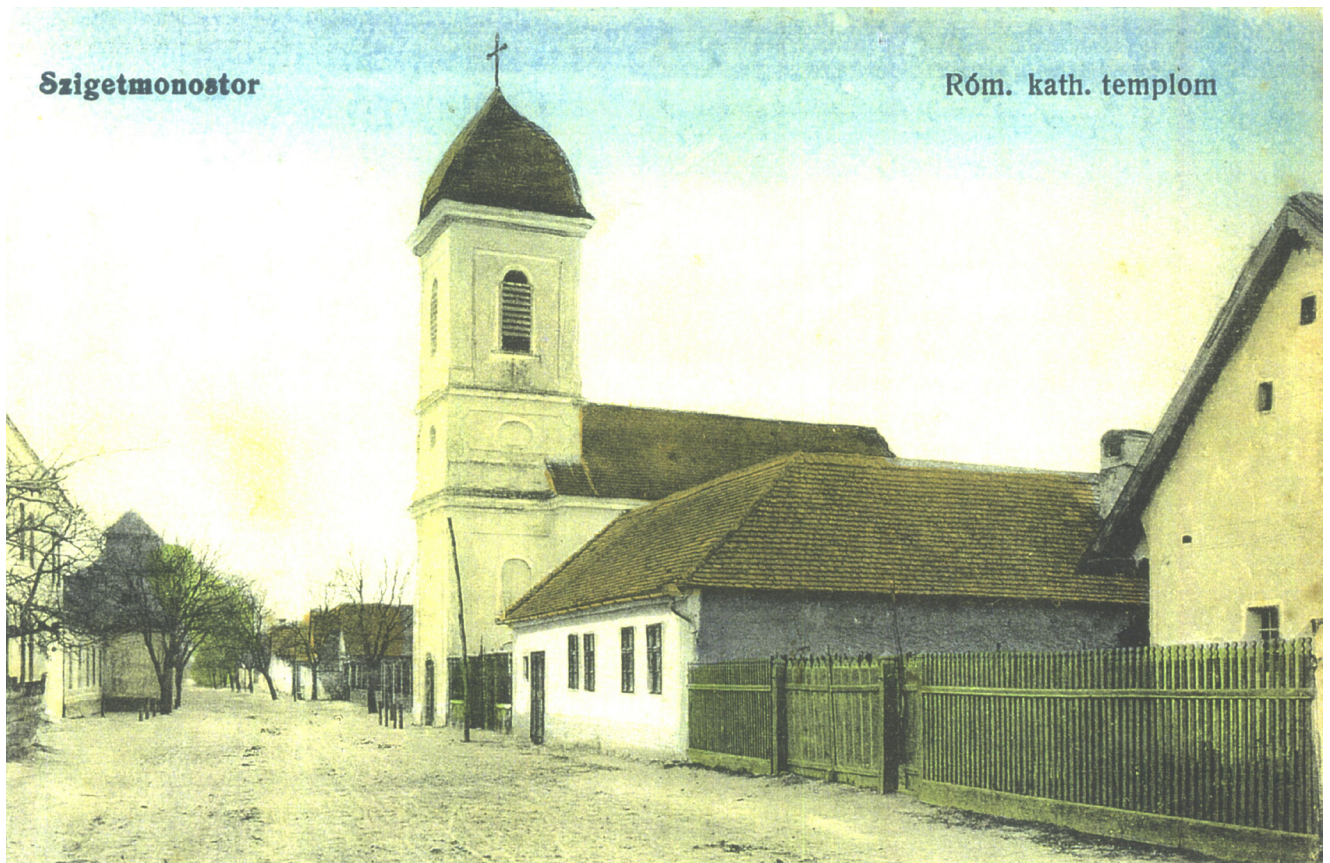
Fig. 13 Szigetmonostor. Rom. Cath. Church. Postcard, published by Mórny Goldstein, 1918 (Herrer collection, Szigetmonostor, published by Herrer, 2007:p.13).

which was recorded by several postcards (Fig. 13). The condition represented by the slate covered nave and the shingled steeple after 1923 can also be seen on several photographs. This type of roof cover had still existed yet in 1958 (Dercsényi, 1958:II.:p.140).
