# Impact of Conservation Planning and Implementations on Cultural Heritage Values in the Historic Urban Site of Kuşadası

The study aims to evaluate the impact of the conservation planning and implementations on the cultural heritage values in a cultural landscape: Kuşadası, Aydın, Turkey. The study is limited to the decisions published on the Internet: decisions between 2013 and 2016. The methodology includes literature research, archive research in the related Regional Commission on the Conservation of Cultural Property, the Regional Directorate of Foundations, and the local administration. A site survey comprehending base map revision and photographic documentation, visual analysis, historical research and comparative study, and evaluation of conservation activities regarding concepts of conservation is also part of the research. As a result, conservation issues stem from inappropriate conservation implementations threatening the integrity of cultural heritage. The majority of the conservation implementations have focused on a single building scale. Unlicensed constructions stemming from insufficient control by the local administration in the historic urban environment and the l

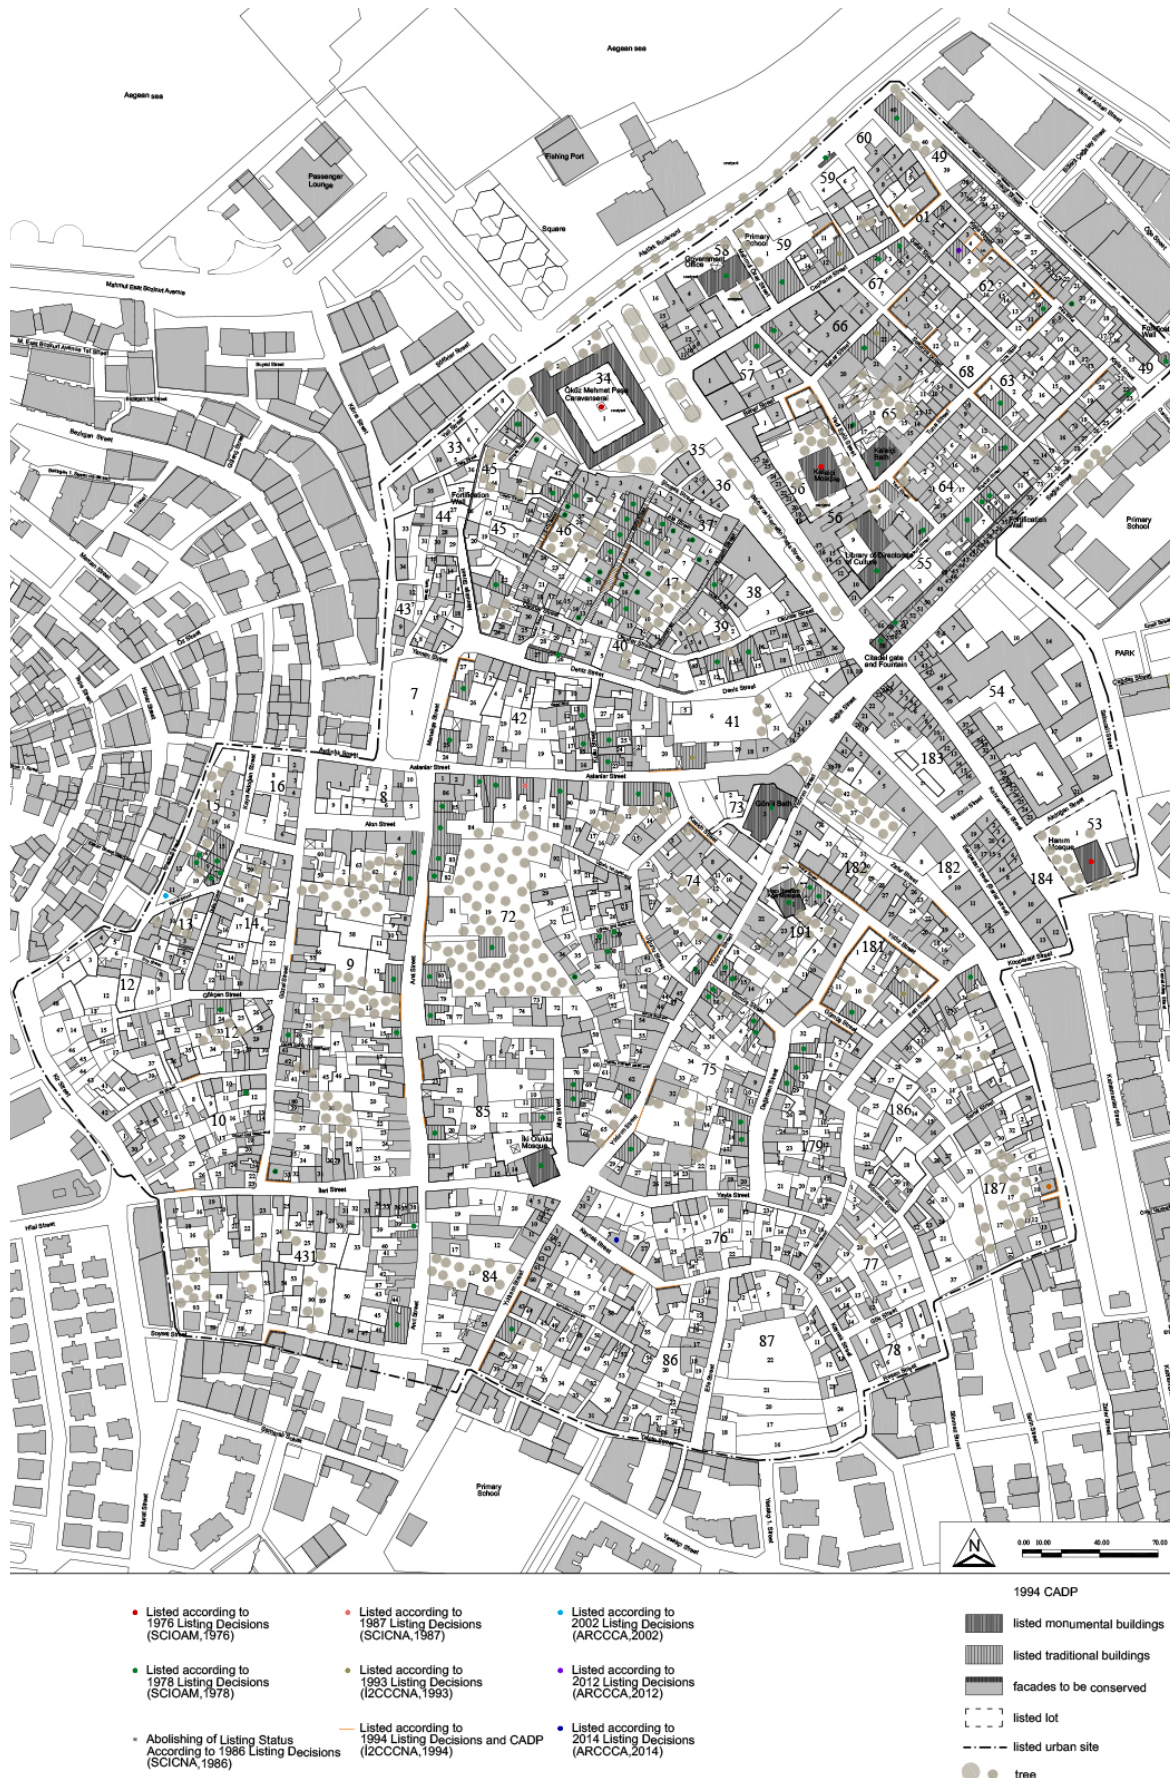
Fig. 4 Evolution of Listing Decisions (revised from Kutluay, 1994)

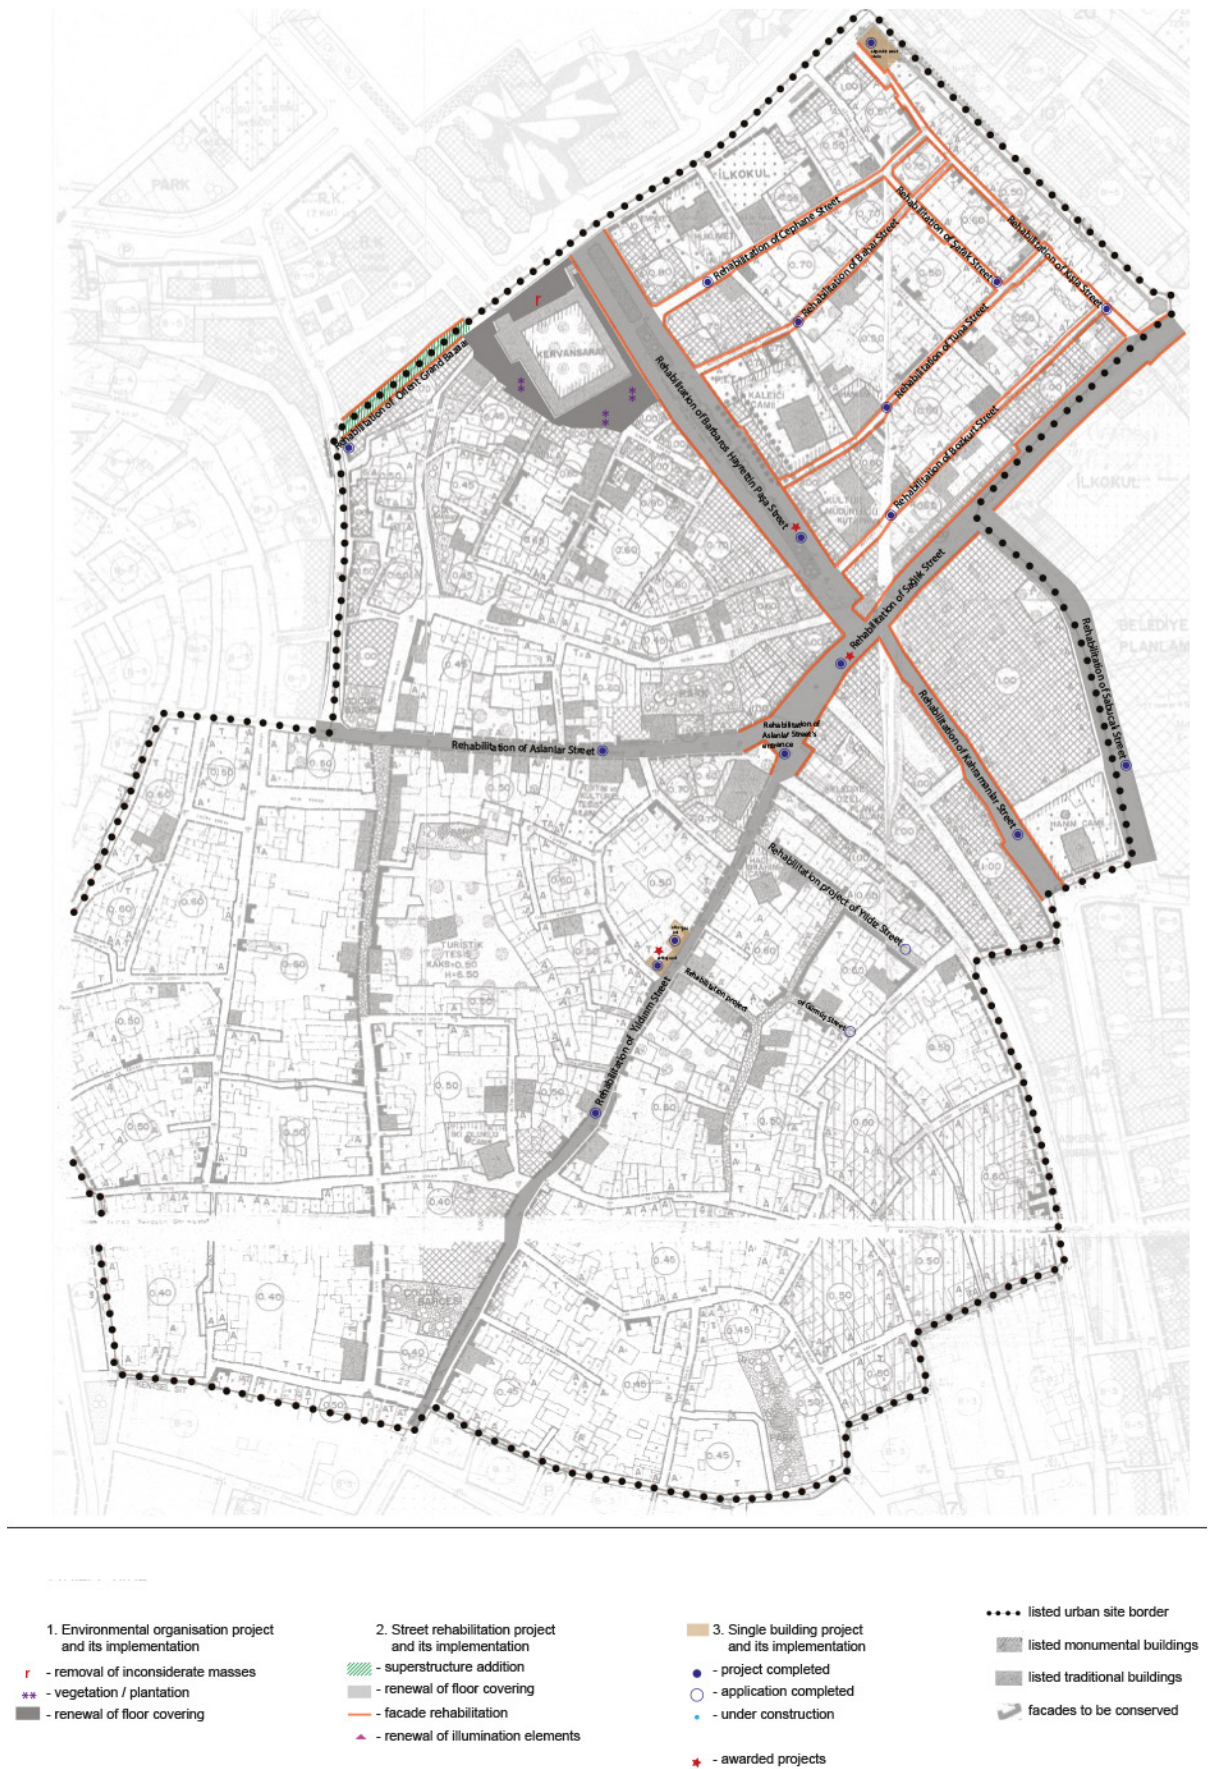
Fig. 5 Urban conservation implementations and building restorations of Kuşadası Municipality in 2000s (revised from Kutluay, 1994)

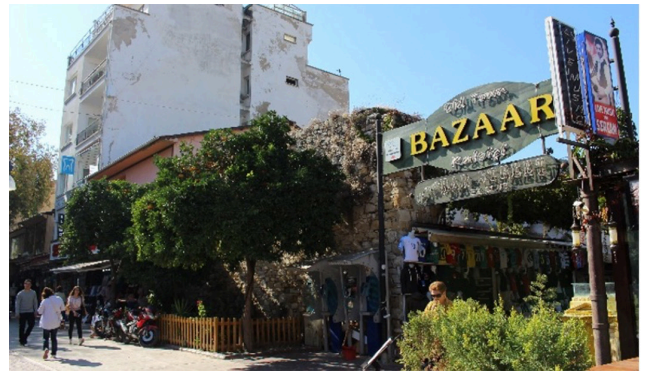
A section of the fortification walls (Fig. 10, Yönetken, 2018) have been preserved on Sağlık Street. The citadel gate is a square prism with an arched opening at the ground level. Both of the structures are rubble stone masonry. The pedestrian circulation continues throughout the gate. Its hipped roof, arched windows and balcony, and the stairs leading to the first floor are period additions. The first floor is to be re-functioned as a micro museum. The relation of the citadel gate and the fortification walls cannot be perceived because of the new shops flanking them. The traditional commercial pattern, which has developed in time, is also damaged as well. The inharmonious buildings in the vicinity have not been removed so far, although this was proposed in the conservation development plan.

Fig. 10 Fortification wall as viewed from Sağlık Street (Yönetken, 2018)

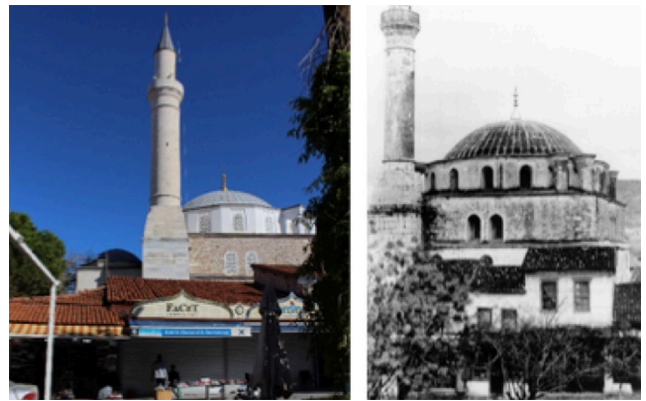
The Kaleiçi Mosque (Fig. 11, Arslan, 1960s; Yönetken, 2018) is a single domed mosque with a colonnaded portico. The building has generally maintained its authenticity,

Fig. 11 Kaleiçi Mosque as viewed from west (a) in 2018 (Yönetken, 2018), (b) in the 1960s (Arslan, 1960s)

but the lot is full of mass additions: a masjid, toilets and an ablution space. They are all approved by the Regional Commission. Preservation of the modest scale shops flanking the lot of the mosque at its west has not been proposed in the conservation development plan, but they should be evaluated as part of the historic urban site. There are

buildings with large lot coverage ratios and heights to the north and south. They were evaluated as inharmonious in the conservation targeted development plan, but their removal was not been realised.

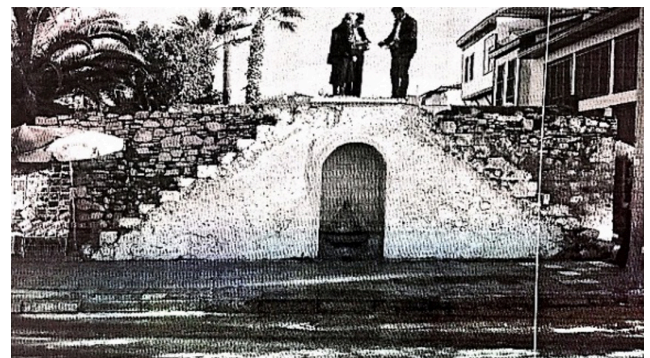
of the central mass with the original rubble stones during restoration (1 of 15: 49/40) (Fig. 12, Regional Commission, 2008). Alteration of window and casing forms, renewal of the *cumbas* (projection), joineries and plaster; removal or renewal of iron shutters, the addition of iron railings and sheds, usage of bright colors on the facades are also common. In general, street-lot and lot-main mass relations have been preserved in the residential areas, but lot coverage ratios have increased with mass or shed additions. The inharmonious buildings whose removal was proposed in the plan have not been removed.

Fig. 12 The building in block 49, lot 40 as viewed from the north restoration phase (Regional Commission, 2008)

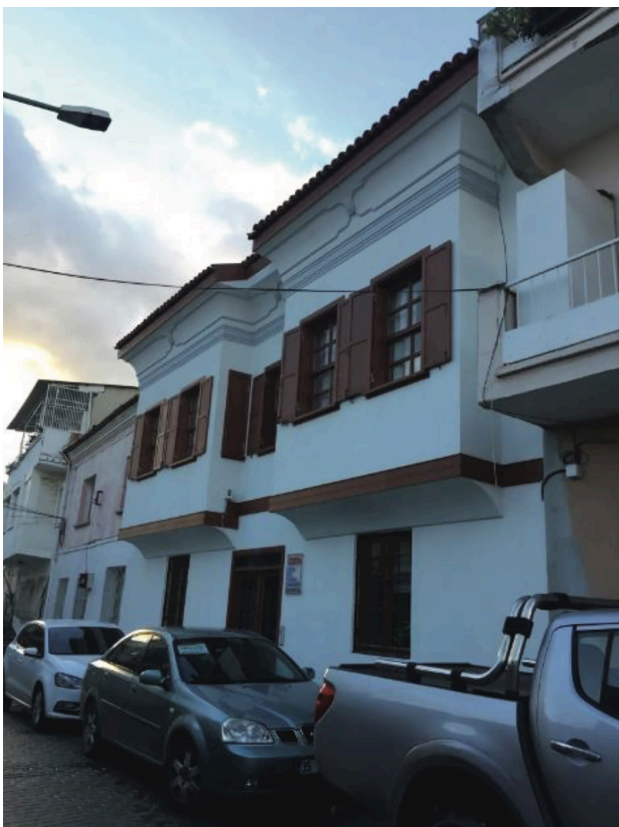
Fig. 13 The building in block 182, lot 22, photograph (Yönetken, 2018)

The monuments are well maintained in general. Original functions of mosques and some fountains have been conserved, while the caravanserai and the citadel gate have been utilized with socio-cultural functions. In turn, the majority are publicly accessible. The authentic design characteristics of monumental structures are preserved in general, while the construction technique and material are often renewed with contemporary interventions (Fig. 13, Yönetken, 2018). Mass additions extensively alter building-lot relationships with the monuments. The original functions of traditional buildings are often lost. They are converted into touristic facilities. Their scale, mass and façade design is preserved in general, while the façade elements have been often altered.

Similarly, the facades' colour and texture have been altered since the repair material is often different from the original. The alterations of the facades to be conserved are generally a result of their enlargement; for example, an increase in building height may be seen. The lot-building relationship of traditional buildings is relatively better preserved compared to the monuments. However, small service masses have been added to many of the courtyards as well. The visual setting of these heritage structures has been altered with urban renewal. The removal of inharmonious buildings, which was proposed in the conservation plan, has not been realized in general. In turn, the perception of monuments with documentary value is hindered, such as the fortification wall ruins (Fig. 14, Yönetken, 2018). The human scale of the traditional buildings is also negatively affected.
