# Airtightness of Nepalese Residential Buildings

Experimental field measurements regarding airtightness following the fan pressurisation method were done on 25 typical residential buildings at different locations in Nepal. The field measurement data were classified according to building type and building age. The mean air permeability ( $Q_{50}$ ) for the studied buildings was 6.9 l/s·m<sup>2</sup> and the mean air change rate was 55.5 air changes per hour at 50 Pa. The maximum air leakage rate ( $Q_{50}$ ) was 28.4 l/s·m<sup>2</sup> for brick masonry in mud mortar type and the minimum recorded was 1.7 l/s·m<sup>2</sup> for brick masonry in cement mortar type building. Brick masonry in mud mortar-type buildings was found to be leakier regardless of the building age, and brick masonry in cement mortar-type buildings was comparatively more airtight. Leakage locations identified through visual inspection included the spacing between the door frame and operable door area, horizontal window slider, joint areas of window frame and wall, wood plank-based wall structure, roof joint areas and holes in the wall. This research is the first of its kind in Nepal to assess the airtightness of b

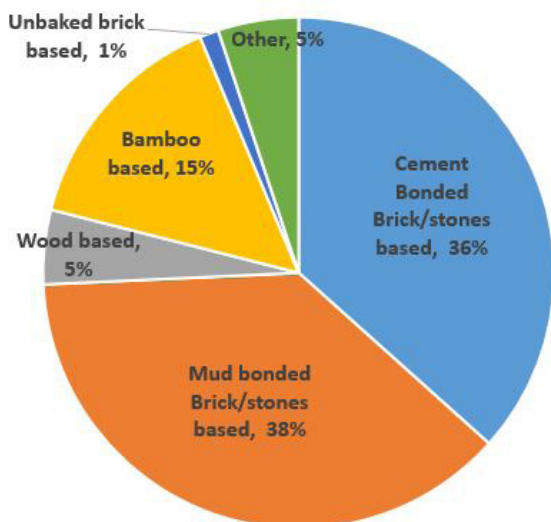
Fig. 1 Household distribution by building type in Nepal (Annual Household Survey 2019)

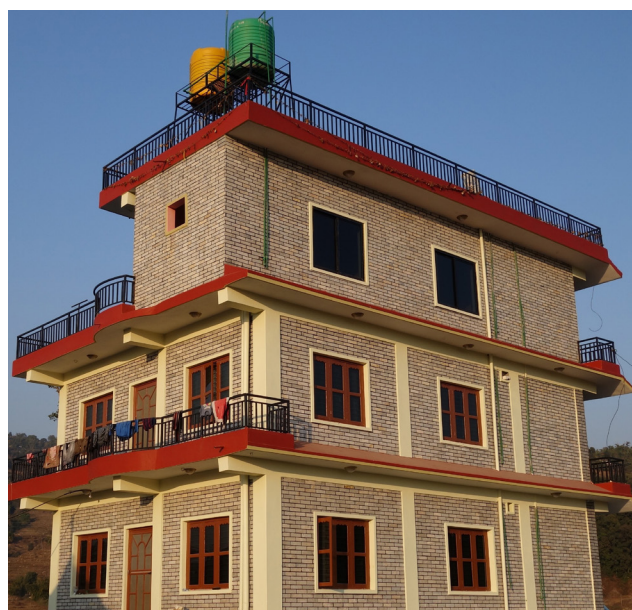
Fig. 2 shows a recently built typical multistory BMC type building with flat roof construction from Pokhara. An SMM type building from Chame, Manang, is shown in Fig. 3. These buildings are characterised by massive 200 mm to 300 mm walls with wooden plank windows. Most SMM-type buildings have attic spaces with pitched roofs with a galvanised iron sheet.

Fig. 2 Typical BMC type building at Pokhara

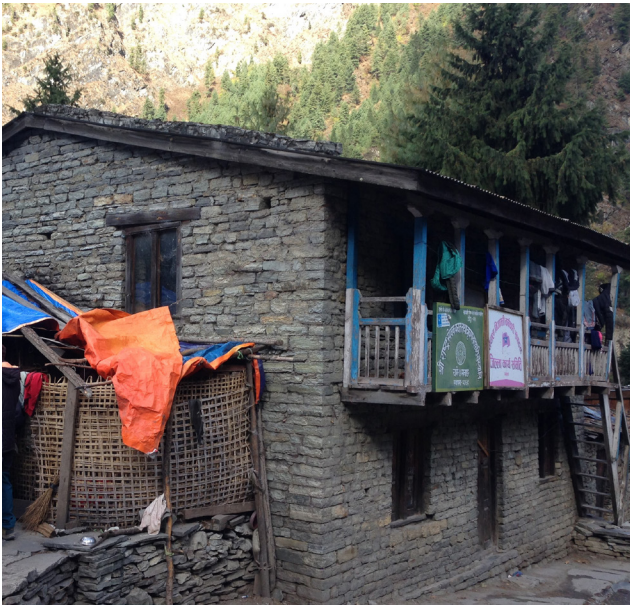
Fig. 3 Typical SMM type building at Chame, Manang

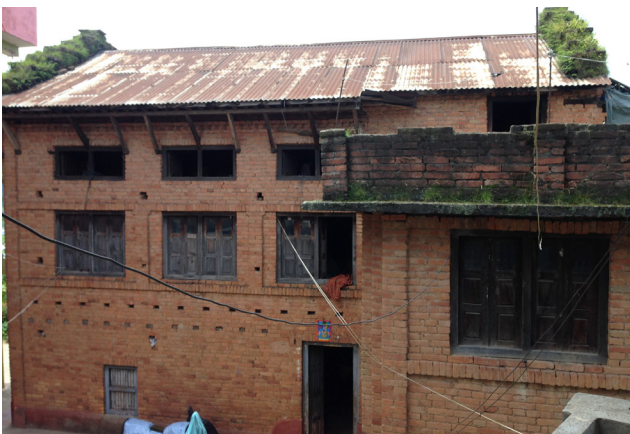
Fig. 4 shows a multistory BMM type building in Dhulikhel, Kavre, with pitched roof construction. Fig. 5 shows the blower door test setup mounted on the exterior door of a study building during an actual airtightness test.

Fig. 4 Typical BMM type building at Dhulikhel

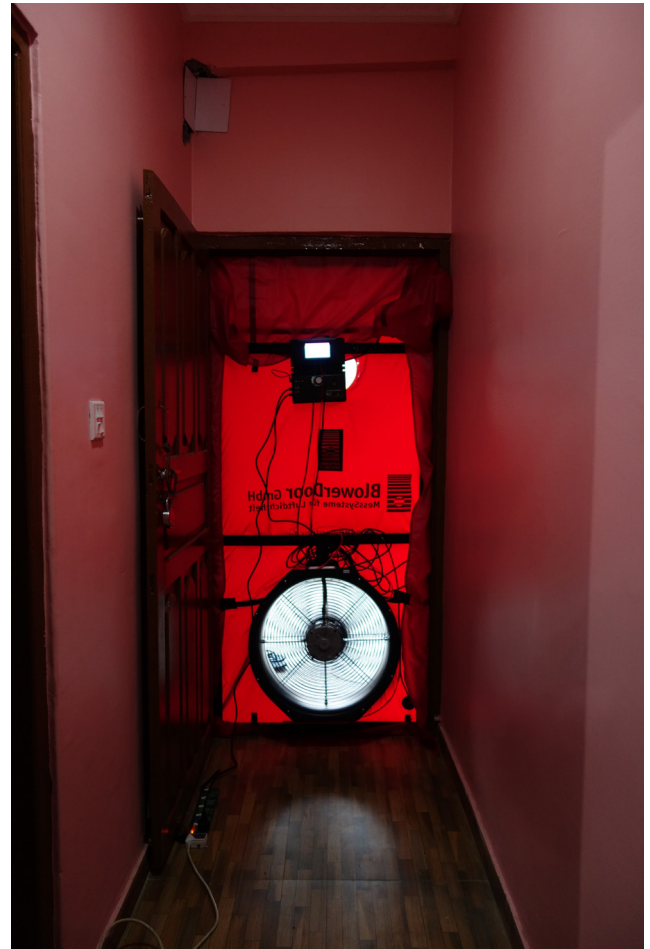
Fig. 5 Blower door test setup in an actual airtightness test

The airtightness test was performed using a calibrated standard Model 4 Minneapolis blower door test setup with DG-1000 pressure and flow gauge with an accuracy of  $\pm 0.4\%$  (TEC, 2017) produced and distributed by The Energy Conservatory (TEC).

The dimensions of the buildings were measured. The blower door test system was mounted on one of the exterior doors. All enclosed intentional openings such as exterior doors, windows and ventilation holes were closed. The blower door fan was connected to the DG-1000 manometer and was wirelessly controlled via the TEC AUTO TEST application. To further comply with the technical standard ISO 9972:2015 (ISO, 2015), indoor and outdoor temperature measurement was read through a calibrated temperature sensor and was duly input in test readings. The test setup included 10 points with flow measurements

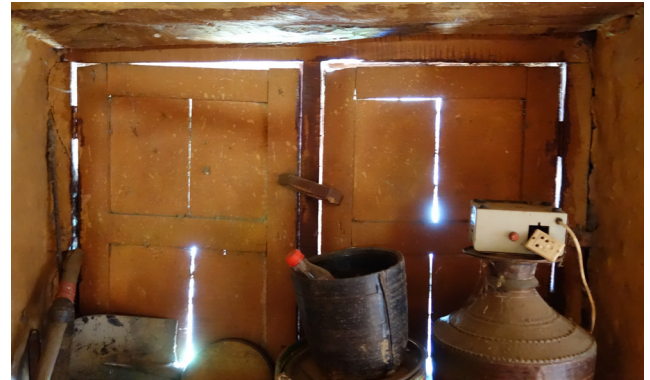
1. As seen in Fig. 6, there was space between the window frame and the wall structure. The operable windows are made of wooden plank and within them had huge holes, which provided a free path for air to flow in and out of the building. Fig. 6 was for the BMM type building. In old and recently built BMC

**Fig. 6** Spacing between window frame, wall and operable window area

type buildings, a leakage path was identified as the spacing between the window frame and window. Horizontal window sliders in aluminium framed

windows also aid the airflow in and out of the BMC type building.

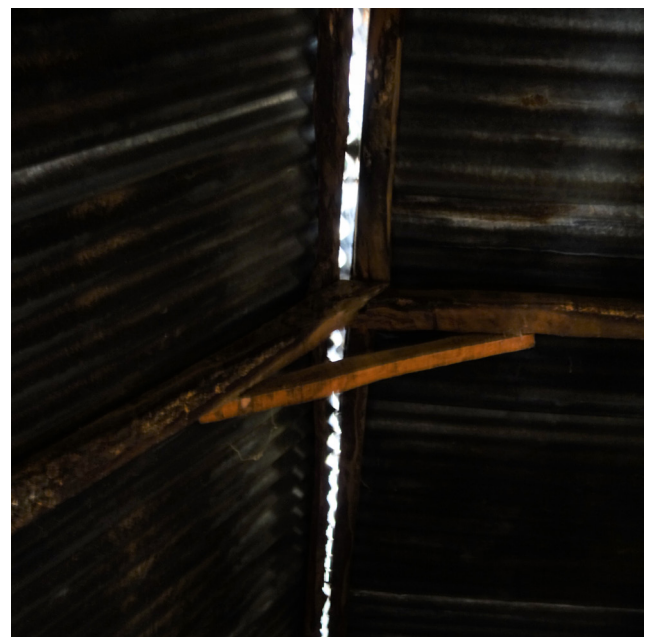
**Fig. 7** Spacing in the pitched roof

2. Pitched roof joint area in the BMM type building was not properly sealed, as shown in Fig. 7, which promoted in/exfiltration of air.
3. Huge spacing between the pitched roof and wall joint area was observed, as seen in Fig. 8. The roof sheets were poorly managed and had holes.
4. As seen in Fig. 9, numerous holes were seen in the wall structures. Bricks/clothes were found pushed into some of the holes, causing some to be partially closed and others were left open.
5. Huge spacing between the door and the floor level was observed in the BMC type building and is prone to air infiltration/exfiltration.

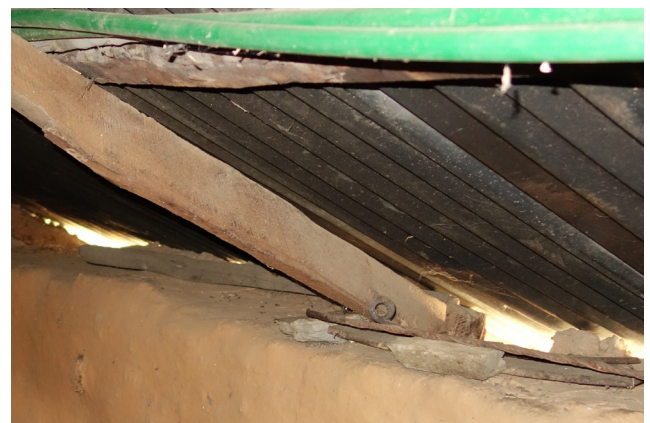
**Fig. 8** Gap in the pitched roof and wall joint area

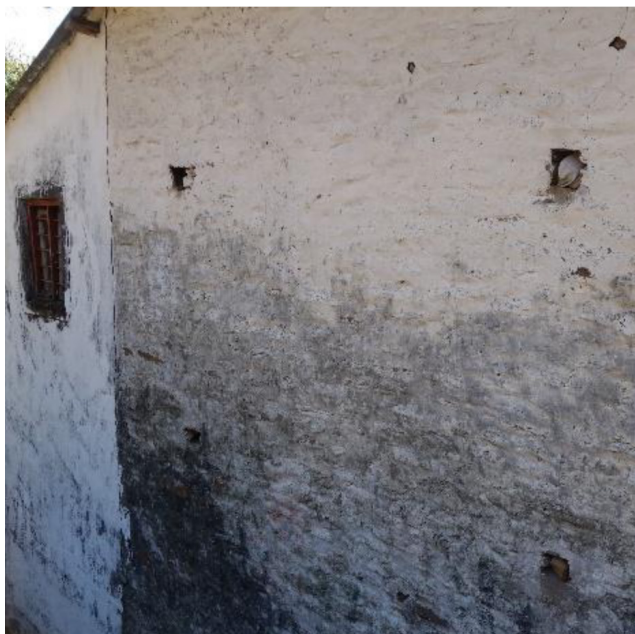
Fig. 9 Holes in the wall surface

Most Nepalese buildings in the Terai belt were found to have fixed openings in the wall surface near the ceiling level. Such openings served as ventilation for the indoor space. The same was true for buildings in the hilly belt with huge cracks/holes in the wall surface. Thus, closing such openings to make the building airtight would require additional consideration of the indoor ventilation and air quality.
