Authenticity and didactics: theory and practice in the preservation of our medieval monuments

Ákos Zsembery

Abstract

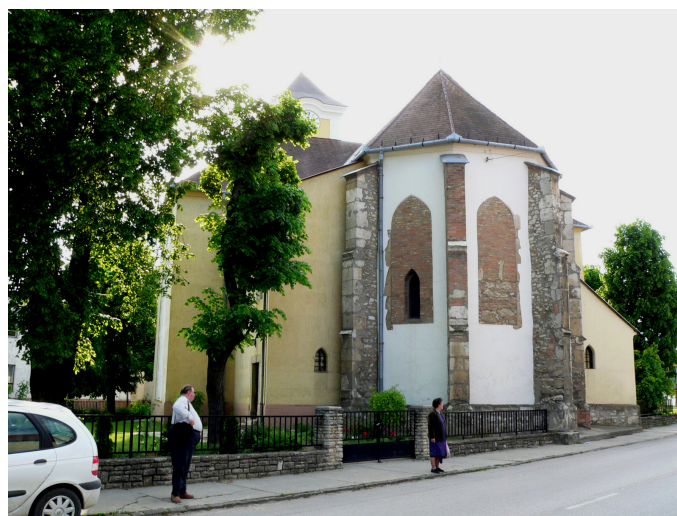
Fig. 1. The View of the Church of Bajna

twice, the preservation of its medieval values and areas is successful. During the reconstruction process, the different aged parts of the building were painted different colours, so the original and the later restored elements are clearly (and visually) separated from each other. The two western pillars show the original length of the medieval building. The old western gate of the new church would have been out of place, so it was rebuilt into the south side aisle, as the in situ entrance of the northern sacristy was presented as a decoration of the present building. Inside the church, next to the original renaissance ciborium, the previously mentioned sacristy door and the two gothic windows on the south wall of the sanctuary were located. Although their sections are thickly whitewashed; their colour does not differentiate them from the wall.

The outside is not so uniform, while the brick completion of the buttresses is a nice solution, the brick surface of the gothic windows is out of place. The original window frame should not have been built in, especially in the case of the eastern window where the surface was completed with stone. It is interesting to note, that only two of the sanctuary’s windows are shown. We have no information about the third one. Two smaller windows are possibly the result of the modern restoration, but we cannot find any information or theoretical reconstruction drawings on the building. To conclude, the original and the restored parts are well separated didactically; the view of the monument is authentic and it is easily understandable by the public.

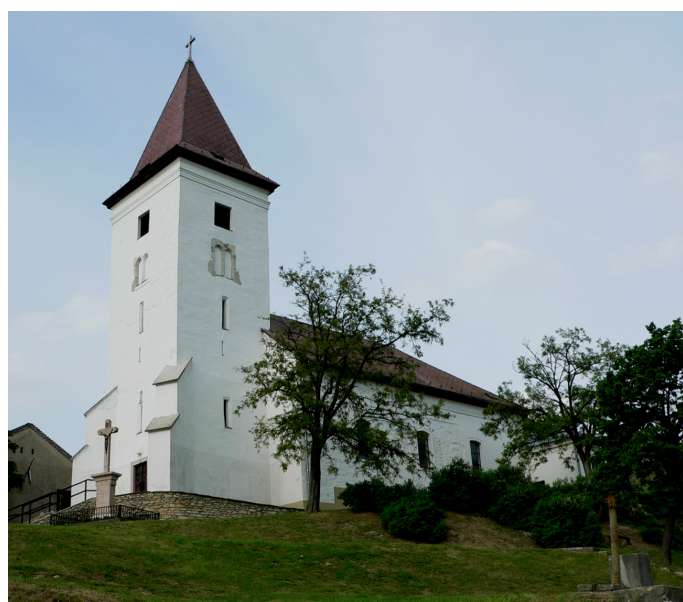
Fig. 2. The Church of Bajót

kept its original medieval size. The medieval elements are visually -with the same whitewash but differentiated by their surface - separated from the latter restored parts. It is slightly disturbing though that this method was not used on the tower, even though its mass, its corner buttresses and its window frames depict its medieval origin. The preservation of the revealed original gothic styled doorway with console on the northern side of the tower, the upstairs loophole and the twin windows are more detailed than in the case of the Bajna church. The colour and the material of the surfaces are the same; the different levels are shown only by the size of the windows and although the yellow coloured base of the church breaks up the small units, they are well presented by clear surface differentiation. Compared to the example earlier, this restoration work is more elaborate, so a more uniform medieval building has been restored using the detailed preservation techniques that were required. Theoretically and in practice this is one of the best examples of correct monument preservation.

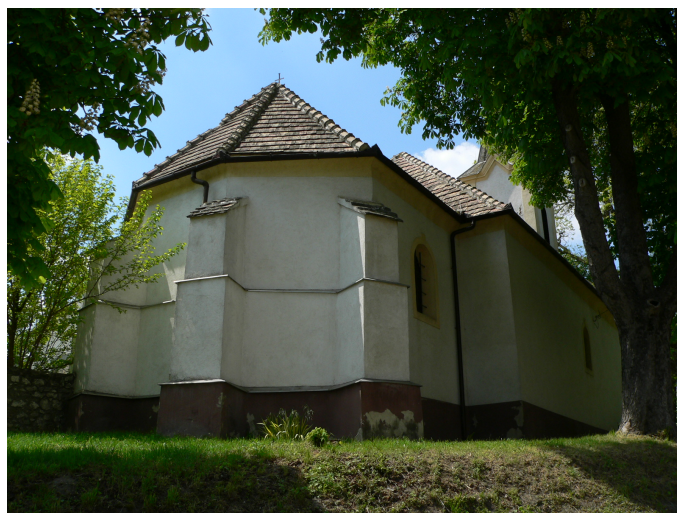
Fig. 3. The Church of Bakonybánk

Not much information has been left regarding this church. All that we know is that it was built sometime in the XV century, and burnt down in 1870. During the restoration works in 1900, its nave, the flat ceiling of its sanctuary and the tower was rebuilt. Only the buttresses of the sanctuary show its medieval character. The measurements and ground plan of the church render the fact probable that the church was rebuilt on its original, medieval base. If its sanctuary had any windows, is not shown. At the time of my visit, the church looked rather desolate: its gate was ajar and no visitors were there apart from me. With a detailed examination, any remaining original features could be re-established, and then be preserved.

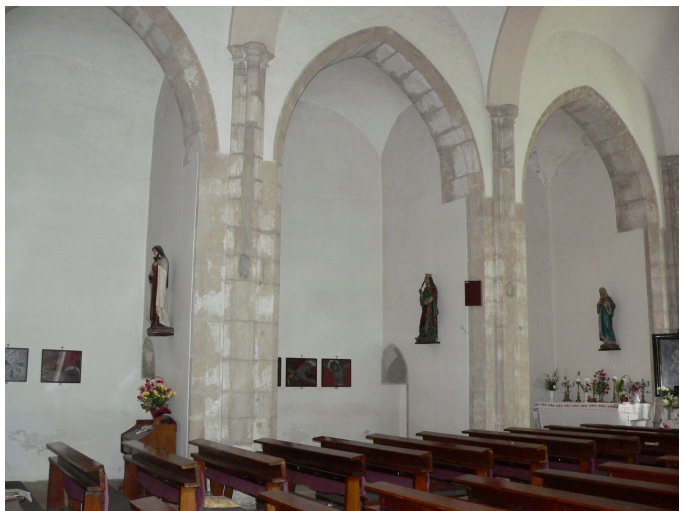
Fig. 4. The Church of Csátka

The preservations of the original elements are well presented in the inner area. The medieval elements are clearly emphasised, and even with the lower arched baroque styled area it has an organic feel. Unfortunately the restoration of the renaissance gravestone on the north wall of the sanctuary was not well done; additionally the flowers placed on the top, cover the relief. Even such minor things can disturb or ruin the preservation of the original elements. On the outside of the church the original stone surface is clearly shown at the corners and buttress of the building. In such cases the differentiation of the original wall surface can not be observed. It is not clear which of the unique square stones are presented. The unified appearance of the original medieval ornament is given by the simple coloured wall surfaces both inside and out. Unfortunately the greenery and trees of the small southern garden hides the south wall's medieval elements and this disturbs the whole view of the building. Although this problem could be easily solved by removing the trees.

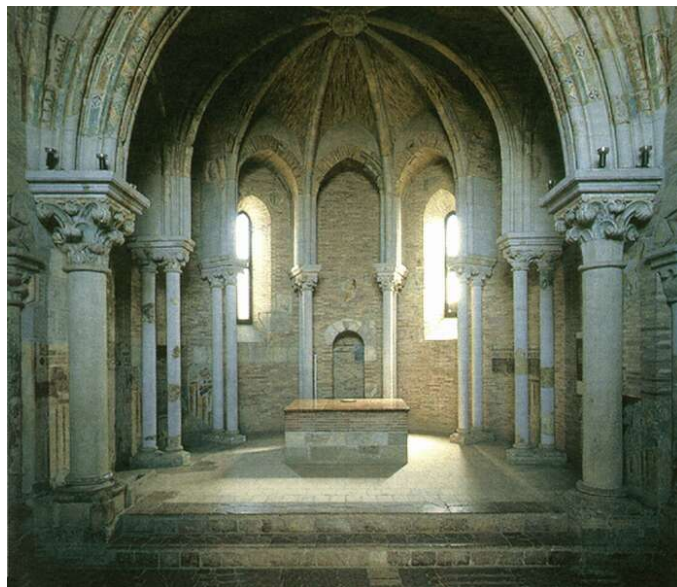
Fig. 5. The Castle Chapel of Esztergom

Its western front gate and nave, up to half of its height, are in their original state. The chapel restored by anastylosis is still a key example of the Hungarian monument preservation executed between 1934 and 1938. During the Lux-Várnai restoration many pieces of its frescos were not replaced. Into the uniform brick surface used at its completion, stone copies were placed sporadically. The original painted elements are now in the process of restoration and replacement. After the work of Zsuzsa Wierdl and her international group, never seen parts of frescos will be returned to their original places, while those already exhibited have been renovated from their badly demolished state. The reinforced concrete ceiling of the building built in the thirties stands on the site of the medieval White tower. The roof of the neighbouring spaces is damp because of structural faults but fortunately the chapel is not yet threatened. As far as I know, competent professionals have not even started to solve this problem. It is incomprehensible, that nowadays an international gem with such famous and valuable frescos can be left in such condition.

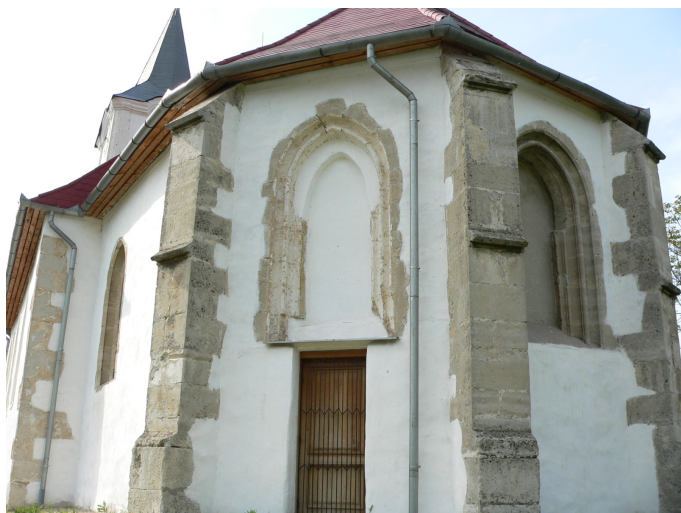
Fig. 6. The Church of Lábatlan

The nave, up to the framework, is from the medieval times. During the restoration works of the XIX century, its original windows were partly taken, partly walled off in order to establish a unified picture. Its southern gate has been split by a wall pillar. As the windows in the sanctuary were only walled off, its four original window frames could have been presented. On two of the frames even the start of the traceries can be seen. The 2001 restoration has managed to show its medieval elements as far as it is possible. Although in the internal area no medieval elements are visible, this is not possible without disturbing the

20th century interior. The outer medieval elements are separated with a rustic finish, since its uniformly coloured surfaces do not differentiate them from the latterly built parts. The armouring on the corners and on the buttresses of the original building shows the original space of the church. The transition between the whitewashed stone surfaces and the outstanding cut stones are more detailed in this case than in Csátka, although the authenticity of the appearance at the corners is questionable. The stressed frames of the new neo-gothic styled windows are out of place, just like the emphasised (by using different surfaces) medieval parts on the north wall of the sanctuary, from which differentiation from the other medieval wall parts is not evident. Having dispensed with these didactically disturbing elements, it remains very satisfying to see the monument in this condition. Unfortunately damp has resulted in frost damage to the base, which damages the aesthetic sight, however we should emphasise the well kept surrounding since it provides a suitable backdrop for the carefully kept monument.

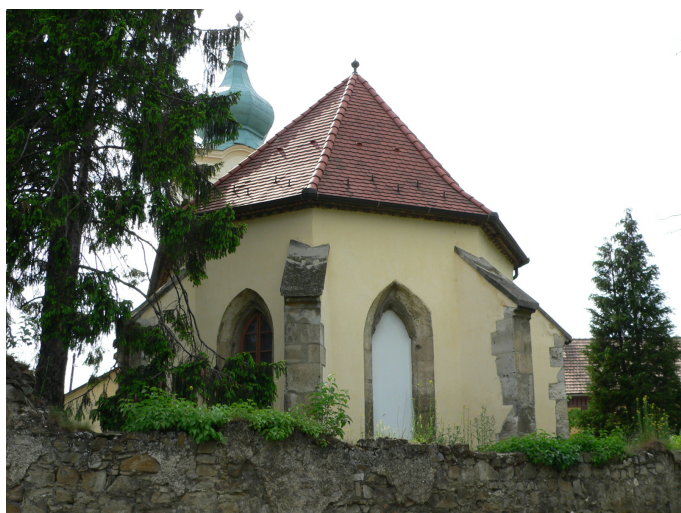
Fig. 7. The Church of Neszmély

The massive tower, up to the baroque styled roof, is medieval. Its cladding and its narrow loop hole styled windows are shown in their original places, the buttresses and window frames of the sanctuary are also presented in their original forms. The original medieval surrounding wall is a valuable part; in addition it emphasises the fortress character of the church. The internal area, just like in the case of Lábatlan, has no indication of its medieval origin although this is clearly shown by the external

site. Of the emphasised medieval elements the northern double openings are didactically disturbing. Even though the restoration work was only a couple of years ago, it is already damp. In spite of the surrounding well kept garden it still looks neglected.

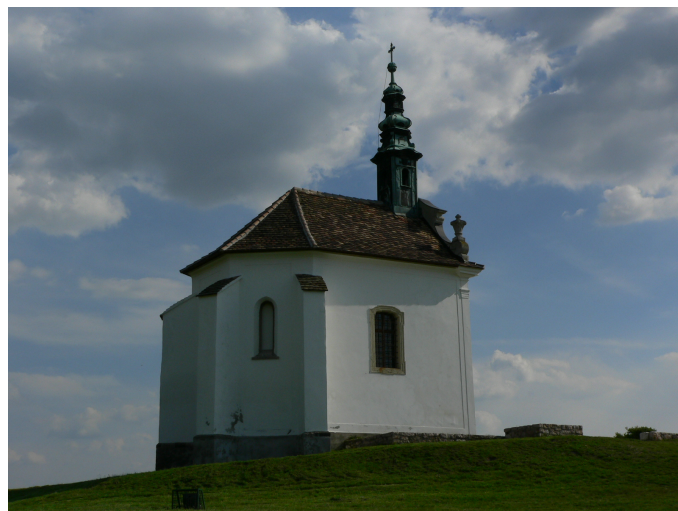
Fig. 8. The Medieval Chapel of Tata

The small sized chapel was formed by three sides of an octagon shaped sanctuary in 1350. In 1755 Jakab Fellner rebuilt the small medieval church into a chapel by keeping its sanctuary. The medieval appearance of the north-east side creates a picturesque sight, the monument keeping its original shape. The preservation clearly shows that until the roof, the buttressed sanctuary is medieval, while the window frames are gothic. The chapel and its surroundings are plain; the state of the building is good although the medieval sanctuary is damp.

The method of monument preservation is based on the same principals as in the case of the other presented buildings: separating the original mass from the latter built parts. I believe the preservation of the cladding is better in Bajna, where the wall

surface was simply shown, while in the other cases it bulged under the whitewash. Apart from the case of Lábatlan the medieval elements on the facade do not coincide with the latter openings. There seems little point to the preservation of the remaining parts of the wall surface, as opposed to the case of Neszmély church. Their appearance does not strengthen the harmony of the façade, although generally we can say the overall appearance is authentically presented.

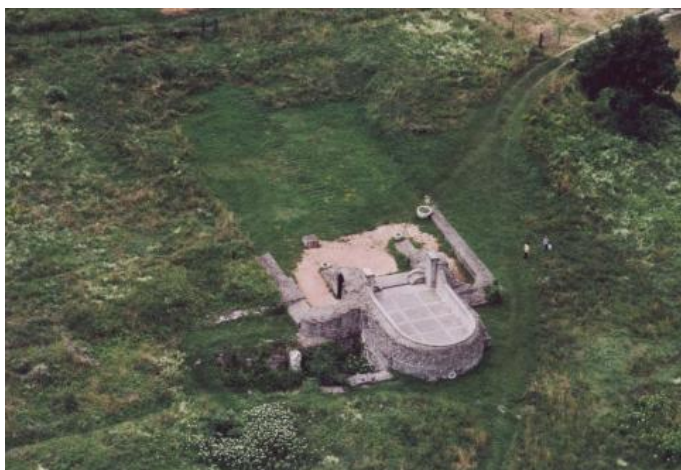
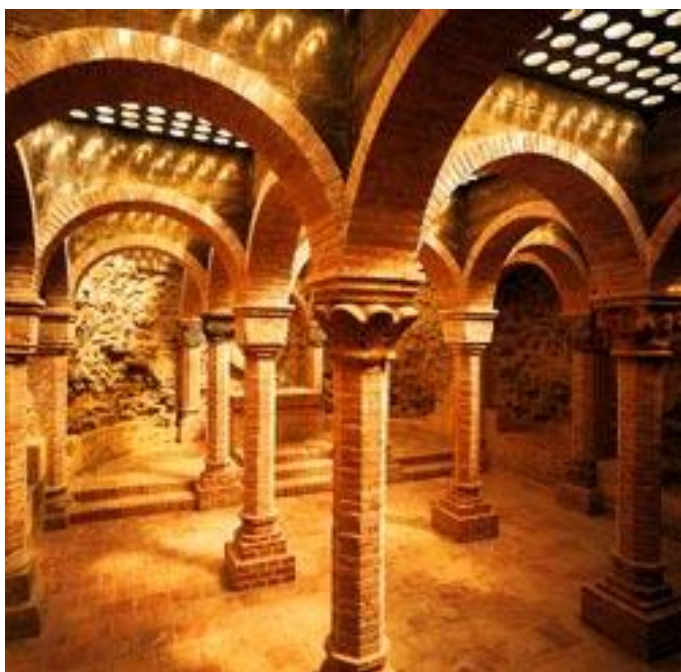
Fig. 9. The Ruins at Dömös

Almost all the church and the attached quarter were demolished; the preservation of its ground walls has yet to be carried out. The south-east corner pillar remains give the original height

of the provostry. The scientific restoration of the crypt without reconstructing the vaulting, provided an authentic preservation. Out of the presented capitals the in situ replacement of one of the most valuable carvings still has to be done. The preservation from 1989 is still viable – even though some parts are not in good condition and the reinforced concrete ceiling with glass oculus is broken in many places. The neglected aisle, presented by landscape architectural elements, is almost indistinct. The appearance of the remains is consistent, but the monument and its area needs further work. One of the most valuable parts of the reconstruction is that the former crypt area still works as a sacral space.

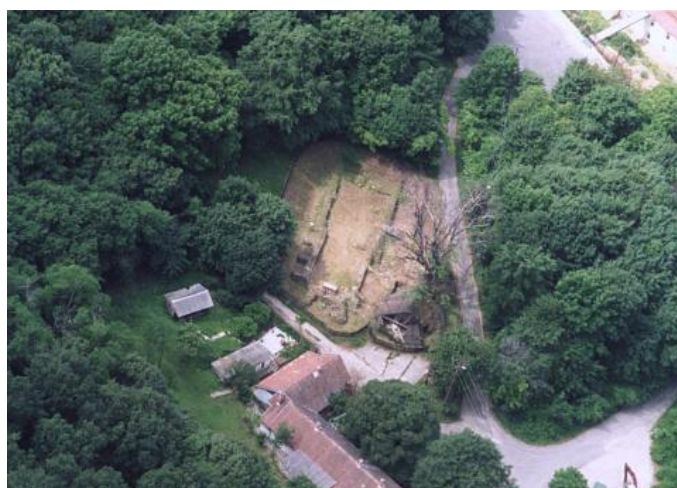
Fig. 11. The Ruins at Klastrompuszta

There are no ashlar on the excavated ground walls although some parts of the chapel are fretworked. The more valuable ashlar were transferred to the National Museum. The remaining site is neglected; the presented ground walls are hidden behind greenery and grass. The wooden roof covering the chapel is in a life threatening state, the fence around the site has been damaged by curious tourists and it has not been maintained. It is a shame to see the founding chapel of the only Hungarian order in such a state; moreover it may hide the grave of blessed Özséb. The remains of Klastrompuszta are located near the settlement, as in Dömös, despite this no one seems to care about it. Maybe after the excavation it should have been recovered to preserve it.

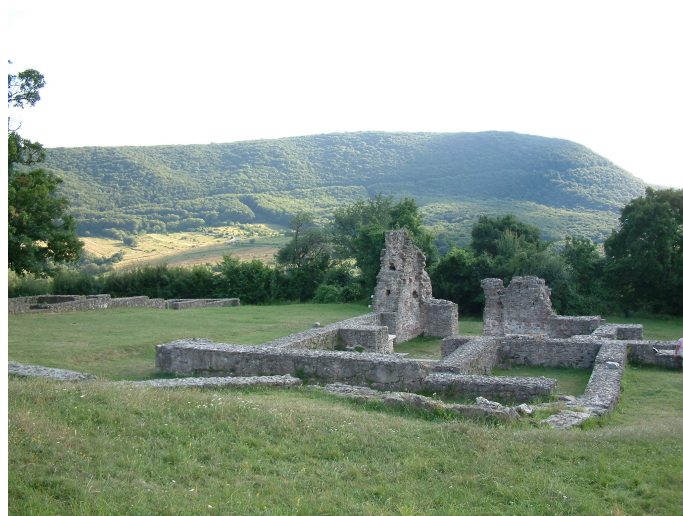
Fig. 12. The Ruins at Pilisszentlélek

There is a part from the carved rib of the shoulder of the vaulting on the north side area of the chapel, there are no ashlar in the remains. Only the walled ground walls depict the original building, although the height of the south-west wall corner remains and even the scaffold junction holes from the medieval walling procedure can be seen. By the instigation of local

residents the monument preservation was established in 1985. The original, excavated stone material was used for crowning the wall. By 1975 two altars were restored moreover a consecrated relic was hidden under the marble stone of the main altar. In the last 30 years, every Pentecost morning a ceremony is held among the remains of the former church of the monastery. The monument is in a good condition since local residents take good care of it with continuous maintenance. The higher reconstructed walls depict the inner areas more effectively than the less completed foundations. The grass surface, instead of pebble stones, of the inner areas does not favourable display the internal and external sites. The completed works clearly show the remains and the authenticity of the site can not be questioned.

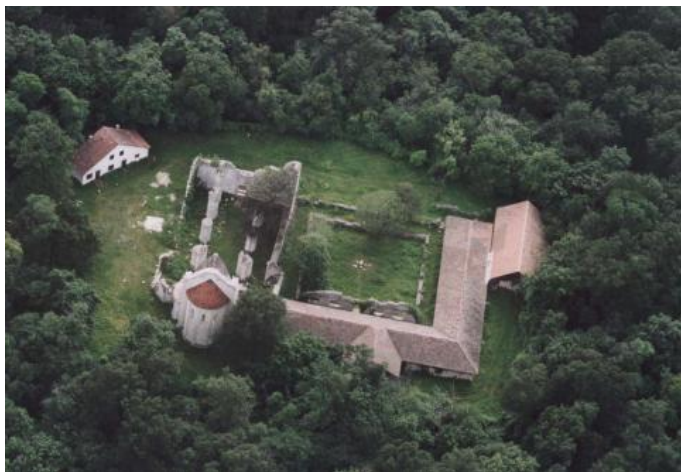
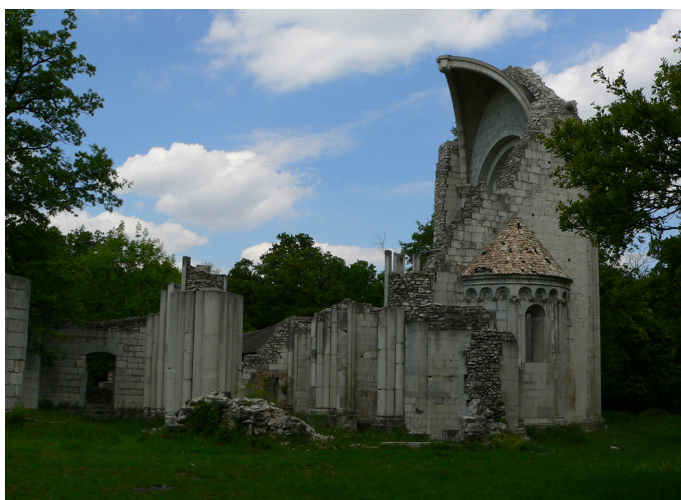
Fig. 13. The Ruins of the Abbey at Vértesszentkereszt

The former two towered abbey church, established in the XII century, was in its prime in the XIII century. The monastery and the western vestibule were added to the church at the same time in the middle of the XIII century. In 1543, during the Turkish occupancy it was deserted. The building’s value is hidden in its history, since the life of the monastery from the XII century up until the XVI century, can be followed through its ruins. Its detailed carved stone works are mostly in museums. Its most valuable local part is its richly carved western gate. The significant remains were renovated in 1994. At present, the monument is in bad repair and the remaining site is closed. At present no one takes care of its maintenance. Just as in the case of Klastrom-

The most disturbing element in the preservation is the non-unified composition of the renovated monument. The reconstructed vaults and the repeated renovation works do not give an authentic picture to the remaining preservation. The original and the reconstructed parts cannot be clearly distinguished in all cases, while the joint use of clinker brick and artificial stone replacement cannot be accepted didactically. This preservation points out the risks of excessive renovation in the reconstruction of remains. In addition to the used material, the lack of clarity is even more disturbing. Apart from the picture above, no information is provided for those visiting the location. These problems have to be solved in order to protect our monuments and make them accessible.

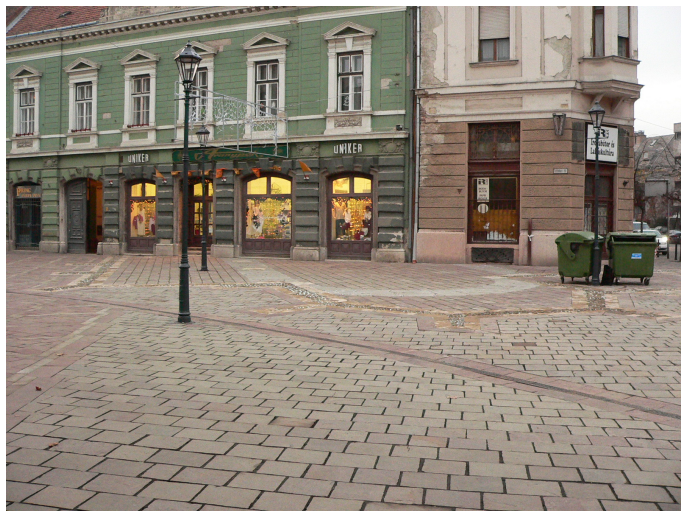
Fig. 15. The Presentation of St. Lawrence Church Esztergom

The significant medieval church, which stands on the north part of Esztergom’s main square, was excavated two years ago, and was presented in 2006. The preservation of a ruin, which stands in the unified baroque-classicist square of a historical town, is very exciting in the field of the protection of monuments. The notorious case of the garden ruins of Székesfehérvár shows the possible pitfalls. In another article I have presented, the previous analysis and the possible preservation of the monument¹⁰. It is essential to compromise during the preservation of such monuments as we could see beyond the preservation of the built in and original medieval elements. Unfortunately this monument presentation owns almost all the mistakes that can be committed in the presentation of a ruin, that has been underground for hundreds of years.¹¹

The colouring and the form of the preserved monument parts do not separate from the newly built panelling. The church is surrounded by a brick wall, which should have given the architect the opportunity to emphasise the preserved church by the partial reconstruction of the band of the encircling wall. Instead of this, the complex design of the pavement stops by the church and without any concept it continues with different incisions. The simple preservation of the ground wall is as much confusing as the reconstructed preserved walls and holes. Moreover, the markings in the panelling are useless without any information boards. I can only hope that these boards will be placed nearby at St. Lawrence’s Church. If it is not going to attract people and become a live exhibit it will be nothing more than a few remains mentioned in this paper. Unfortunately, in this case this may well be the result.
