# Supplement

## Characteristics of Housing in Darkale Rural Settlement, Soma, Manisa

Ayşen Etlacakuş<sup>1\*</sup>, Mine Hamamcıoğlu Turan<sup>1</sup>

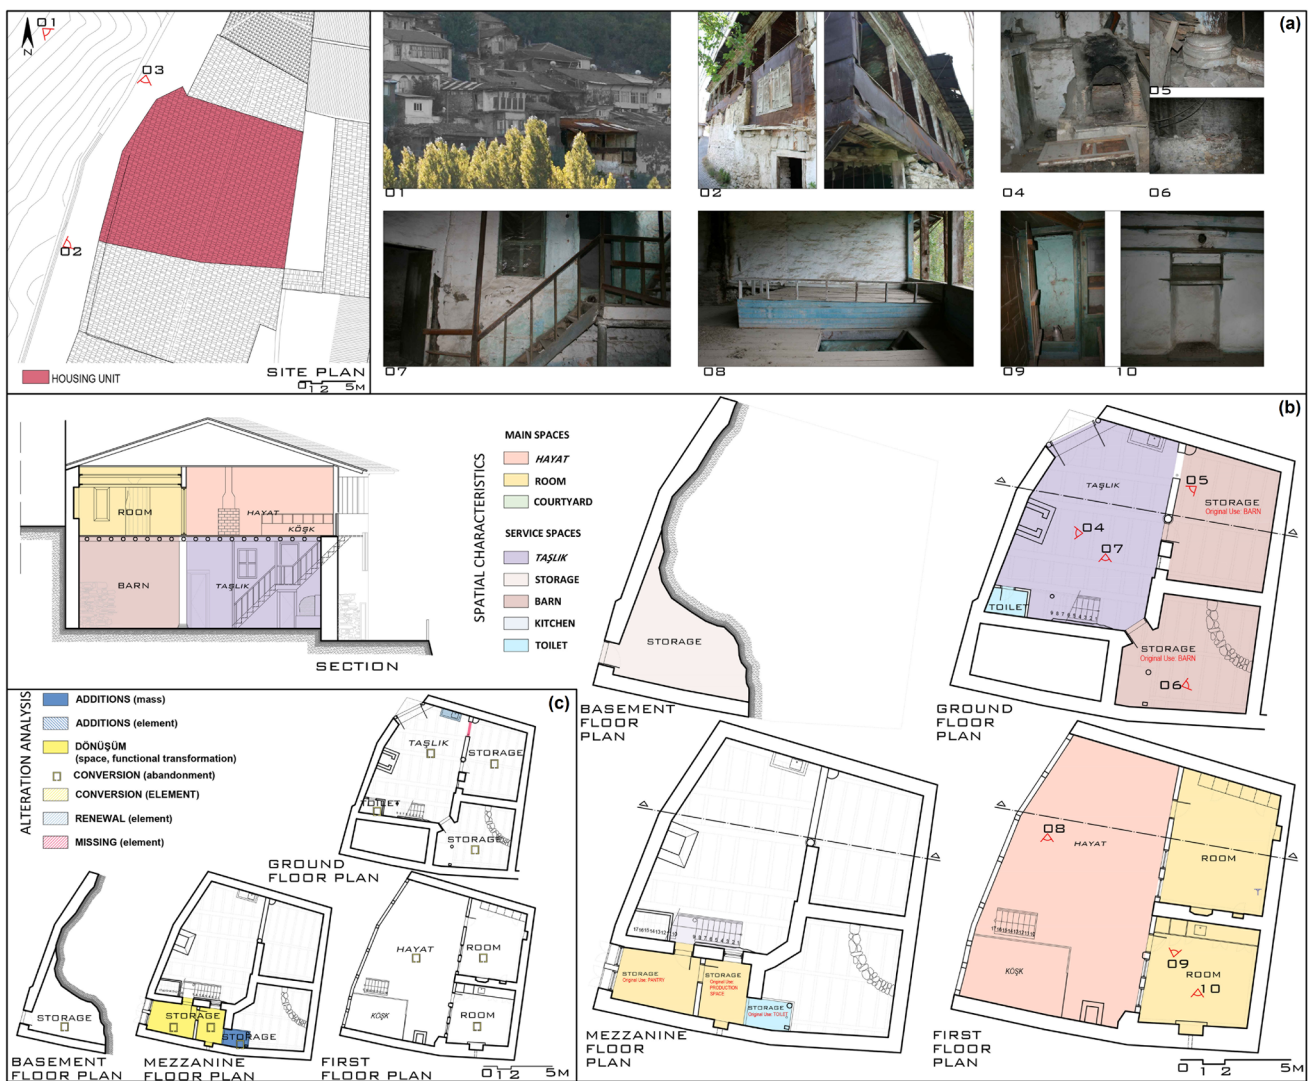
Fig. S1 (a) Site plan and photos, (b) spatial analysis, (c) alteration analysis of current of house number 8

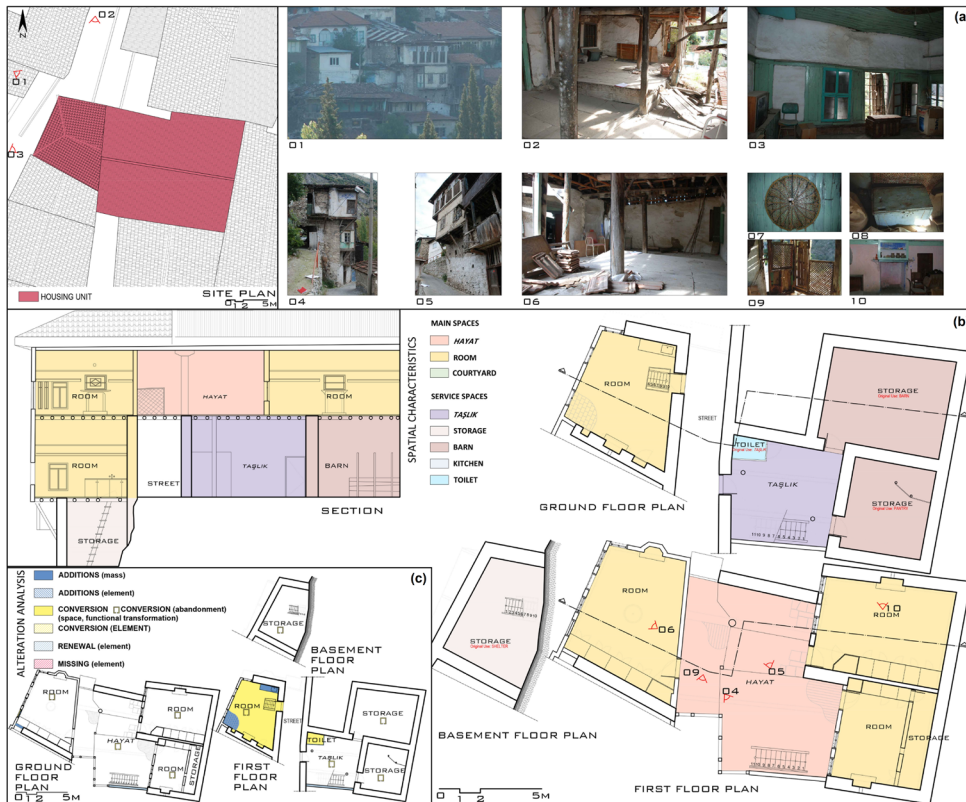
Fig. S2 (a) Site plan and photos, (b) spatial analysis, (c) alteration analysis of current of house numbered 13

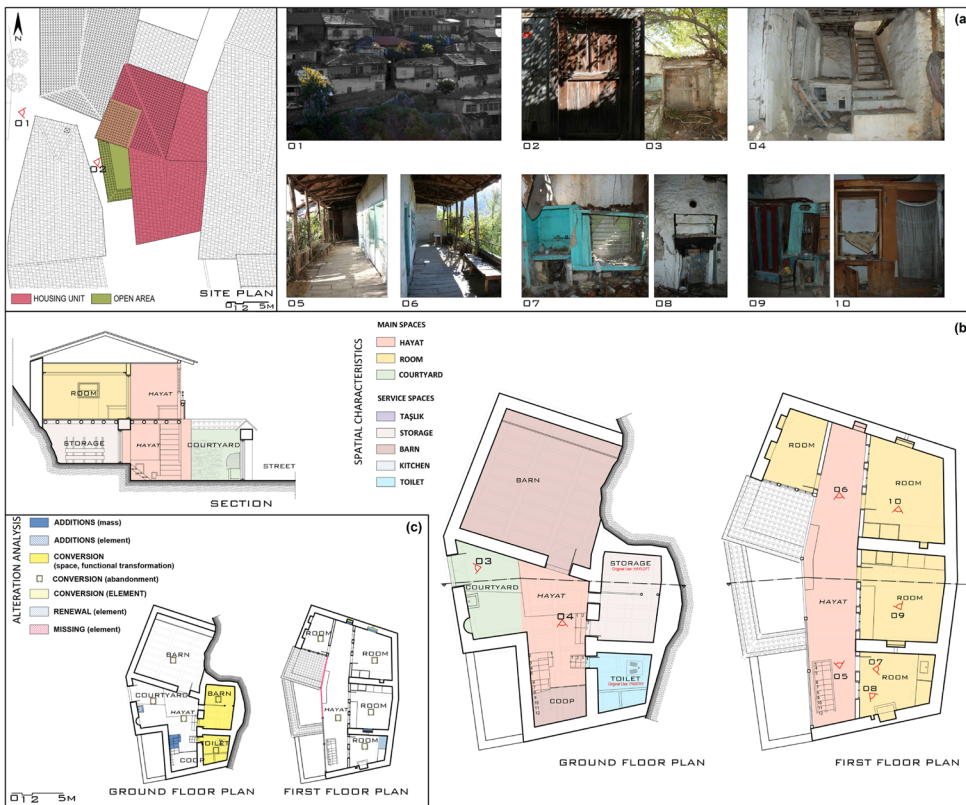
Fig. S3 (a) Site plan and photos, (b) spatial analysis, (c) alteration analysis of current of house numbered 45

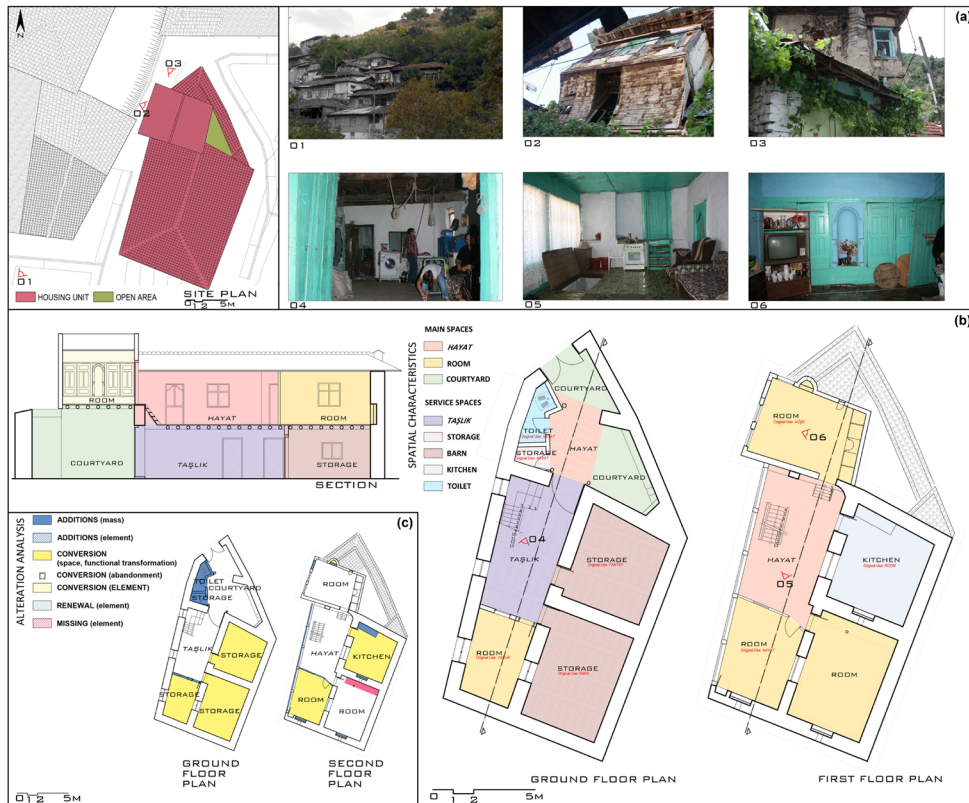
Fig. S4 (a) Site plan and photos, (b) spatial analysis, (c) alteration analysis of current of house numbered 152

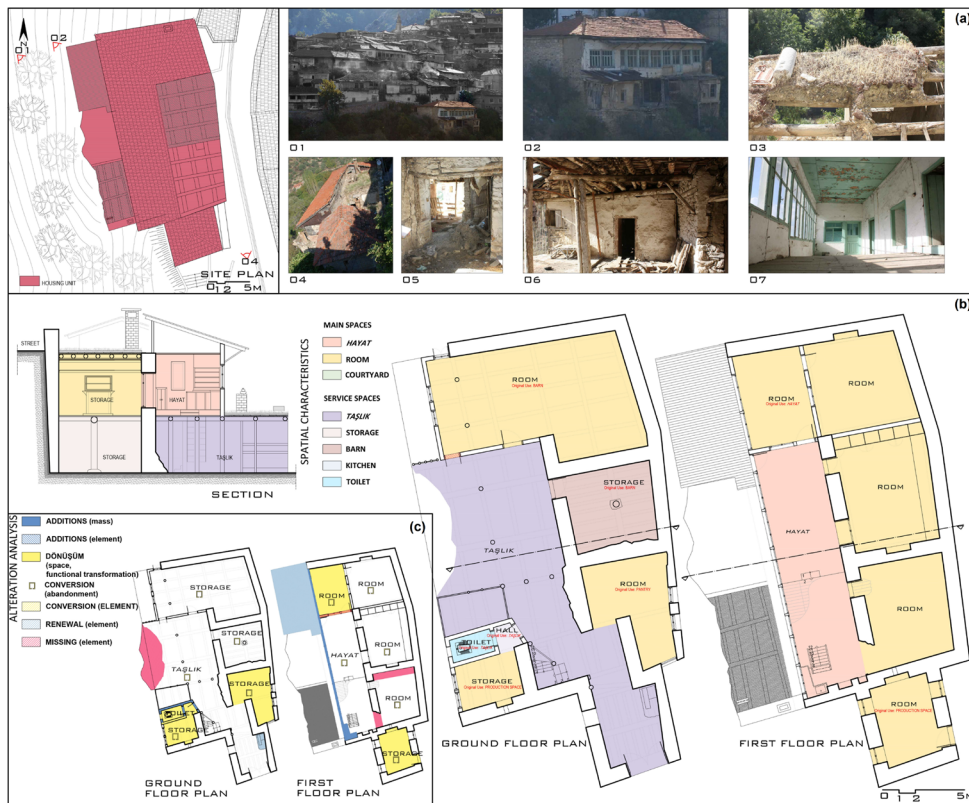
Fig. S5 (a) Site plan and photos, (b) spatial analysis, (c) alteration analysis of current of house numbered 43
