LIGHT AND ELECTRON MICROSCOPIC STUDY OF SURFACES OF TEST-SPECIMENS TESTED IN WEAR APPARATUSES

I. SZEBÉNYI, A. ZALAI and G. SZÉCHY

Department of Chemical Technology, Technical University, Budapest

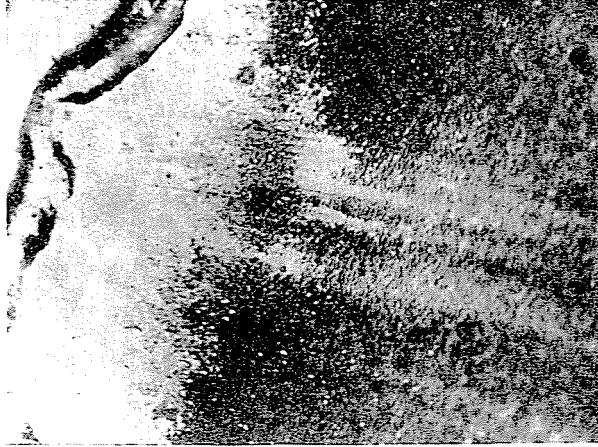
Very slight wear, its character being the same as that observed in the case of Ball 1. (Fig. 5) Fig. 5 shows the edge of the wear track.

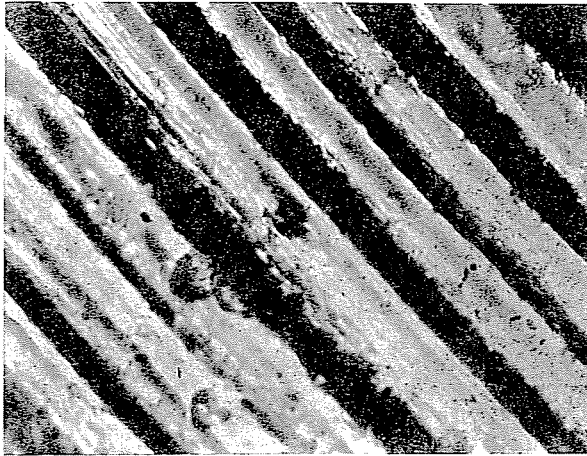
Fig. 8

Very severe wear, in the middle area of the track, deep and well defined grooves can be seen (Fig. 8). The inlet edge is sharp in this case too, and the formation of grooves begins immediately at the edge. At the outlet edge, plastic flow having occurred, protruding material could be observed.

(compare with Fig. 8). This picture demonstrates the large depth of focus of the electron microscope.
