OnlineFirst (2018) paper 10661
<https://doi.org/10.3311/PPci.10661>
Creative Commons Attribution

RESEARCH ARTICLE

defective connection, RC frame, retrofitting, brittle behavior of RC connections

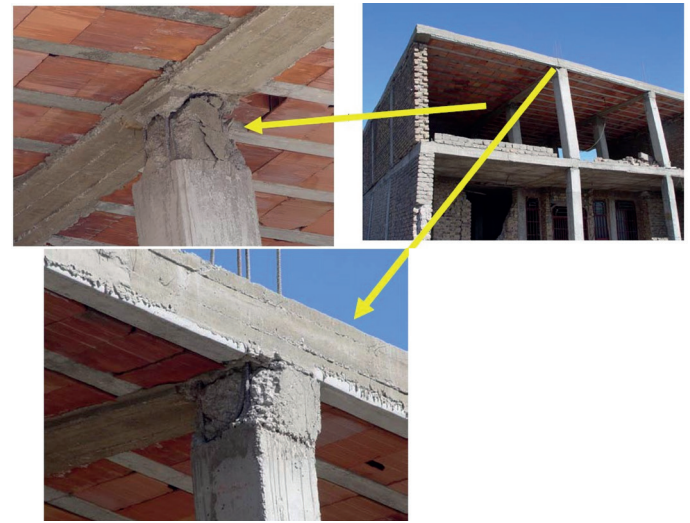
Fig. 2 Damage and rotation inflicted upon the end of the columns of a building by the 2003 Bam earthquake, Iran

Fig. (2) displays an obvious example of an incorrectly constructed beam-ceiling connection in Kerman province, Iran whose top section has suffered substantial seismic damage and rotation caused by the 2003 Bam earthquake. It is clear that a defective column-ceiling always threatens the stability of a structure and therefore retrofitting becomes imperative.

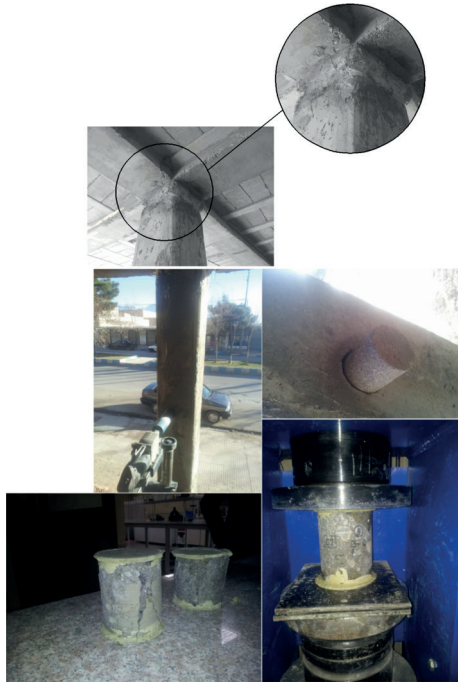
Fig. 3 View of the poorly constructed connection and the core extraction operation

To obtain the mechanical properties of the concrete, a series of core extraction were performed. A total of 16 samples were taken from 3 columns and two beams (10 samples from 3 columns and 6 samples from 2 beams). Four samples were taken from the defective areas of the column-ceiling connection and 6 more samples were extracted from 2 other columns at, 1/4, 2/4 and 3/4 of their height. The remaining six samples were extracted from two beams at 1/4, 2/4 and 3/4 of their length. The

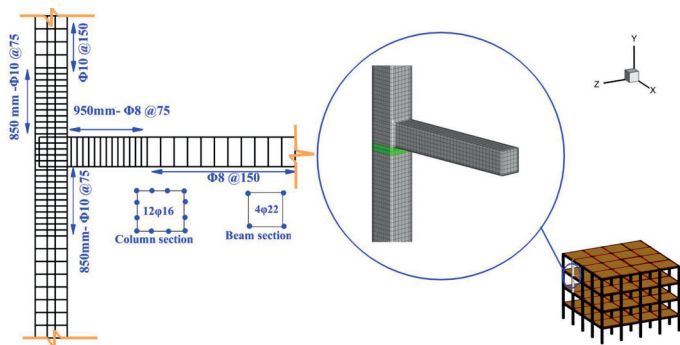
Fig. 4 Dimensions and the reinforcements of the connection

Based on the carried out tests, the compressive strength of the samples extracted from the intact parts of and the defective parts were chosen to be 25 and 3 MPa, respectively. The tensile strength of the longitudinal steel bars and the stirrups used in the beams and columns is 400 MPa and are in compliance with the Russian GOST 5781-82:1993 standard. Based on the acquired data from the tests and field observations, the concrete at the upper 150 mm of the column (colored in green), is defective. The dimensions of the column of the studied connection are 500*500. Also, the beam has a height of 450 mm and a width of 400 mm. The details of the poorly constructed connection in the high school, including the dimensions and the reinforcements are depicted in Fig. (4).

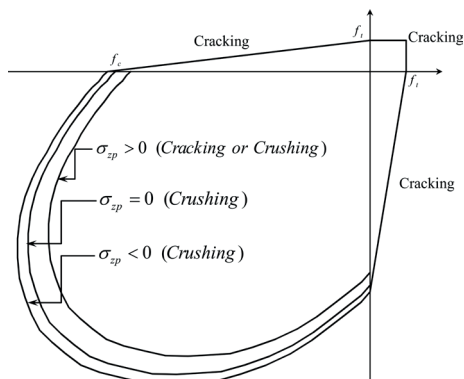
Fig. 5 Willam-Warnke yield surface in 2D space

It has to be mentioned that this yield surface has the ability to take into account the crushing effect in compression and cracking in tension. It is noteworthy, also, that the behavioral model employed for the concrete assesses the cracks in the principal planes and in the Gauss points [40]. Thus, considering the positioning angles of the principal planes in 3D space and in each Gauss point, the model is capable of accounting for lateral cracks. Therefore, if a fine enough mesh is used in the simulation, these cracks are merged in the Gauss points and the paths of the lateral cracks can be modelled. A good example of evaluating the lateral crack effect can be found in the work done by Brunesi and Nascimbene [42] where a good agreement was seen between the results of the numerical model and the experimental observations. Also, to model the behavior of the steel plates, the eight-node, three dimensional SOLID45 element with 3 degrees of freedom in each node was utilized. Further, the Von Mises yield surface was used to model the nonlinear behavior of the steel material. The friction between the concrete and the steel plates was accounted for using the contact elements CONTA174 and TARGET170 and the Mohr-Coulomb yield surface was used to model the frictional behavior. The friction coefficient was considered equal to 0.5 [43].

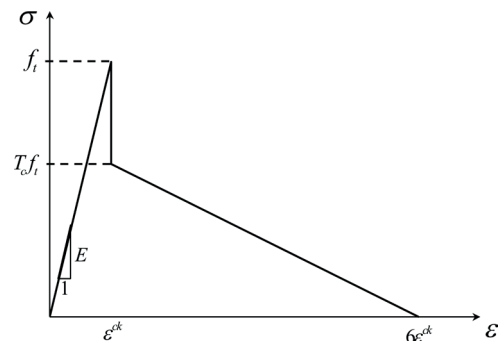
Fig. 6 Tensile behaviour of the concrete

In the numerical modelling, this equation was used to model the compressive behavior of the concrete. Also, the following diagram presents the stress-strain curve used for the concrete in tension. The tensile relaxation (softening) was presented by a sudden reduction of the tensile strength to $0.75 f_t$ upon reaching the tensile cracking strain (ϵ_{cr}). After this point, the tensile response decreases linearly to zero stress at a strain of $6 \epsilon_{cr}$ (Fig. 6).

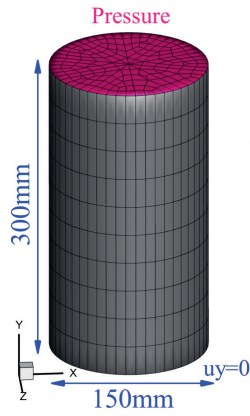
Fig 7 Finite Element modelling of the concrete cylindrical sample

Now, numerically modelling a cylindrical concrete sample (pictured below) can furnish the necessary information to draw a comparison between the mathematical relationship and the numerical analyses.

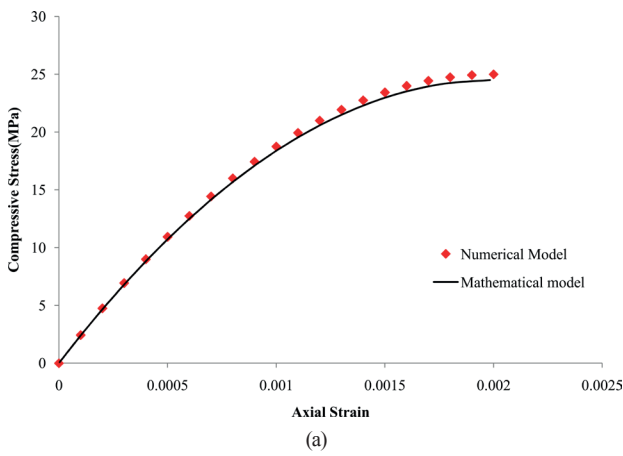
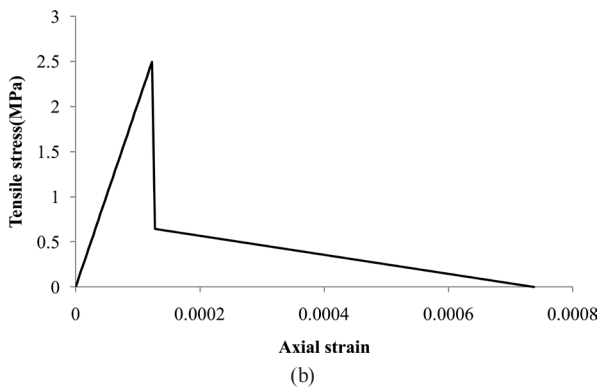
Fig 8 (a) The compressive stress of the mathematical and numerical models and (b) response of the Finite Element cylindrical sample

As it can be seen from Fig. 8-a, there is a very good agreement between the mathematical model and the numerical simulation:

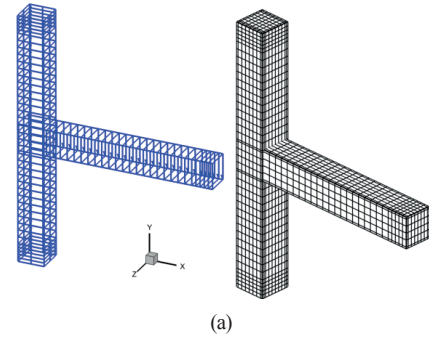
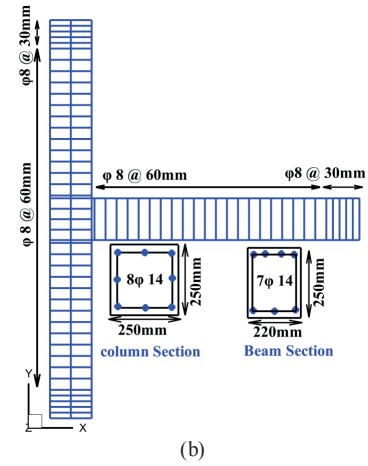
Fig. 9 (a) The steel reinforcement (left) and the Finite Element mesh (right) (b) the experimental model (the C1 model)

To verify the parameters used in the software and also to ensure the correct performance of the numerical model, the beam-column connection studied by Shafaei et al [27] (the C1 model), which in terms of concrete strength, reinforcement and geometrical properties is almost similar to the reference model of this study, was used. The geometrical properties of the model by Shafaei et al [27] and also the simulation carried out in the ANSYS software are presented in Fig. (9).

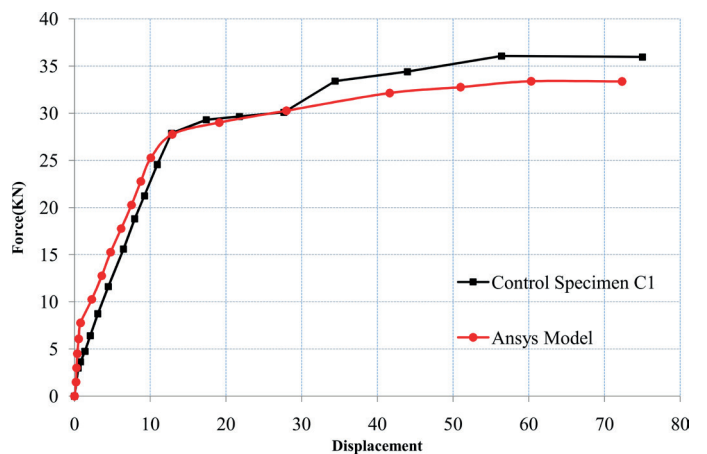
Fig. 10 Load-displacement diagrams of the C1 model and the finite

By comparing the load-displacement diagram of the C1 model and its simulation in the ANSYS software using the obtained parameters, a good agreement can be seen (Fig. 10). Also, by assessing the developed cracks in the experimental and the numerical models, it can be ensured that the failure modes of the two models match (Fig. 11). In this study, by keeping the strength parameters of concrete and steel constant, the retrofitting of the poorly constructed connection is investigated.

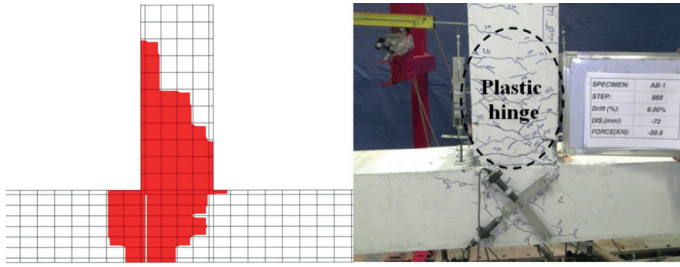
Fig. 11 Crack development pattern in both the experimental and the numerical models

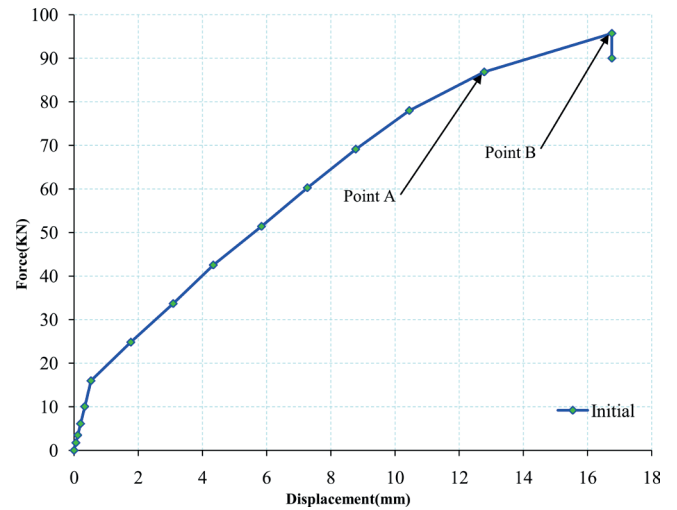
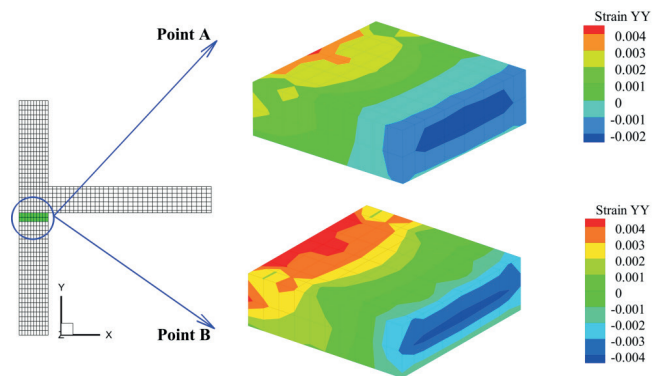
Fig. 13 (a) The load-displacement diagram of the imperfect connection; (b) The strain of the defective part at points A and B at the final moment of load carrying

By carrying out the nonlinear static analysis on the imperfect connection and analyzing the results, it was revealed that the connection fails at the weak point before the structure reaches its maximum capacity. The load-displacement diagram of the

connection signifies its brittle behavior (Fig. 13-a). Considering the plastic tensile and compressive strains of the defective concrete at point A in the load-displacement diagram, it can be seen that the concrete is destroyed at the compressive area and cracks in the tensile area have clearly expanded. At point B in the load-displacement diagram, considering the plastic compressive strains, it can be observed the concrete of the defective area has been completely destroyed and this causes the longitudinal steel bars to buckle and the connection to lose its load bearing capacity. Thus, point B was taken into account as the ultimate capacity of the connection (Fig. 13-b).

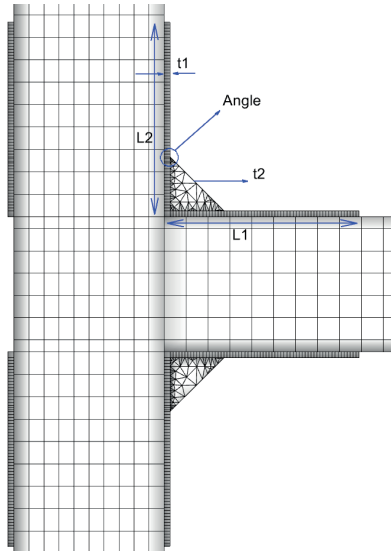
Fig. 14 The overall view of the reinforcement

same, the common specifications of the models are depicted in Fig. 14. The remaining details are given in the sections in which each model is described. The mechanical properties of all the models are identical and are tabulated in table (3).

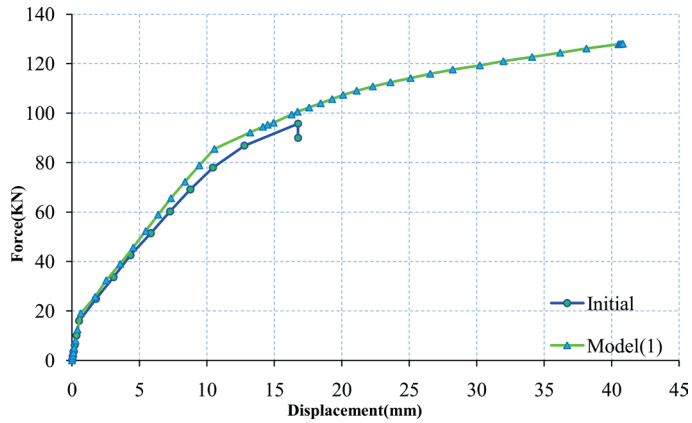
Fig. 16 Load-displacement diagram of model 1

The triangular stiffeners shown in Fig. 16 are used to stiffen the connection and redistribute the developed forces from the confined concrete to the steel plates. The dimensions of the triangular stiffeners are 10*200*200 mm. As it can be seen from the results of the Push-over analysis given in Fig. 16, the ductility of the model has increased and the brittle behavior of the connection has improved.

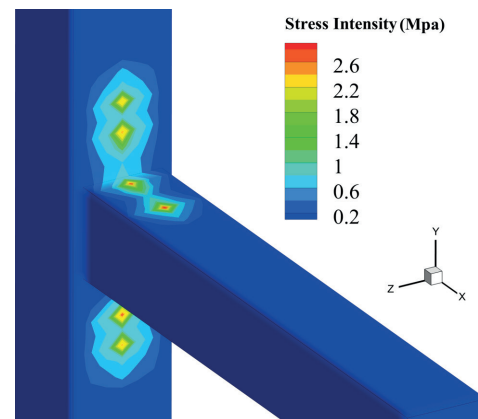
Fig. 18 Stress distribution on the concrete caused by pre-stressing of the bolts at the location where the bolts are connected to the plates

It has to be mentioned that the bolt is pre-stressed equal to 40 percent of its yield stress and it has a diameter of 20 mm. The force in the bolt is equal to 52778 N. The pre-stressing in the bolt has caused stress concentration in the area of the plate where the bolts is present has penetrated the concrete and the areas away from the bolt, the plate has separated from the concrete. So, assuming that the pre-stressing affects a 200*200 mm area, the average applied pressure was obtained to be 1.3 MPa. By investigating the stress distribution induced by the pre-stressed tensile bolts on the beam and the column, the contact elements are properly transferring the compression caused the pre-stressing (Fig. 18).

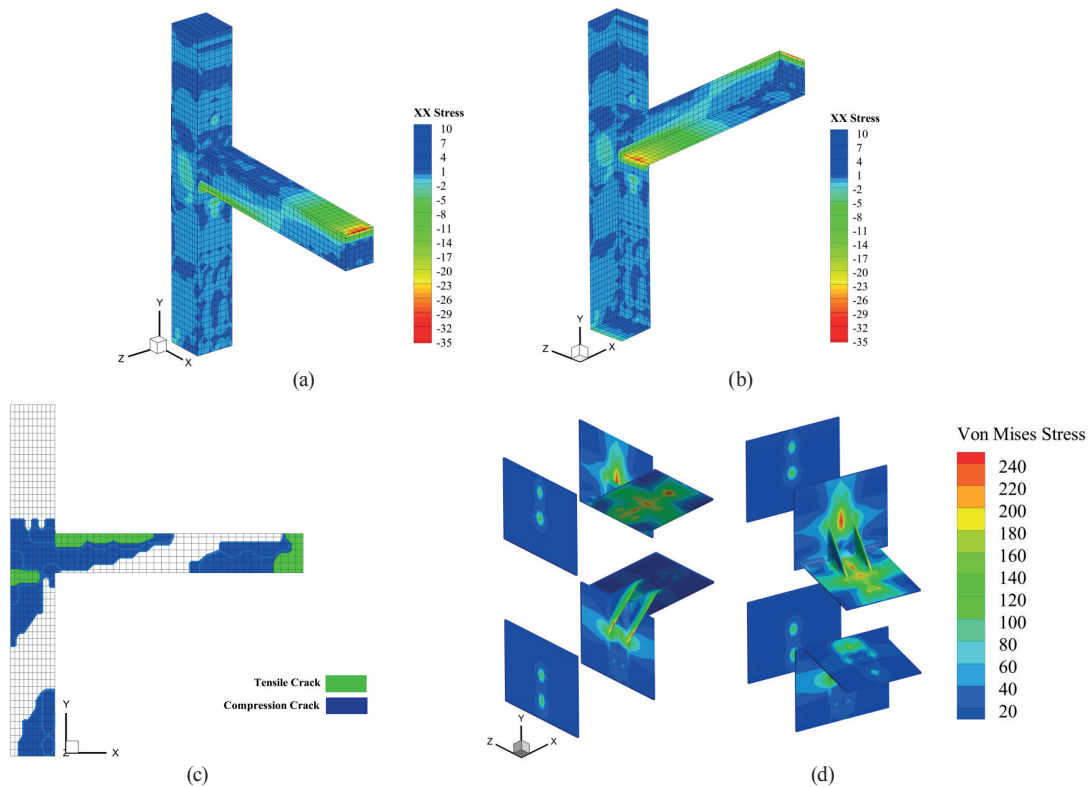
Fig. 17 (a) Normal stress on the beam at the final moment, (b) Normal stress under the beam at the final moment, (c) Expansion of the cracks at the final moments, (d) Von Mises stress distribution on the plates at the final moment

By observing the normal stress at the final moment, it is revealed that the failure of the connection has occurred at the front of the column. Videlicet, the location of the plastic hinge is in the front of the column which is not desirable and the expansion of the tensile cracks and the crushing of the concrete of the face of the connection at the final moment confirms this assertion.

Correspondingly, by observing the Von Mises stress distribution of the reinforcing plates at the final moment, it can be seen that the maximum capacity of the steel plates has not been employed. This is probably due to the fact that the edges of the steel plates are not attached to each other, but at the location where the steel plates are connected by tensile bolts, the plates have fully contributed to stress transfer. From these results, it becomes clear that the steel plates should, at all points, be

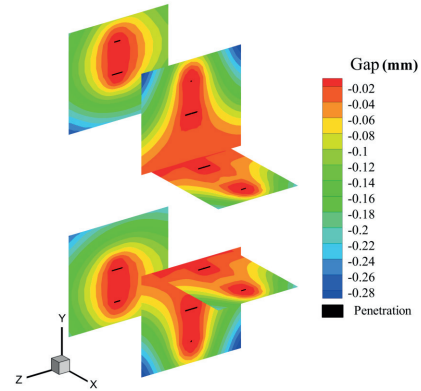
Fig. 20 Separation and penetration contour of the plate at the final load carrying

By assessing the separation of the plates in model 2, it can be seen that the initial pre-stressing of the bolts causes the plates to penetrate the concrete at the location of the bolts and separate from the concrete in other locations and this causes the plate not to perform desirably. So, the separation of the plates at the edges has to be also sufficiently controlled. In the next model, this objective is met (Fig. 20).

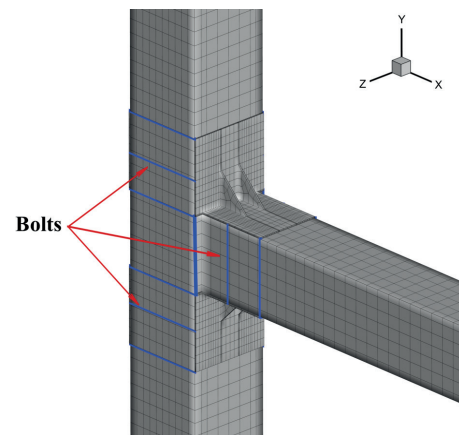
Fig. 21 View of model 4 and the placement of the side bolts

In this model, in order to prevent the separation of the steel plates from the concrete, especially the separation of the corners, it was decided to omit the medial bolts so that only the effect of the friction between the steel plates and the concrete and also the effect of the un-prestressed side bolts can be investigated. The steel plates on the column and the beam were annexed to each other using 3 bolts with the diameter of 14 mm and no pre-stressing. The location of the side bolts are shown in Fig. (21).

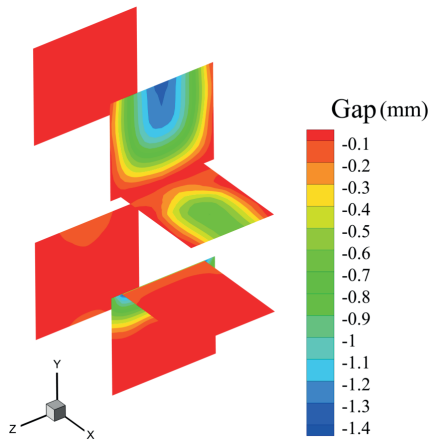
Fig. 22 Separation contour of the plate from the concrete in model 4 at the moment when the connection reaches its final strength

After applying the load and controlling the separation of the plates from the concrete, it is observed that the plate does not separate from the concrete at the edges. However, it does occur in the middle section. Fig. (22). So, the simultaneous use of both side and medial bolts will probably prevent the separation of the plates and causes the reinforcement to perform suitably. In model 5, the medial bolts were pre-stressed equal to 70 percent of their yield stresses and the side bolts were not pre-stressed and the performance of both types of bolts was investigated. Fig. 24 presents a comparison between the load-displacement diagrams of models 3, 4 and 5. In model 5, one can easily note that the simultaneous utilization of medial and side bolts has quite effectively increased the ductility of the connection.

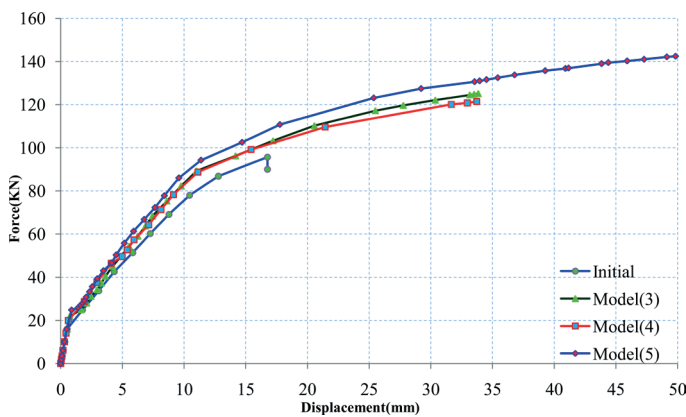
Fig. 23 Comparison between the load-displacement diagrams of models 3, 4 and 5

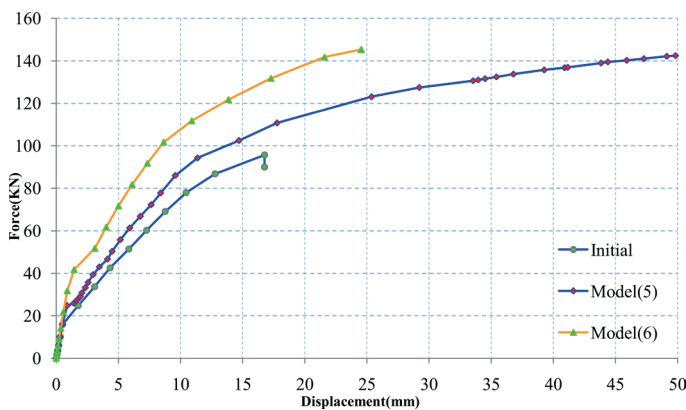
Fig. 24 Comparison between the load-displacement diagrams of model 5 and 6

In model 5, by assessing the critical stress of the side bolts, of which the maximum stress is 78 MPa, it is revealed that the bolts are far from reaching their maximum capacity. Therefore, it is possible to arrive at more suitable results by pre-stressing the side bolts and increasing the confinement stress. Model 6 was constructed to take into account these two factors. In this model, in addition to the medial bolts, the side bolts were also pre-stressed equal to 70 percent of their yield stress. By comparing the load-displacement diagrams of models 5 and 6, it is obvious pre-stressing the side bolts has increased the initial stiffness and the confinement stress of the connection (Fig. 24).

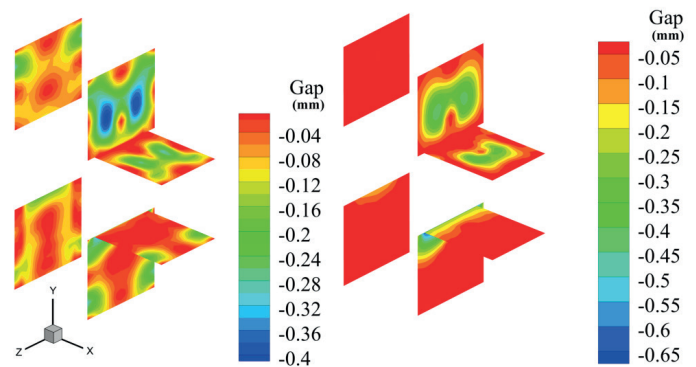
Fig. 25 Comparing the separation pattern of steel plates from the concrete at the final moment in models 5(a) and 6(b)

Increasing the initial stiffness of model 6 has decreased its ductility. By comparing the separation patterns of the steel plate from the concrete in models 5 and 6, it was concluded that simultaneously pre-stressing the side and the medial bolts has caused the plate between them to separate from the concrete and as a result, the uniformity of the friction stress between the plate and the concrete has decreased which in turn has caused the connection to have a brittle behavior. By pre-stressing the side bolts, the concrete covering acts as a support and at the moment the load is applied, it causes the plate between the side bolt and the medial bolt to separate from the concrete. G. Santarsiero et al [41] have also used tensile straps to connect steel plates to beams and columns. The strength of the connection was increased by relatively 95 percent but the initial stiffness did not change at all which probably is due to the use of tensile straps whose presence has caused the support-like role of the concrete covering and also has caused the mid-section steel plate to separate from the concrete (Fig. 25).

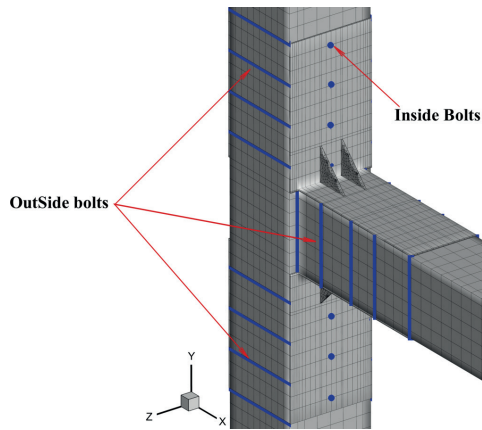
Fig. 26 View of model 7 and the placement of the bolts

In this model, to level out the transitive stress between the plate and the concrete and also to drive away the plastic hinge from the column and moving it into the beam, plates with the length of 950 mm and the thickness of 10 mm were used. The reinforcing plates were attached to the beam using 5 un-prestressed side bolts. To connect the plate to the column, 4 medial bolts pre-stress equal to 70 percent of the bolts' yield stresses and 4 un-prestressed side were used. The reason behind using the medial bolts is to increase the confinement in the column and in the defective area.

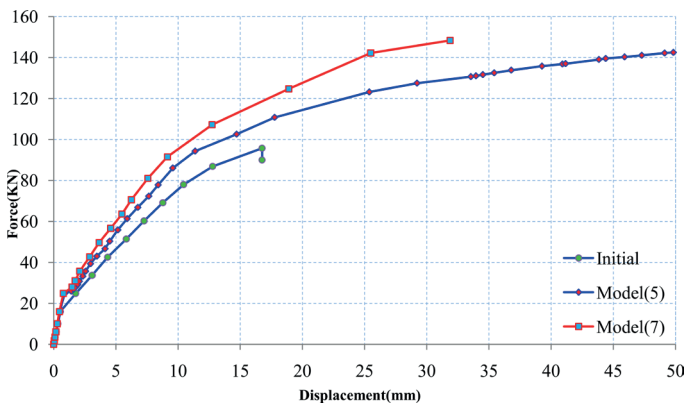
Fig. 27 Comparing the load-displacement diagrams of models 5 and 7

By comparing the load-displacement diagrams of model 5 and 7, it can be seen that model 7 demonstrates a higher initial stiffness and carries more load. However, compared to model 5, its ductility has diminished which probably is due to the absence of medial tensile bolts in the beam. Fig. (27). Therefore, for the concrete to perform desirably and have sufficient confinement stress, it is necessary to use tensile bolts in both the beam and the column simultaneously.

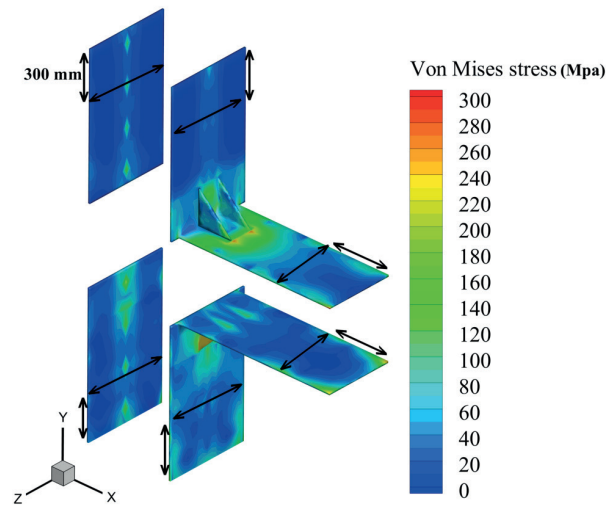
Fig. 28 Von Mises stress distribution of the reinforcing plates at the final moment

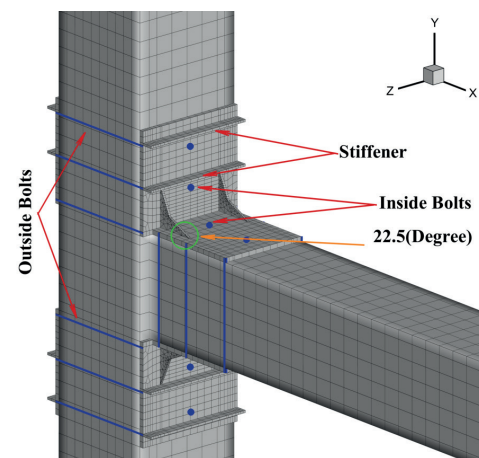
Fig. 29 View of model 8 and the placements of the bolts and the stiffeners

In model 8, to uniformly distribute the stress resulted from the pre-stressing of the bolts, transverse stiffeners with the dimensions of 10*50 were used. It has to be mentioned that the length of the reinforcing steel plates in this model is 450 mm. The medial bolts in this connection have a diameter of 18 mm and the side bolts have a diameter of 14 mm. Both bolt types have a pre-stressing of 70 percent of their yield stresses. In this model, to increase ductility, the angle of the triangular stiffeners has been decreased from 45 degrees to 22.5 degrees. Fig. (29).

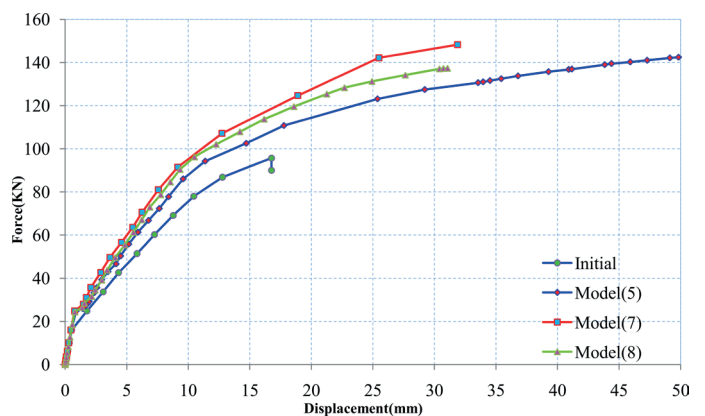
Fig. 30 Comparing the load-displacement diagrams of models 5, 7 and 8

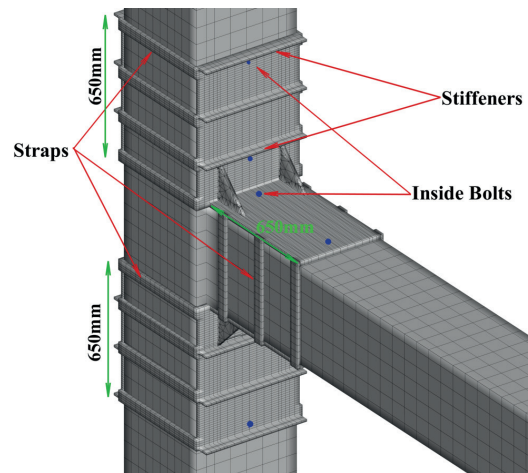
Fig. 32 View of model 9 and the placement of the straps and the bolts

respectively. Considering that the pre-stressings of the side bolts cause local failures, straps with the width of 50 mm have been used in place the side bolts to annex the reinforcing steel plates together. The straps are placed based on the position of the joists that are placed perpendicular to the beam so that when the retrofitting is being performed, as little damage as possible is inflicted upon the ceiling. Fig. (32).

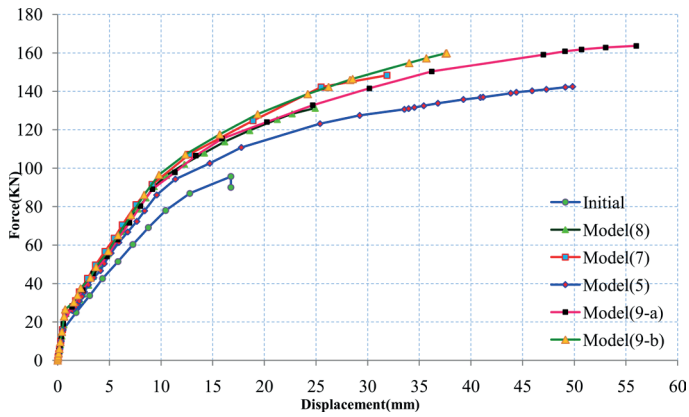
Fig. 33 Comparison between the load-displacement diagrams of model 9 and the other models

By comparing the load-displacement diagram of model 9 to those of the other models, it can be seen that both the ductility and the load bearing capacity of the connection has considerably increased and therefore this model is a suitable choice with which to retrofit the connection. Using straps instead of pre-stressed side bolts has brought about a more ductile behavior and has barred the steel plates to separate from surface of the concrete which was due to the support-like behavior of the pre-stressed side bolts. It should be noted that the use of straps instead of pre-stressed side bolts prevents the development of local stresses in the concrete covering and the confinement behavior of the concrete is also more effective. Moreover, compared to model 7, more optimized steel plates have been used in this model which in practice has the benefit of destroying a smaller portion of the ceiling at the time of retrofitting. Model 9-a, whose bolts are pre-stressed equal to 40 percent of their yield stresses, displays a more ductile behavior compared to model 9-b whose bolts are pre-stressed equal to 70 percent of their yield stresses. Therefore, high pre-stressing has probably caused local stresses in location where the steel plates are connected to the concrete and the connection fails before it reaches its maximum capacity. Fig. (33).
