# Effect of the Water-Rock Interaction on the Creep Mechanical Properties of the Sandstone Rock

62(2), pp. 451–461, 2018

RESEARCH ARTICLE

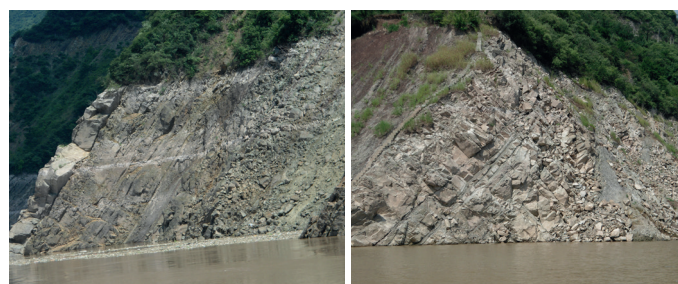
**Fig. 1** Typical failure of the sandstone rock mass in the vicinity of hydro-fluctuation belt (Three Gorges reservoir area, 2015)

and so on. Different types of rock slopes exhibited different deformation and failure criterion under the long term reservoir water, And a detailed literature review [7] has been done to investigate the effect of moisture content on the strength and modulus of different types of rocks. Statistics showed that many bank slope instabilities were occurred after subsequent fluctuations in the reservoir water level. Since the commencement of the Three Gorges project in June 2003, the bank slopes have been subjected to cyclic wetting and drying conditions. Based upon the water level changes, each cycle can be divided into three stages: rise period; relatively stable period, drop period. Due to cyclic fluctuations in the reservoir water level, the rock mass of the bank slopes will be in a dry or a saturated state. The change of the seepage field will not only change the mode of dissolution and the intensity of the water, but it also repeatedly changes the direction of dissolution-precipitation. This phenomenon exacerbated the water-rock interaction (physical and chemical), and yielded sharp drop in the strength of the rock. Figure 1 shows typical bank slopes in the Three Gorges Reservoir area. As it can be seen from Figure.1, the sandstone rock mass is highly weathered and eroded due to the change in the reservoir water level (145–175 m).

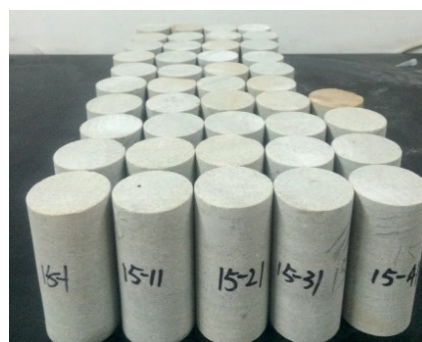
**Fig. 2** Sandstone specimens

A number of cylindrical sandstone specimens ( $\Phi$  50mm  $\times$  100mm) were prepared from the rock sample brought from the Three Gorges reservoir area (Figure 2). Besides, samples with noticeable defects were screened and rejected. The P-wave velocities and the rebound values were used to eliminate the samples with large discreteness [26].

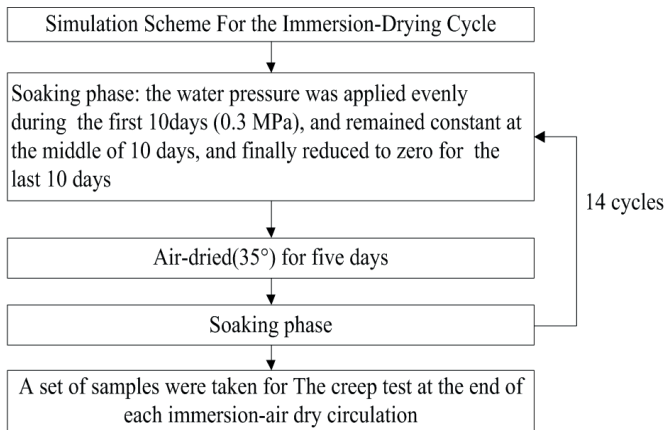
Fig. 3 Flow chart that shows the immersion-air dry circulation process

The simulation procedures are presented in Figure 3. Hence, the basic objectives of this paper were simulation of the reservoir water fluctuation and the resulting immersion - air dry circulation. A rock dissolution apparatus was used to place the rock specimens. A uniform water pressure (0.3MPa) was applied for the first 10 days to replicate the rise in the reservoir water level. This is because the reservoir water level has been fluctuating by 30m head difference. In the next 10 days, a relatively steady state of the reservoir water level has been simulated. In the last 10 days, the water pressure was uniformly reduced to 0MPa to simulate the drop in the reservoir water level. The immersion stage took for a total of 30 days. Then soaked specimens were air-dried at 35°C for 5 days. This is to demonstrate the air-dried rock mass in the dry season. A total of 14 cycles were designed during the experimental program. The dissolution and air drying devices are shown in Figure 4. The devices were used to prepare the rock specimens for the water-rock interaction tests. The fluctuations in the water pressures were efficiently captured by soaking the rock specimens. It is possible to simulate the reservoir water immersion-air-drying cycle at the water-level-fluctuating zone, scrutinize different water immersion pressure, and simulate the air-drying process after the reservoir water level decreases. The whole processes were computerized, which controlled the water pressure, air drying temperature, mixing time; automatic collection of water pressure, temperature and other parameters.

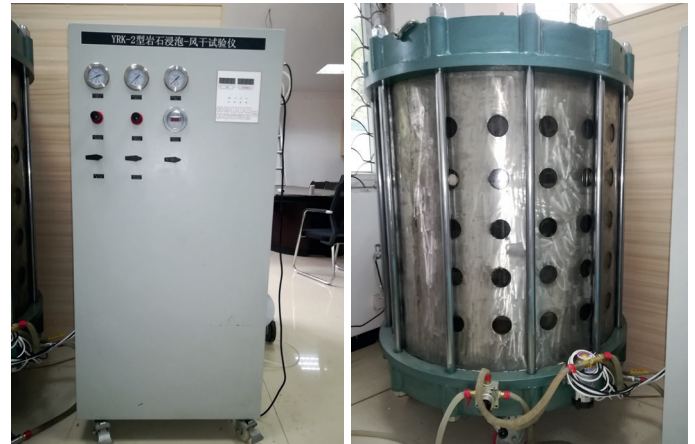
Fig. 4 YRK-2 rock pressure and soaking-air drying equipment

The sandstone samples were soaked in a rock dissolving immersion apparatus. After each immersion-air dry cycle, a group of rock samples were subjected to a triaxial compression creep test. The creep test at the saturated state of the rock sample was used as a basis. The employed confining pressure was 10MPa. Axial stress was applied in multistage till failure developed. The initial axial stress was about 60% of the

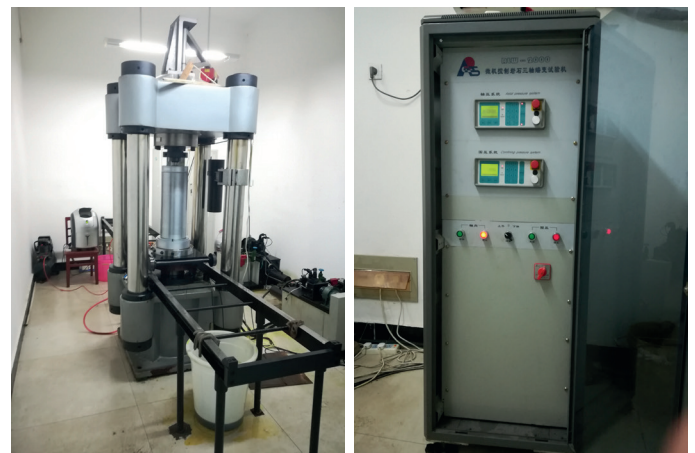
Fig. 5 RLW-2000 rock creep testing apparatus

ultimate compressive strength. The applied axial stress in a decreasing order is listed in Table 1. The triaxial compression creep test was conducted by using RLW-2000 rock triaxial creep testing machine, as shown in Figure 5.

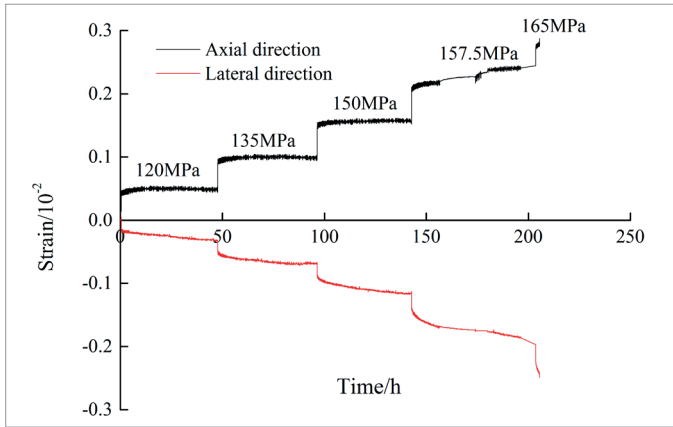
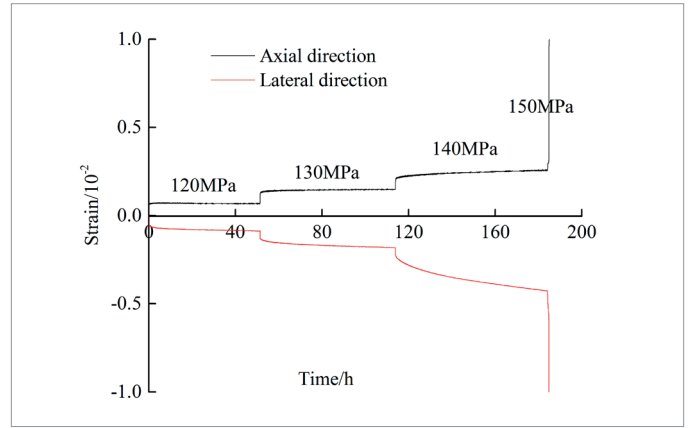
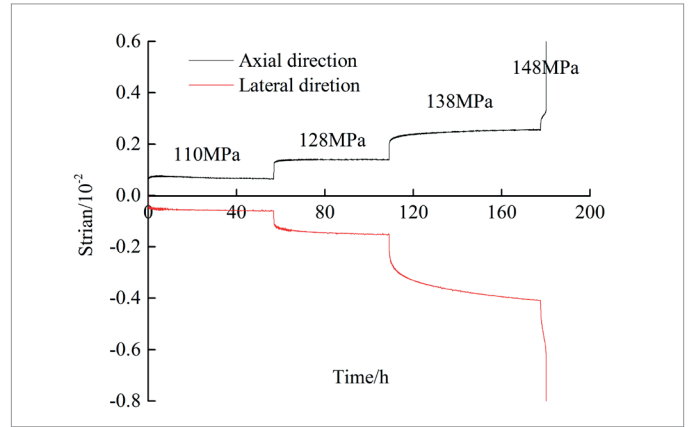
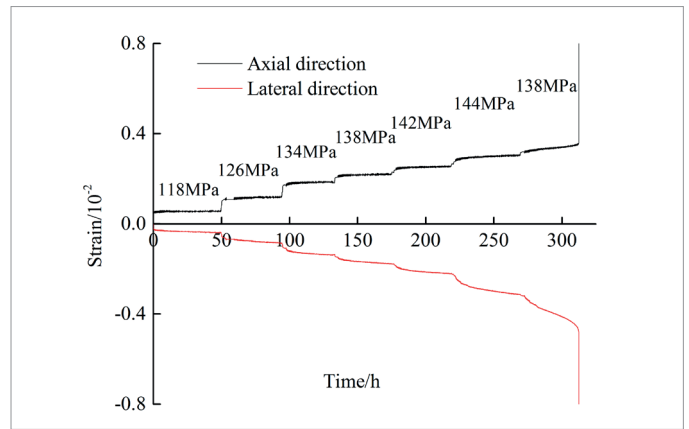
At the end of each soaking, a group of rock samples were subjected to triaxial compression creep tests. The creep curves of the specimens were obtained by using the superposition principle. The axial and lateral strain creep curves for different water-rock cycles are shown in Figure 6. The numbers indicated on the curves (Figure 6) are the axial stress values.

**Fig. 6** Typical creep curves obtained from the triaxial compression tests at different testing conditions

The specimens' deformation gradually reduced under low axial stress level, and mainly exhibited two creep stages (the attenuation and steady-state stages). However, at the failure stress level, the specimens' deformation exhibited different types of creep stages. Namely: attenuation creep stage, steady-state creep stage and nonlinear acceleration creep stage. Large creep deformation and rapid fractures were noticed when the duration was too short. It is important to address this practical problem. Therefore, an in-depth study is still important to capture the deformation characteristics of these rocks. The axial and lateral creep rate curves (Figure 7)

The following conclusions were pointed out based on Fig. 6:

Under different loading stress conditions, the creep characteristics of the rock specimen were axial and lateral. The creep process was getting stability when the applied axial stress was less than (or closed to) the long-term strength, which includes the initial and the stable creep stage. The axial and lateral strains were attaining stability and gradually decreasing to zero. However, the creep process showed instability when the

axial stress exceeded the long-term strength that underwent the initial creep stage, stabilized creep stage, and accelerated creep stage. Rock specimens showed instantaneous deformation due to the transient stress. The instantaneous deformation was decreasing when the axial load increased by a unit stress. Similarly, the sandstone creep rate reached a steady state and then gradually increased, while the axial stress was increasing. Moreover, the instantaneous deformation, the axial and the lateral creep deformation, and the proportion of total deformation were gradually increasing when the number of cycles and the axial stress increased. This phenomenon indicated that the water-rock interaction affected the physical and mechanical properties of the sandstone rock, which in turn affected its creep characteristics. The lateral creep deformation was increasing more rapidly than the axial creep deformation when the number of cycles increased. The lateral deformation was very noticeable at the failure stress level.

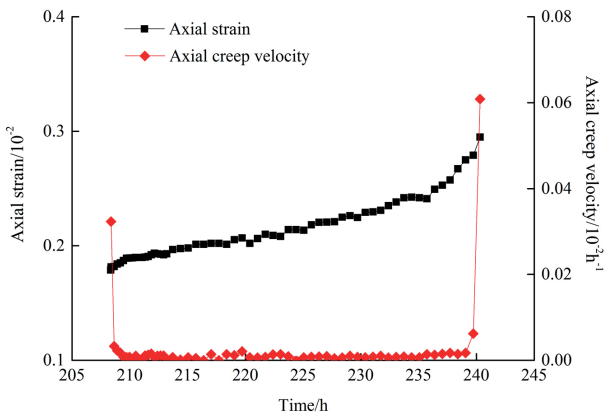
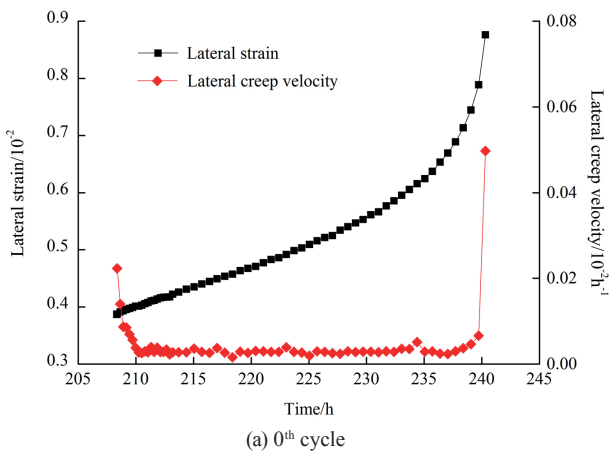
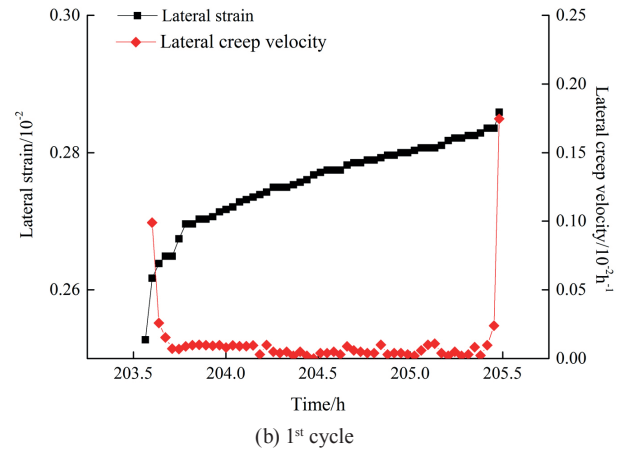
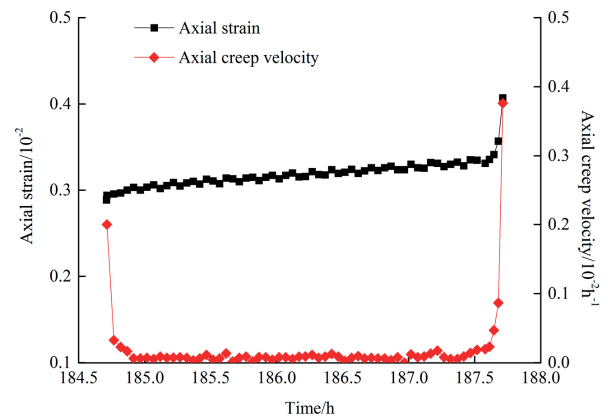
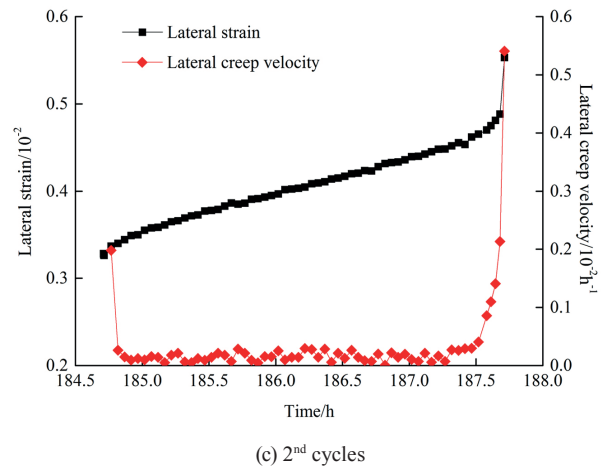
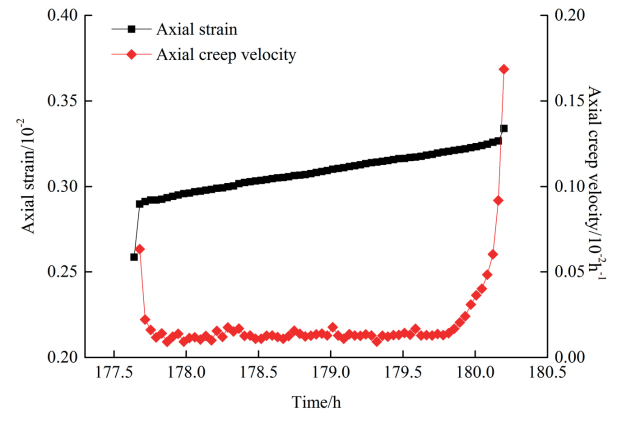
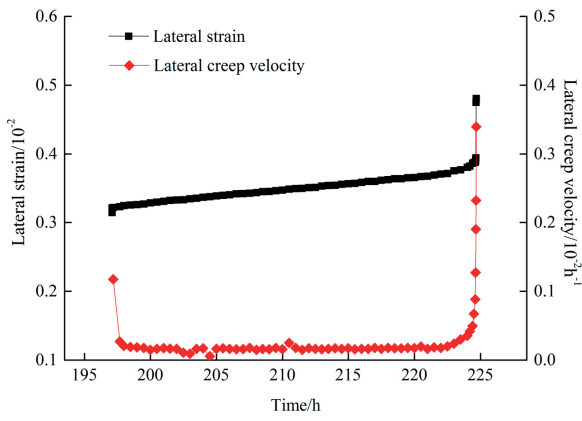
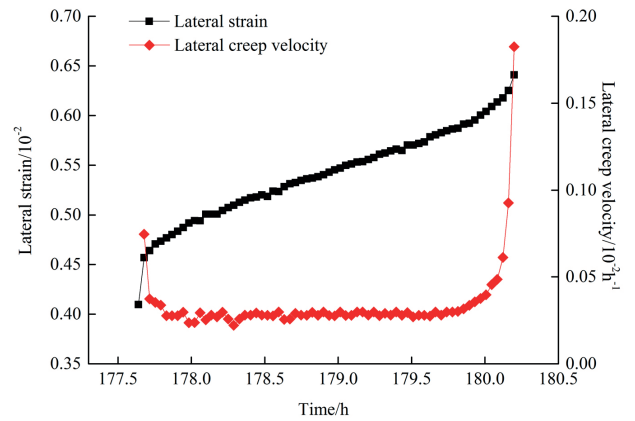
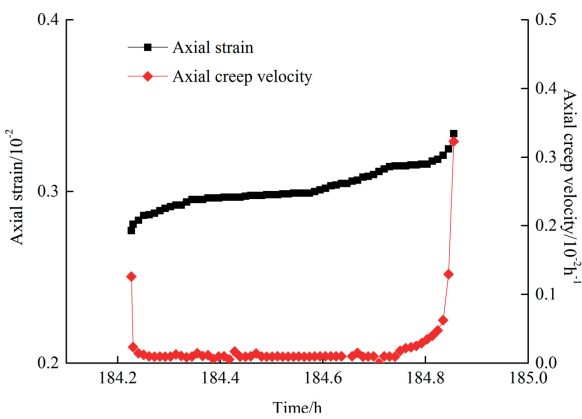
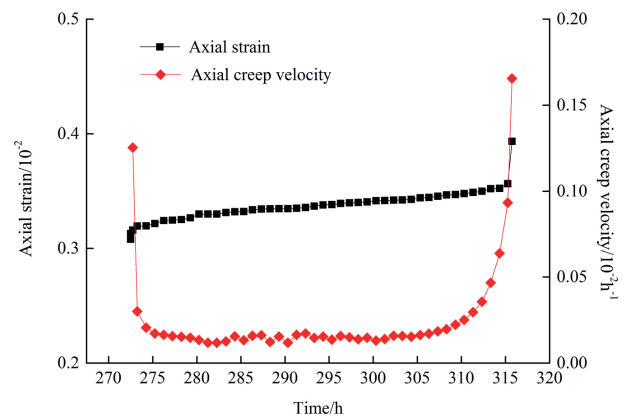
Fig. 7 Strain rate vs. time for the accelerated creep stage at different soaking condition

at the failure stress level were used to analyze the deformation characteristics of the sandstone at the accelerated creep stage. Moreover, Table 2 shows the creep duration at the failure stress level for different stages.

The sandstone rock showed the following deformation characteristics (Table 2 and Figure 7) at the nonlinear accelerated creep phase:

The proportion of the total cessation at the steady creep stage was more than 75%, the ratio of the initial creep stage and the nonlinear accelerating creep stage to the total diachronic phase were small. The rate of steady creep was decreasing from 89.06% to 75.00% when the duration of the water-rock interaction increased. However, the proportion of non-linearly accelerated creep has been increasing from 5.37% to 13.54%. Similarly, the brittleness of the rock specimens was decreasing while its plasticity gradually increased. The rate of lateral deformation was larger than the axial deformation at different water-rock interaction cycles. The ratios of lateral deformation to axial deformation were 1.99, 3.59, 3.71, and 4.14 corresponded to the 0<sup>th</sup>, 3<sup>th</sup>, 10<sup>th</sup> and 14<sup>th</sup> of water-rock interaction cycles. The rates of lateral and axial deformations were increasing while the duration of the water-rock interaction increased. Since the softening of the specimen increased with the duration of the water-rock interactions, the creep stage enhanced lateral expansion. The axial and lateral creep rates (at the steady creep stage) of the sandstone were increasing and the nonlinearly accelerated creep stage was decreasing while the number of water-rock interaction cycles increased. The ductility of the sandstone rock has been increasing at a higher water-rock interaction cycles.

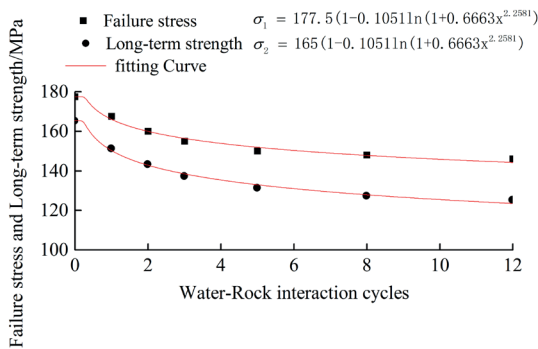
**Fig. 8** Failure stress vs. long-term strength for the sandstone at different water-rock interaction cycles

The long-term strength of the rock mass can be defined when its strength decreased and converged [27]. The most reasonable way to determine the long-term strength is to define it, and to take a single-stage dead load test and to determine the relationship between the rock breaking strength and time. The failure duration corresponds to infinite load for the long-term strength. However, this method requires multiple testing machines, and it utilizes both time and money. Hence, it is rarely used in practice. In this paper, the long-term strength of the sandstone rock was determined by using the commonly used stress-strain isochronal curve [28]. After plotting the stress-strain isochronal curve cluster, the long-term strength was determined from the inflection point on the curve cluster (Table 3). Figure 8 shows the creep failure strength and the long-term strength degradation curves for the sandstone rock specimens.

The following points were noticed from Table 3 and Figure 8: the failure stress at the saturated state was 177MPa, and the strength of the rock specimens were decreasing by 5.63%, 12.68% , 15.49%, 16.62% and 17.75% (at the 1<sup>st</sup>, 3<sup>rd</sup>, 6<sup>th</sup>, 10<sup>th</sup>,

and 14<sup>th</sup> cycles respectively.) For the first three successive water-rock interaction cycles, the long-term strength of the rock was dramatically reduced. In contrast, the rate of reduction on the long-term strength of the rock was getting a steady state after six successive water rock interactions. The initial long-term strength of the rock samples was 165MPa, and the strength of the rock samples decreased by 8.48%, 16.97% , 20.61% ,23.03% and 25.45% (at the 1<sup>st</sup>, 3<sup>rd</sup>, 6<sup>th</sup>, 10<sup>th</sup>, and 14<sup>th</sup> cycles respectively). For the first three successive water-rock interaction cycles, the long-term strength of the rock was dramatically reduced. In contrast, the rate of reduction on the long-term strength of the rock was attaining a steady state after six successive water rock interactions. During constant water-rock interaction, the long-term strength of rock samples has been decreasing. Besides, the long-term and failure strength ratios were decreasing. This is because the rock specimens were softened due to the water-rock interaction.
