# An Experimental Study on the Strengthening of RC Frames with Soft Storey Irregularities with Different Types of Steel Diagonals

RESEARCH ARTICLE

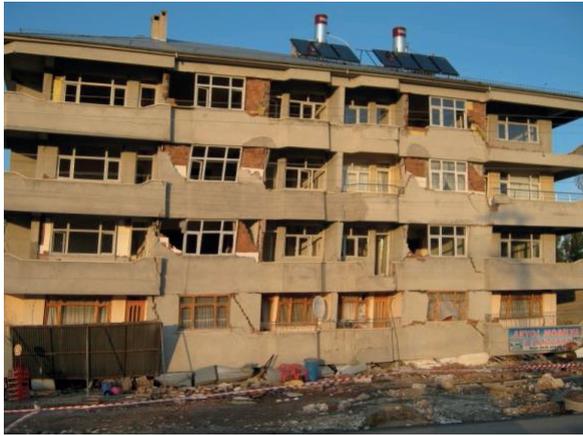
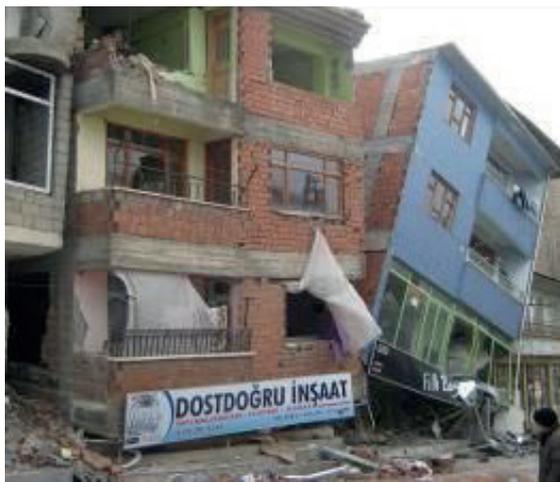
**Fig. 1** Collapsed ground stories in 2011 Van, Turkey earthquake (soft storey mechanism) [3]

Field observations after earthquakes in developing countries reveal that formation of soft storey irregularity is one of the major reasons for the loss of life/damage in the buildings [2–5]. The most important reason for this is the use of especially the ground floors for commercial purposes. Infill walls on the ground floor are removed in order to make presentations, and also, the height of the ground floor is increased compared to the upper floors by constructing mezzanine floors. These two factors considerably reduce the rigidity of ground floors. The infill walls, which are considered to affect the structure only as a vertical load during the design stage (non-bearing elements), both contribute to the bearing of lateral loads and limit story drifts by applying reactions to the column-beam joint areas. Therefore, the increase of the story height in addition to the removal of the infill walls leads to a sudden decrease in the rigidity of the ground floor. Since the shear walls, which provide the structure with lateral rigidity, are usually very limited in the existing building structure, the damage concentrates on the ground floor. Since they do not comply with earthquake code requirements, the columns with limited deformation capacity are fractured without consuming sufficient energy and the building usually collapse on the ground floor after the plastic hinges formed on the column ends.

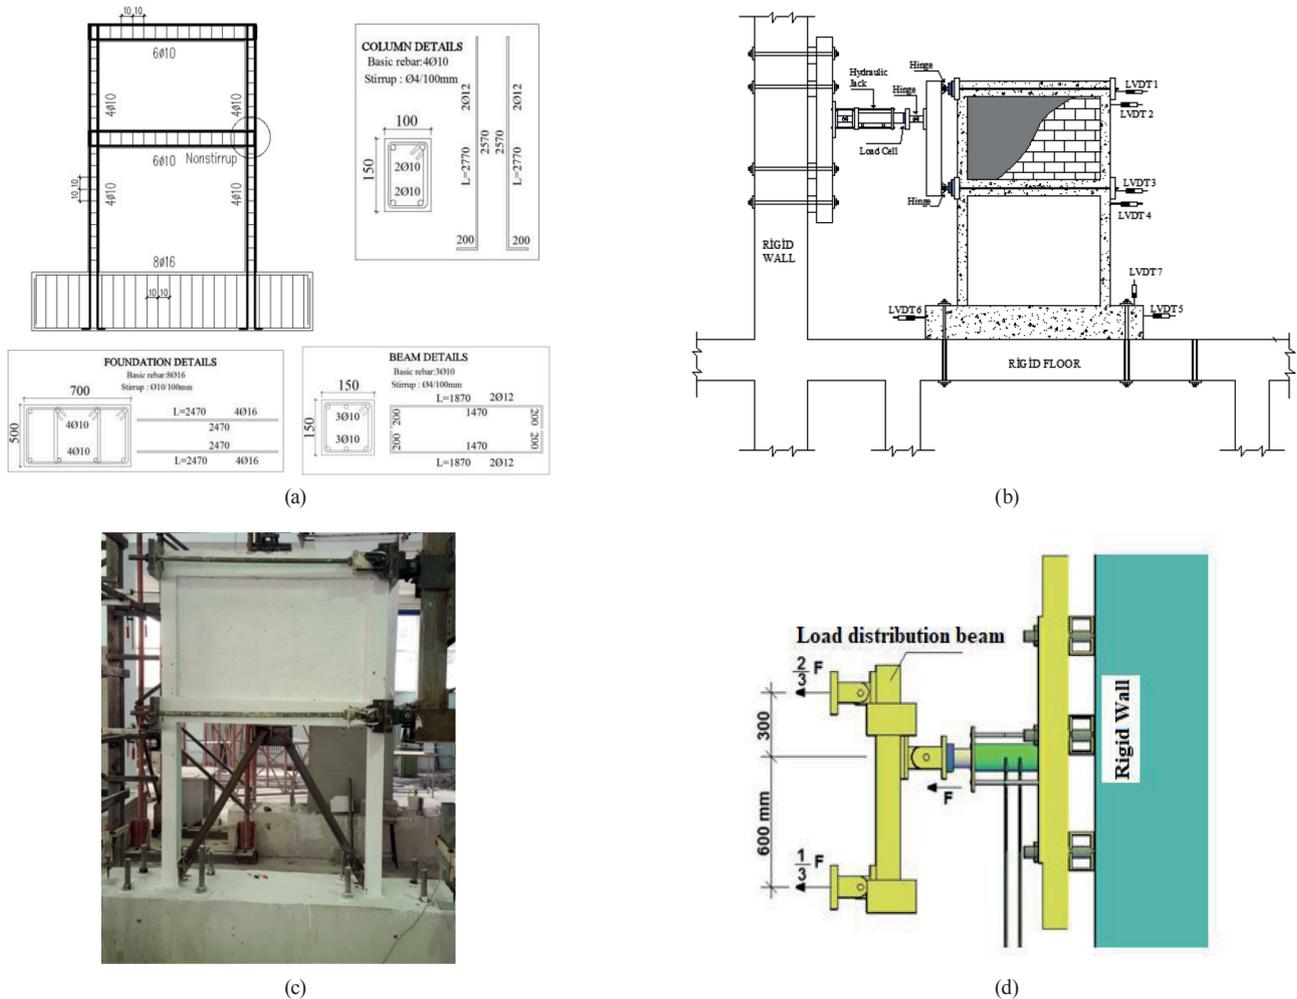
**Fig. 2** (a) Reinforcement details of the frames (b) Loading system, test set-up for Exp2-SS specimen (c) view of EXP3-SV specimen (d) load distribution

The bare reinforced concrete (RC) frame was designed in accordance with the dimensions of the columns and beams in existing buildings and the span-height conditions and was prepared in 1/3 geometric scale. The out-to-out distance on the span in the RC frame is 1500 mm and the height of the floor is 1200 mm from the foundation to the upper level of the beam of the 1st floor. The height of the 2nd floor is 900 mm. Thus, the height of the ground floor was increased and lateral rigidity of the lower floor was reduced as frequently seen at the buildings used for commercial purposes. Since the rotation and settlement on the foundation would not be considered in the study, the dimensions of the foundation were selected to be quite rigid and a foundation beam with the dimensions of  $500 \times 700 \times 2500$  mm was produced. The column dimensions were decided to be  $100 \times 150$  mm. Beam dimensions were also decided to be  $150 \times 150$  mm in order to ensure strong beam-weak column formation which is a construction defect observed frequently in the existing building stock. The longitudinal reinforcement of the columns was prepared in  $4\text{Ø}10$  mm and produced by using stirrup with  $\text{Ø}4/100$  mm. No confinement zones were formed at the ends of the columns; the stirrups were not extended at the foundation and beam-column joints. Longitudinal reinforcements of  $3\text{Ø}10$  mm at the top, and  $3\text{Ø}10$  mm at the bottom and transverse reinforcement of  $\text{Ø}4/100$  mm were applied to the beams. As can be understood from the design of the frames, many design defects in the existing building stock in the developing countries were considered.

irregularity. Instead of the infill walls removed from the lower floors in the remaining 2 specimens, ST37-type steel profile with cross-sectional dimensions of L60.60.6 mm was used to make central X and inverted V-shaped strengthening. The steel profiles were connected to the frame by using M16 anchorage bolts. No chemical adhesive was used during the anchorage. Since the ends of the bolts are hold with the concrete after they were inserted into the drilled holes, they were mechanically connected. General characteristics of the test specimens are showed at the Table 1, reinforcement and connection details of the specimens are showed at the Figure 2.a–c. A schematic illustration of test set-up and loading system is shown in Figure 2.b–2.d for specimen Exp2-SS. The horizontal load applied to the frame to represent the earthquake effect is applied from the upper peak point in some studies [10]. But to ensure accurate representation of the actual distribution of earthquake force on the structure, lateral loads should be applied on story levels at various rates (triangular load distribution) [11]. To this end, a special loading system was designed in this study. Load cell was fixed to a steel plate and by means of making a vertical box profile system with a hinge to the end of this steel sheet; it is aimed to move easily the system at the different displacements that may occur between the floors of RC frames.

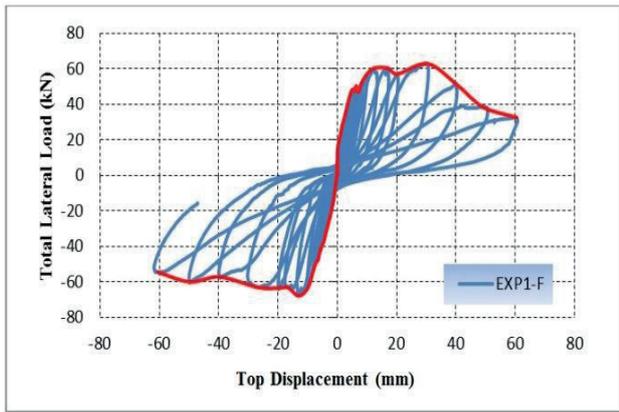
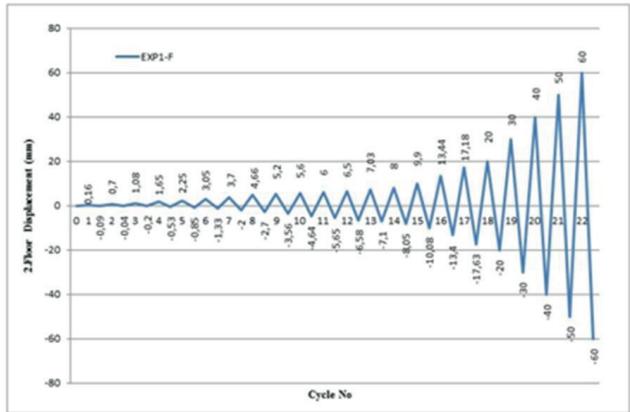
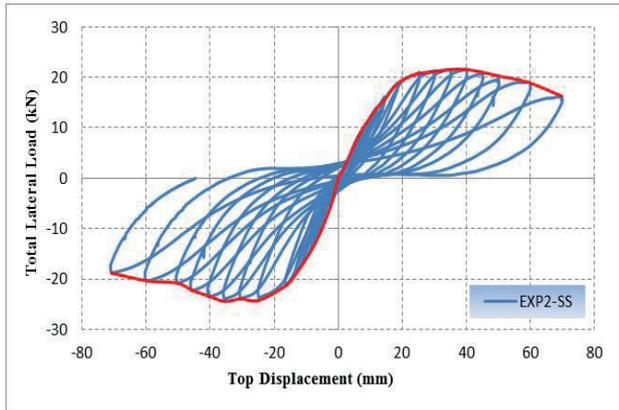
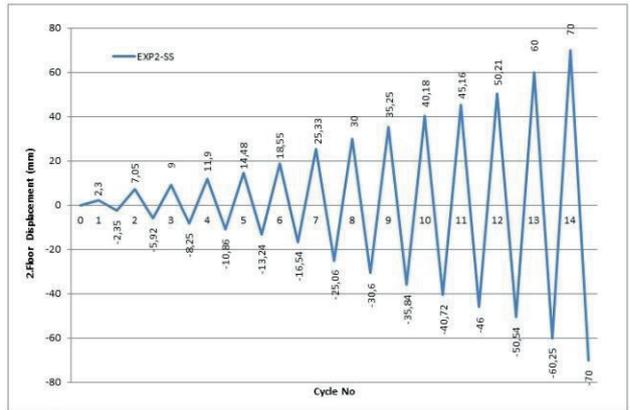
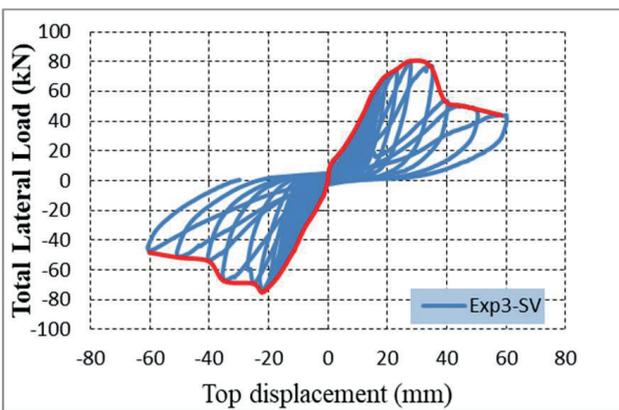
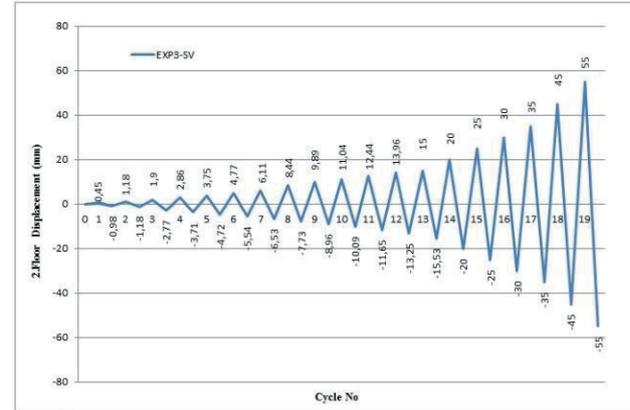
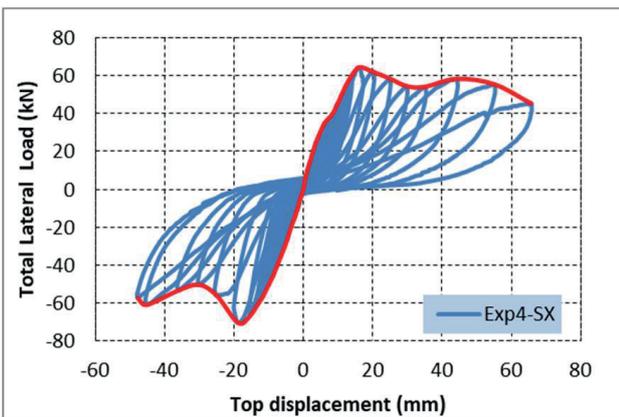
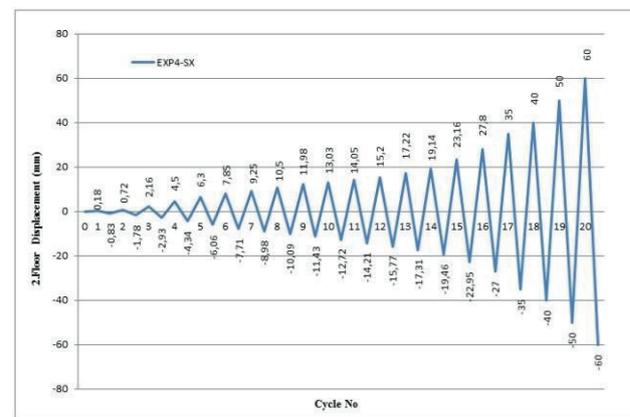
Fig. 3 (a) hysteresis and envelope curves of test specimens [12] (b) 2nd floor displacement-cyclic graphics of test specimens

The displacement history graphs and load–displacement envelope curves that were observed during testing are illustrated in Figure 3. Also load history graphs are illustrated in Figure 4. Response envelope curves shown in Figure 3 were plotted by connecting the peak points of lateral load–top displacement hysteretic curves for each specimen. Response envelope curves show the strength and rigidity characteristics of the specimens and also their general behavior. Also, the view of the test specimens at the failure stage and the schematic representation of the cracks observed during testing are illustrated in Figure 5. While the maximum load obtained from EXP1-F specimen was approximately 62.86 kN for positive loading, it was 22.11 kN at the end of the 22nd cycle. And, the maximum load, which was –67.67 kN, for the negative loading was reduced to –24.78 kN. Therefore, the load bearing capacity was reduced by 60% at the end of the test. As can be seen from the displacement history graph given in Figure 3, Exp1-F specimen reached an ultimate peak displacement of 60 mm. As shown in the damage drawings in Figure 5, there were specific X cracks on the infill walls. And also, the crushing on the infill walls caused short column effect in the further loops.

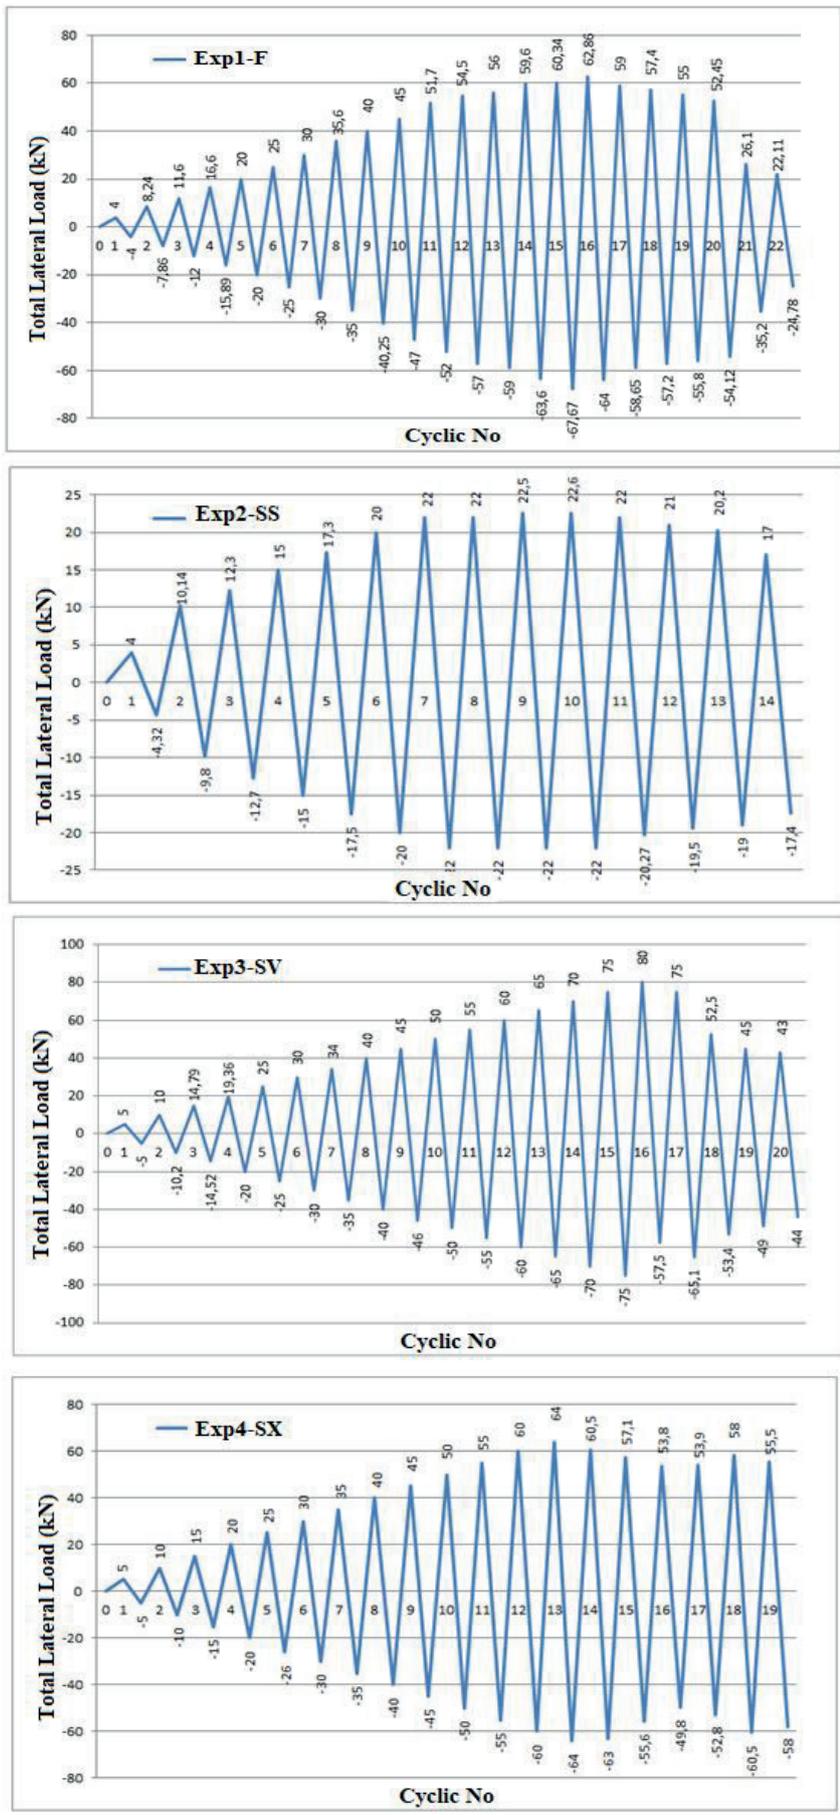
Fig. 4 Total Lateral Load - cyclic graphics of test specimens [12]

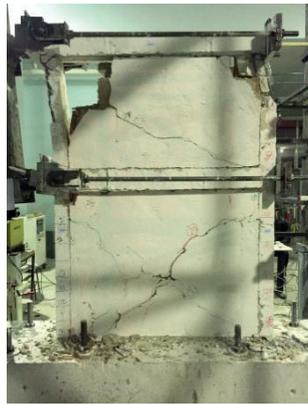
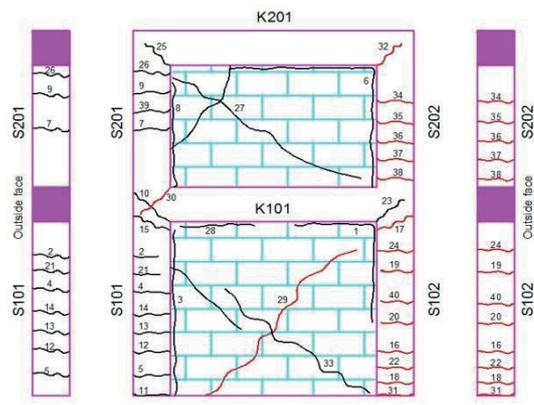
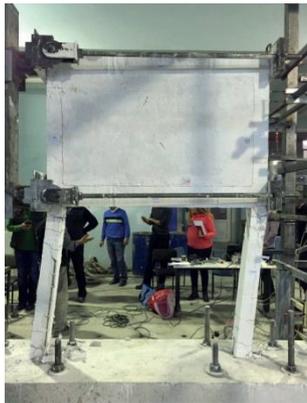
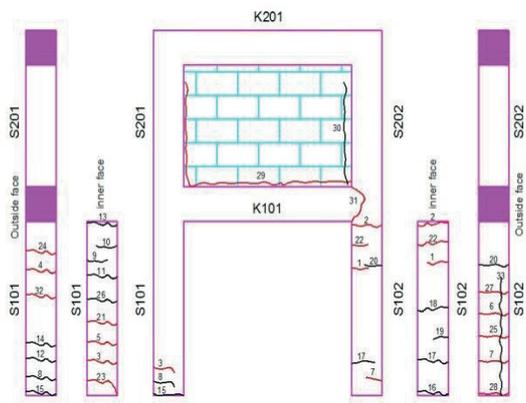
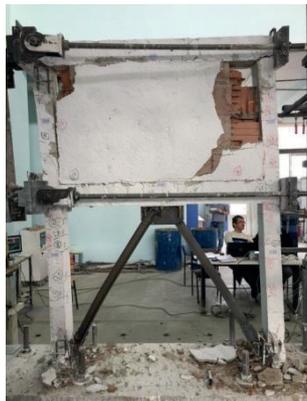
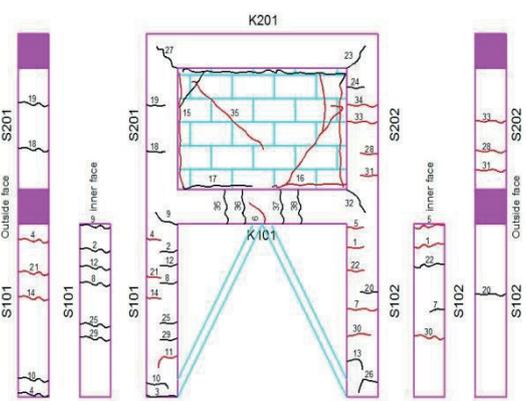
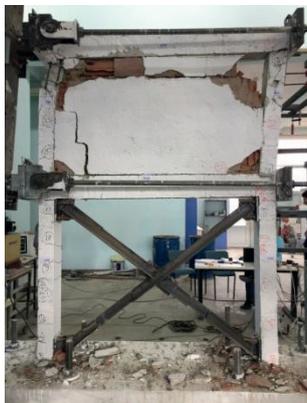
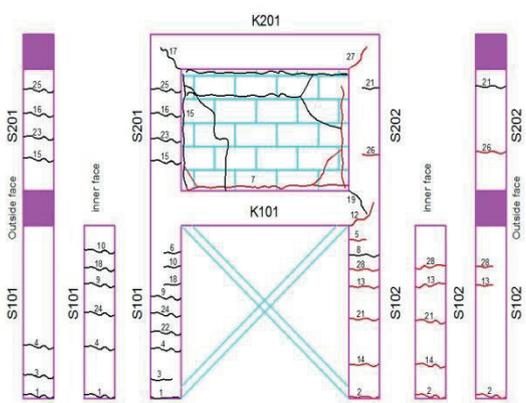
Fig. 5 (a) The view of the test specimens at the end of the tests (b) schematic representation of the cracks observed during testing [12]

While the maximum load value at Exp2-SS specimen was approximately 22.00 kN for positive loading, it was 17.00 kN at the end of the 14th cycle. And, the maximum load, which was -22.00 kN, for the negative loading was reduced to -17.40 kN. The maximum peak displacement was measured as 70 mm. Cracks and damages were completely concentrated on the lower floor due to the effect of soft storey formation. The specimen reached the capacity by the formation of plastic hinges at the ends of the lower columns whose deformation capacity were limited. The maximum lateral load was measured as 80.00 kN on the specimen Exp3-SV, which was strengthened by using diagonal steel elements in inverted V-shape on the ground floor. And the peak displacement value under this load was determined to be 27.80 mm. The maximum displacement value in the specimen was determined to be 60.00 mm and the lateral load at this displacement value was determined as 43.00 kN. Therefore, the load carrying capacity was reduced by 45% at the end of the test. When the displacement value got 60 mm on the specimen, the buckling of the steel profiles was observed. The total load at this displacement value was determined as 43.00 kN. It is observed that vertical cracks were occurred at the connection region in beam where the V cross was connected, based on peel at the anchors. (Figure 5.b. crack no: 35–39).

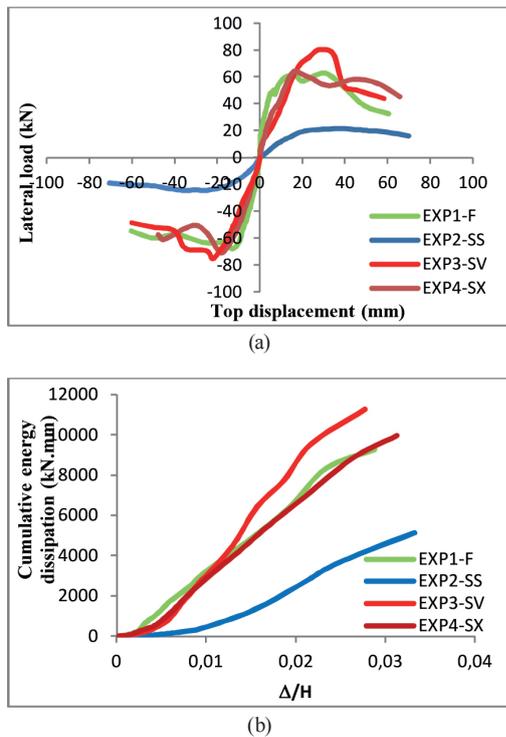
Fig. 6 (a) Comparison of lateral load–top displacement envelope curves (b) Comparison of energy dissipation characteristics of specimens

Comparisons of response envelope curves are shown in Figure 6.a. and comparisons of energy dissipation characteristics for specimens are shown in Figure 6.b. When we consider test results; soft storey frame's (EXP2-SS) strength was decreased %65 in positive cycles, and %68 in negative cycles in comparison with reference specimen (EXP1-F). EXP4-SX specimen was reached to %2 more maximum load in positive cycles, and %5 less maximum load in negative cycles in comparison with reference specimen (EXP1-F). So EXP4-SX and EXP1-F

specimens showed nearly the same behaviour in terms of lateral load capacity. Exp3-SV test specimens were reached to % 27 more maximum load in positive cycle, and % 11 more maximum loads in negative cycle in comparison with reference specimen (EXP1-F). As can be seen from the energy graphics which are given at Figure 6.b., EXP2-SS specimen was consumed %54 less energy than EXP1-F specimen at the last cycle. So soft storey formation was highly reduced energy dissipation capacity of frame. EXP3-SV, EXP4-SX specimens were consumed %22 and %8 more energy than EXP1-F specimen at the end of the test, respectively. Dissipated energy values were obtained by detecting the areas limited by load–displacement loop in each cycle with the help of test result data. For this purpose, the area under the load–displacement curve in the forward cycle was first calculated. Later the area under the load–displacement curve in the backward cycle is calculated and the total energy consumed for this cycle is calculated by summing these values. Then by

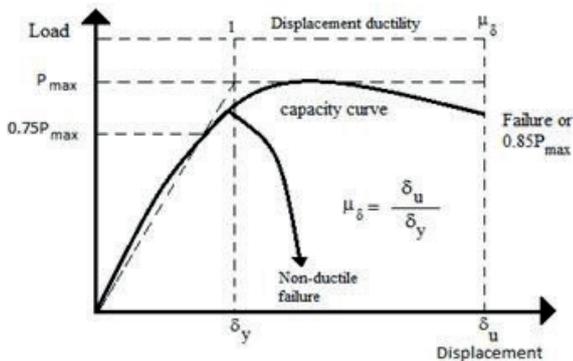
Fig. 7 A typical load–displacement relationship and definition of the displacement ductility for reinforced concrete structural elements [15]

Test results are summarized in Table 2. Table 2 presents load and displacement values of the test specimens in yield, maximum load and collapse modes and upper storey displacement rates and displacement ductility coefficients in these modes. Yield displacement is obtained by idealizing total load–top displacement envelope curve according to the two-line elasto–plastic behaviour model. Linear and nonlinear capacity curves overlap at the point which corresponds to 75% of the load-bearing capacity of the system [14,15]. The literature states that the value recorded at the moment when capacity reduction reaches 15% or 20% can be taken as the collapse displacement value [11,16–17]. In the present study, 15% capacity reduction was taken as the basis for the collapse displacement. A typical load–displacement relationship obtained in the scope of these definitions is given in Figure 7 [15].
