# Performance Evaluation of Circular Flange Bolted Connection in Ultra High Performance Fiber Reinforced Concrete Segmented Communication Tower

communication tower, ultra high performance fiber reinforced concrete, circular flange bolted connection, precast hollow tower, lateral shear capacity

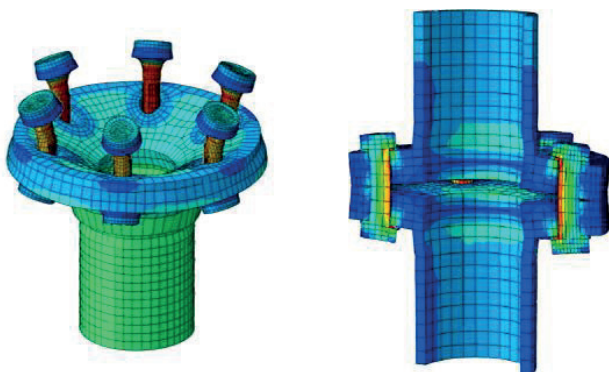
Fig. 1 Bending of bolts under tension of connection by Blachowski [7]

Observing the cross-sectional counter stresses of the prestressed connection of Blachowski and Gutkowski [7], it is noted that flanges were in contact along the outer borders. In the same vein, due to deformation on the flanges the inner borders became separated, a phenomenon described as prying effect. Several researchers have reported this effect among which include is Cao and Bell [8]. The same Blachowski and Gutkowski [7] and Cao and Bell [8] reported this prying effect in their study in which the relationship between the forces on the bolt and tensional force applied to the connection were examined. The differences exist only in numbers that resulting from the relationships flange diameters to their thickness.

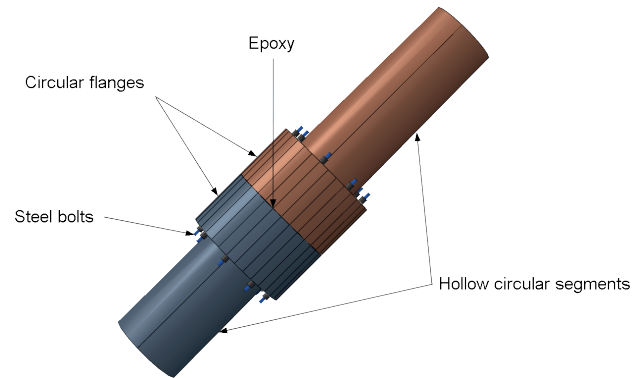
Fig. 2 UHPFRC circular flange bolted connection

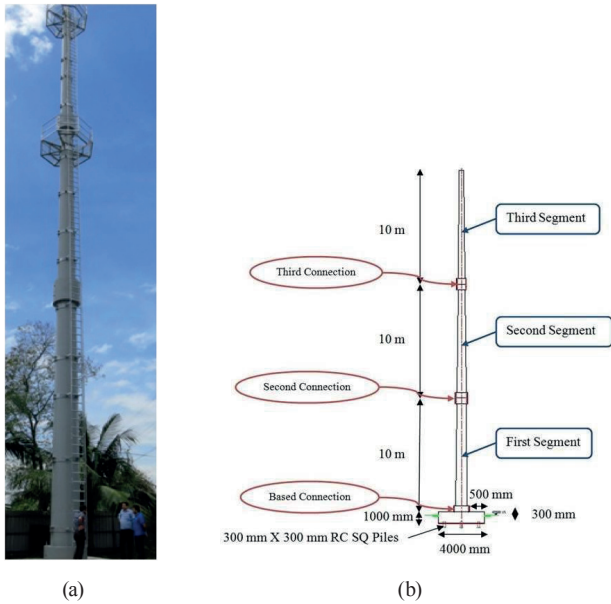
Fig. 3 The whole communication tower

In this study, CFBC joint for transmission tower of 30 m height was designed and constructed using UHPFRC material in Ipoh/Malaysia. The CFBC consists of two circular hollow flanges with sections of hollow tower segments connected to each other using steel bolts and epoxy resin, as shown in Fig. 2. The communication tower under consideration was segmented into three sections, with each segment 10 m high. Each segment was made from ultra high performance fiber reinforced concrete as shown in Fig. 3. The tower was connected to the foundation base of dimension  $4 \times 4 \times 1$  meters as length, width, and height respectively. The foundation was fixed to the ground using nine number of  $300 \times 300$  mm reinforced concrete embedded piles. The tower was pre-stressed with 8S15 strand cables of 230 kN pre-stressed force in each segment in addition to 8T16 steel reinforcement at both edges of each segment as shown in Fig. 4. The UHPFRC material was considered as the construction material for the communication tower due to its indubitable properties. CFBC in UHPFRC structure is termed as an interconnecting set of elements between the tower's sections.

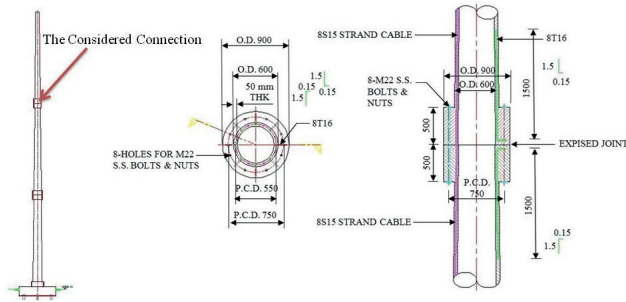
Fig. 4 The CFBC connection details

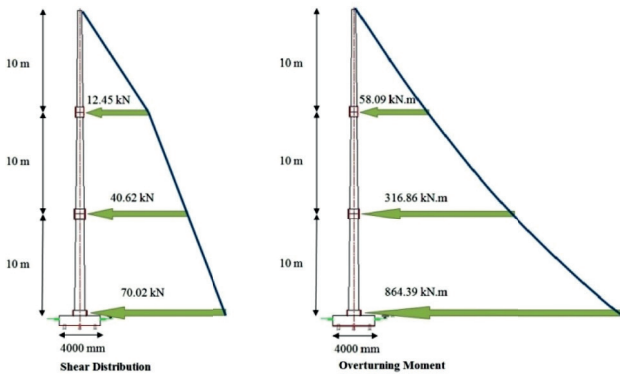
Fig. 5 Shear and moment distribution in the ultimate limit state

The designed seismic load was calculated using International Building Code IBC [31]. The design shear forces and overturning moments in the tower's connection for both the ultimate and serviceability limit states are given in Table 3. Besides, the distribution of the design shear forces and overturning moments on the tower is illustrated in Fig. 5 and Fig. 6 for the ultimate limit state and serviceability limit state, respectively.

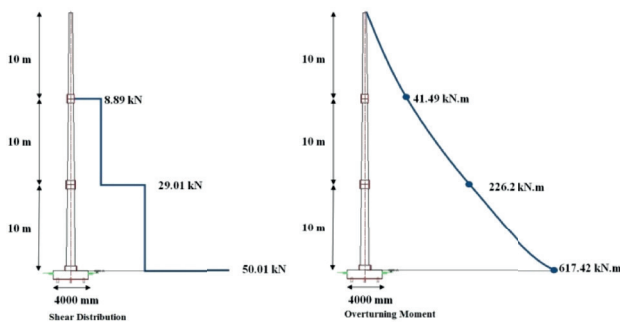
Fig. 6 Shear and moment distribution in the serviceability limit state

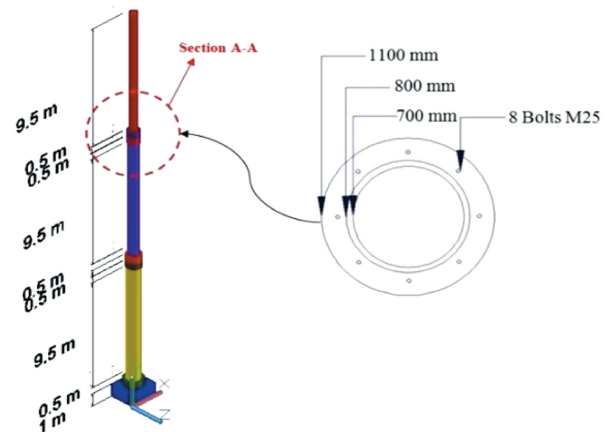
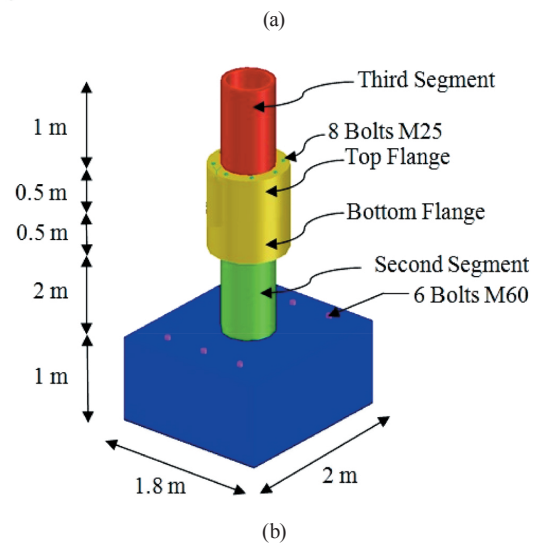
Fig. 7 The considered top connection for testing

The top CFBC joint of the communication tower was considered in this study to evaluate the maximum moment in the CFBC and the tower segment due to the applied lateral load. Also, the shear capacity in both connection and tower body are evaluated. The CFBC designed for the experimental test include two circular flanges, top and the bottom section of the second and third hollow segment tower, respectively as shown in Fig. 7 segment of the hollow tower with 2.5 m height and flange thickness of 0.5 m was cut from the top of the second hollow segment. Beside, a hollow tower segment with 1.5 m height and flange thickness of 0.5 m was cut from the bottom of the third hollow segment Fig. 8. Then, the two hollow tower segments were connected to each other using 8M25 bolts in their flanges. In addition, an epoxy material was used between the two surfaces of the flanges to improve the connection capacity.

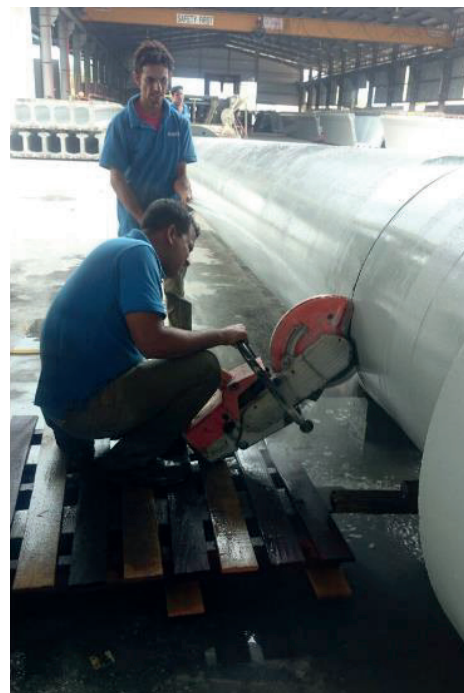
Fig. 8 Cutting the CFBC with segments sections from the real tower

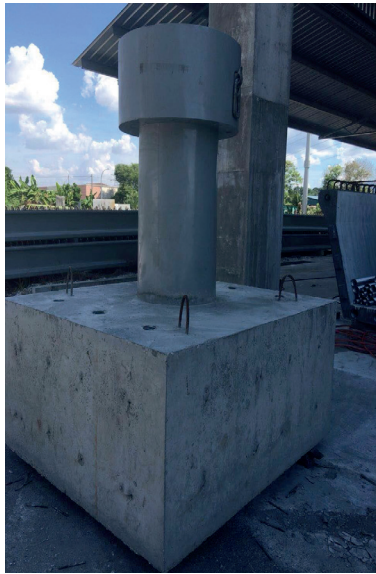
Fig. 9 The top section of the second segment and its connection cast to the foundation

In order to tie the specimen to the strong floor during the experimental test, the hollow segment (that has been cut from the second segment) has been grouted in UHPFRC foundation from its bottom as shown in Fig. 9. The UHPFRC foundation has been designed with 1.8 m width, 2 m length, 1 m height and has been tied to the strong floor by using 6M60 bolts.

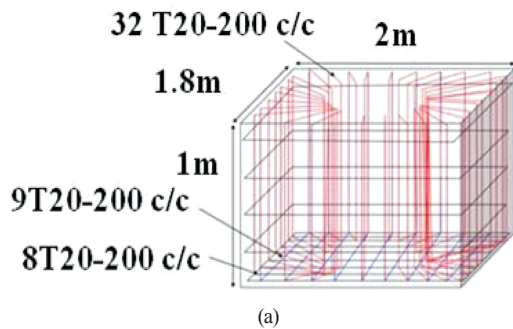
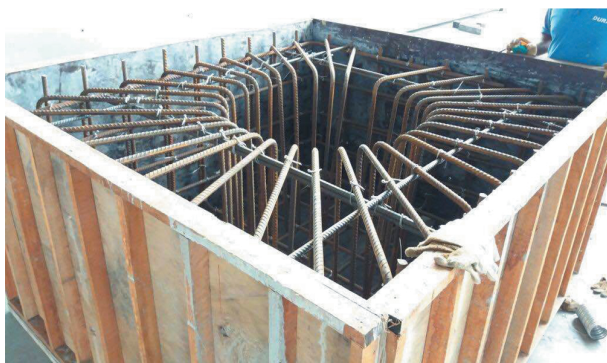
Fig. 10 Tower's foundation reinforcement details

In order to increase the strength of the tower foundation against the tensile stresses, 4T20-200 c/c of horizontal reinforcement was used to reinforce the foundation. Also, the foundation was reinforced vertically with U shape reinforcement 9T20-200 c/c along the long side and 8T20-200 c/c along the short side to increase the stability of the foundation against the horizontal shear forces. In addition, 32 vertical stirrups of T20-200 c/c were used to reinforce the whole foundation in all sides as shown in Fig. 10.

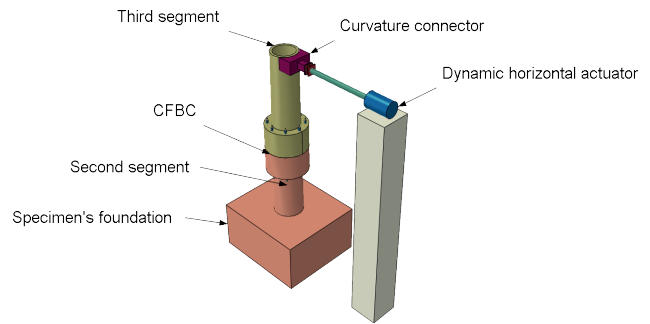
Fig. 11 The test setup of base connection

The experimental test was carried out on the connection section by applying cyclic displacement laterally with 0–150 mm amplitude on the top of the hollow segment representing cyclic load with a dynamic actuator of 300 kN capacity as shown in Fig. 11.

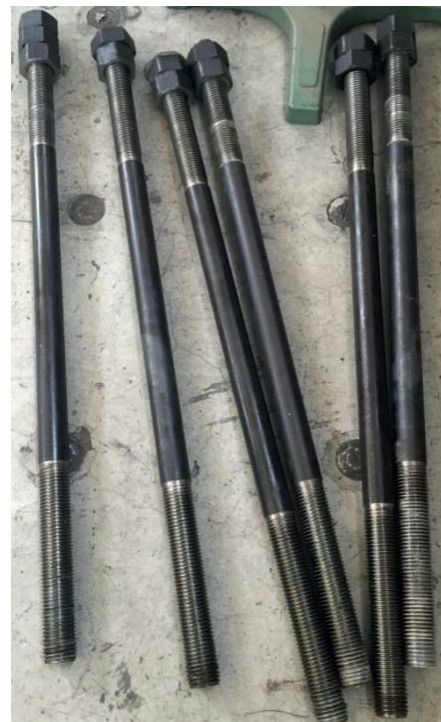
Fig. 12 The bolts used for fixing the foundation on the rigid floor of the lab

The experimental test setup was constructed by locating and tying the specimen to the rigid floor of the structural lab with the aid of bolts. Six M60 bolts of 1500 mm length were used to fix the specimen to the foundation (lab floor) as shown in Fig. 12. Before commencement of the test, the hydraulic pump pressure for dynamic actuator of 300 kN capacity was set at 20 MPa and time history data was applied through actuator as cyclic displacement at the top of the tower Fig. 13 segment in accordance with ATC [32] as shown in Fig. 14.

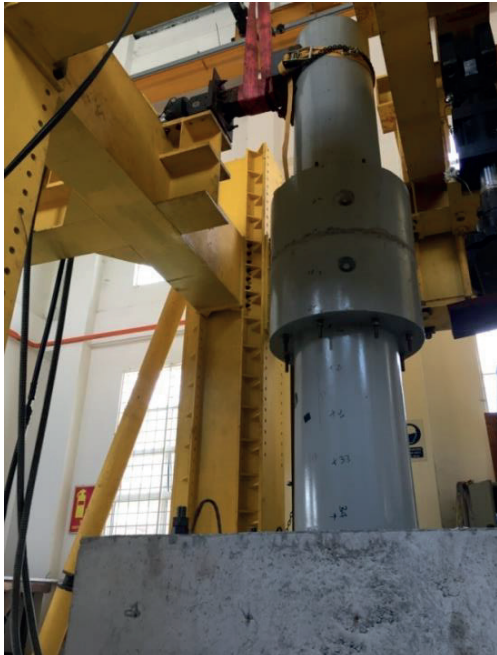
Fig. 13 Testing the top connection

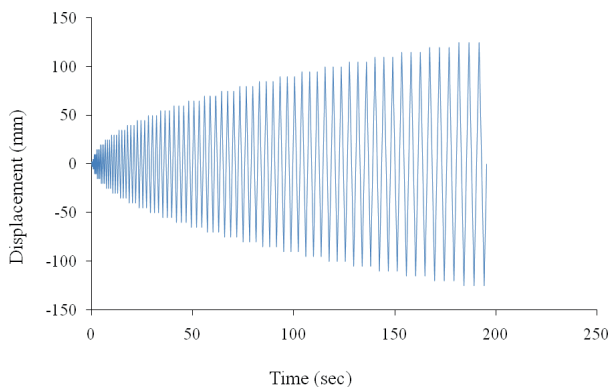
Fig. 14 Displacement time-history data [32]

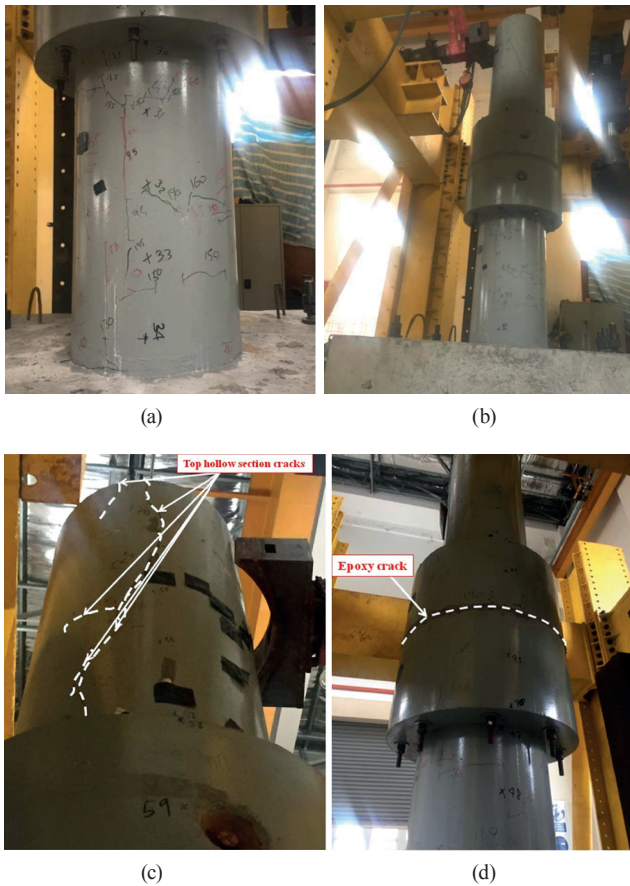
Fig. 15 The top connection after testing.

some sections of the tower subjected to lateral loading. Furthermore, it has been observed that at 98 kN some diagonal and vertical cracks were developed in both the bottom and the top segments along with few fine cracks in the flange of the top segment, as shown in Fig. 15(b) because of the occurring of shear and tension failure modes in the connection components. Moreover, diagonal cracks appeared at the force of 123 kN at the 35 mm applied displacement due to shear failure in the area of crack. When the applied displacement was 50 mm, a flexural crack was propagated horizontally in the hollow segment section at force of 151 kN.

Then few cracks were propagated vertically at the top hollow segment of the tower at the force of 170 kN with 65 mm applied displacement, as shown in Fig. 15(c) due to tension damage in the segment. In addition, the 72 mm displacement caused 180 kN force and some horizontal cracks in the bottom and the top segment as well due to flexural failure which means that the applied moment reaches the cracking moment ( $M_{cr}$ ) of the connection's segments. Finally, at 188 kN force some horizontal fine cracks have been occurred at the top and the bottom segments and also in the applied epoxy place, as shown in Fig. 15(d) due to flexural failure. The results showed that the UHPFRC didn't have reached the material yield limit. As a result, the integrity and stability of tower segment were not affected by the appearance of the cracks as it continued to resist the applied load. Furthermore, the tower showed high integrity and the structure was considered safe even with the pushed displacement of 125 mm. According to the experimental test, applied epoxy in the joint resisted up to 188 kN force. However, after increasing the load, the epoxy which was in contact with the surface to two segments were cracked. Meanwhile, the bolts in the joint were observed provided enough integrity for the connection in higher force. Furthermore, the bolts connecting the tower to the foundation were damaged at beginning of the test Fig. 16 as result of the shear forces and moments generated in the foundation and the lateral forces acting during the pushing and pulling processes but it didn't affect the test results. The bolt failure in the connection was due to the limited strength of the rigid floor. From calculated test, it could be concluded that the CFBC showed good performance during applied lateral forces to the UHPFRC tower. No permanent bending or deformation of the connection and tower segment were recorded after experimental connection tests had failed in conformity with the design.

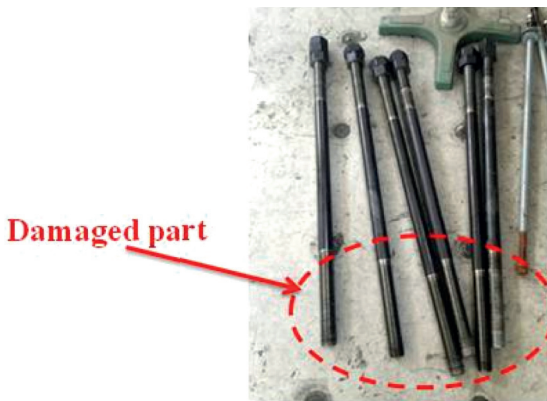
Fig. 16 Loosened bolts in the foundation

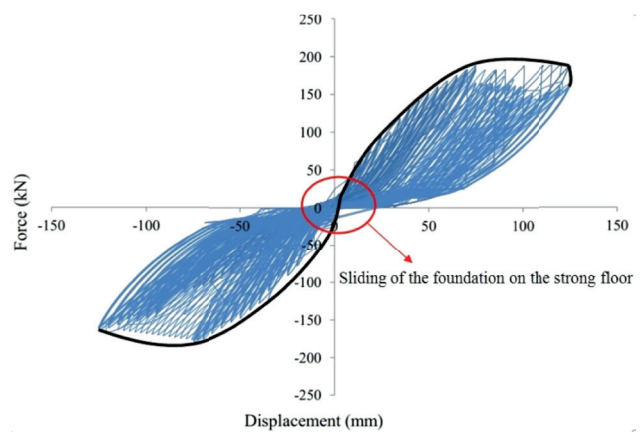
Fig. 17 Experimental cyclic test's result

The cyclic force–displacement curve obtained for the circular bolted connection under study is presented in Fig. 17. It is clear from the plot that specimen displayed mostly stable hysteretic behavior with gradual transition between elastic and inelastic responses. As shown in Fig. 17 that changes in reloading branch is accompanied with increment in displacement level, having to attain the same point at which the former cycle unloaded. However, irrespective of the displacement level the unloading branches were mostly

parallel to each other. Results of the hysteresis loop revealed that the maximum crack force at the connection reached to 188 kN with maximum displacement of 125 mm. The hysteresis loop of the specimen was quite stationary showing excellent energy dissipation. The loosening of the connection between the specimen and the actuator connector after few cycles caused small resistant forces at the beginning of the test. In addition, the loosened connection between the specimen and the rigid floor caused the specimen slide laterally during the test because of the limit capacity of the rigid floor. This led to flattening of the hysteresis loops during the load reversal due to the reduction in specimen fixing.

According to the backbone curve, the influence of construction details on ultimate lateral strength, initial stiffness, deformation capacity as well as secant stiffness could be seen. Then, the specimen began to exhibit strength loss due to bolt loosening between the specimen and the floor. The specimen behaved linear until cracks began to develop at the epoxy between the flanges resulting to softening in the lateral stiffness.

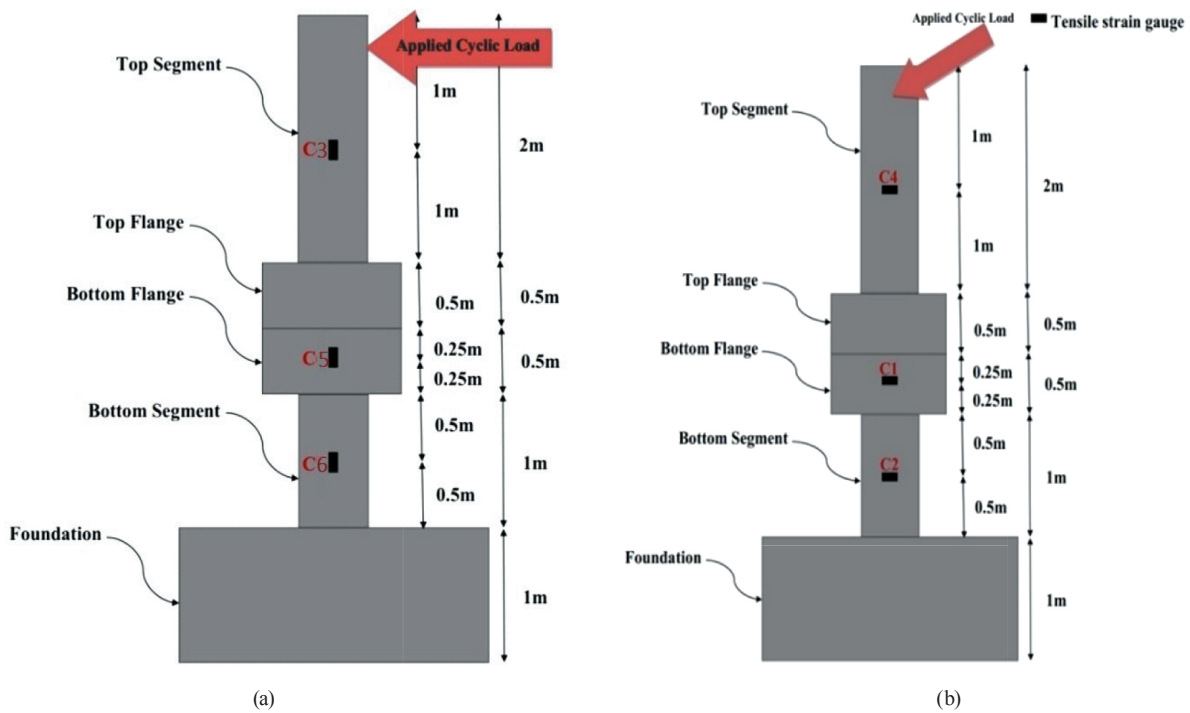
**Fig. 18** Location of strain gauges at the RC models for the side face (Tension strain gauges) and the forcing face (Shear strain gauge)

Fig. 18 shows positions of strain gauges on the concrete surface. Six concrete strain gauges were attached to the smooth concrete surface with the aid of standard rapid adhesive. Three strain gauges designated as C3, C5 and C6 were placed vertically at the specimen side in order to measure the tension strain in the connection and the hollow tower. At the load application direction, three strain gauges C4, C1 and C2 were placed horizontally at the specimen for shear strain measurement in the connection and tower.

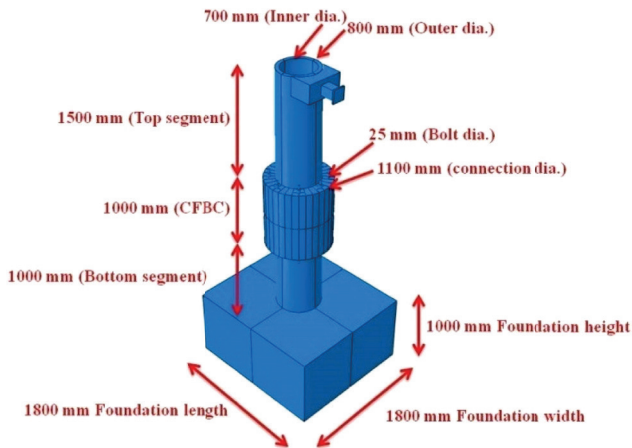
Fig. 20 Top connection in the ABAQUS (with details)

In order to verify the experimental results, FEM was used for the numerical modelling and analysis of the considered specimen. The numerical simulated model of the CFBC was developed in accordance with the dimensions of the real model as shown in Fig. 20. The CFBC model includes the top 1000 mm of the second segmental tower connected with the first 1500 mm of the third segmental tower by using two 500 mm thickness flanges (cast together with the hollow segments) with 8M25 steel bolts and epoxy resin. A prestressed tendon of grade 270 eight wire strands ( $270 \text{ ksi} = 1861 \text{ MPa}$ ;  $E = 196.5 \text{ GPa}$ ; and area of  $1600 \text{ mm}^2$ ) was placed at the circumference of the hollow section of the tower.

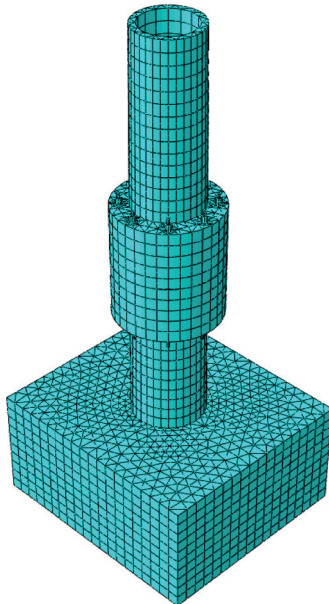
Fig. 21 Meshed FE model of the CFBC

The proposed models were meshed with the aid of assigned mesh tool with controlled element size to capture the stress distribution over the process of loading. In the current study, the connection was modelled using reduced-integration 20-noded plain stress elements (C3D20R). The UHPFRC connection and the steel wires section were meshed using element size 15 mm 100 mm respectively. The meshed model of the cycling test is shown in Fig. 21. Considering the shape complexity of cylindrical model elements, sweep mesh was used for circular shape elements.

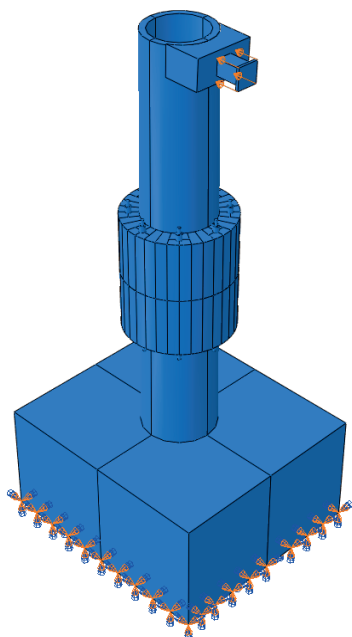
Fig. 22 The top connection with 125 mm amplitude displacement

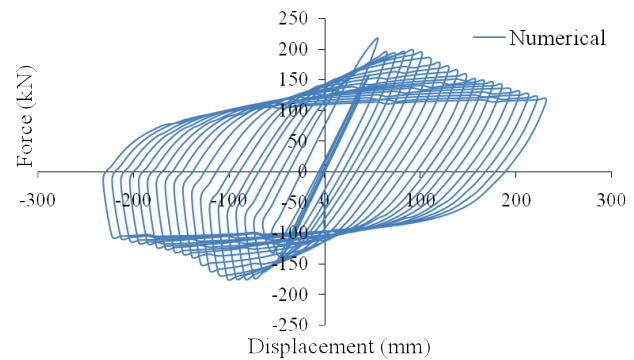
Fig. 23 Numerical force-displacement results

After conducting the analysis using FE software, the CFBC joint in the UHPFRC tower showed very high strength capacity. The high shear capacity of the connection was due to the high strength of UHPFRC material reinforced with high-tensile steel fibers in the CFBC joint. Analysis results of FE showed that the UHPFRC connection with a total height of 4.5 m can resist forces up to 216.6 kN and displacement of 231.3 mm as showed in Fig. 23.

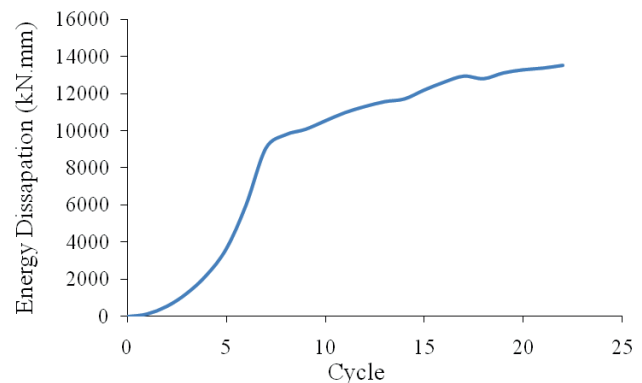
Fig. 24 Energy dissipation curve

High energy dissipation is a desirable property whenever a structure is subjected to a severe seismic event. The amount of energy dissipated per cycle is equal to the area within the lateral load versus displacement hysteresis curve of this cycle. Fig. 24 shows a plot of cumulative energy

dissipated versus cycle number. It indicates that the UHPFRC circular connection specimen dissipated highest amount of hysteretic energy due to the existence of the steel bolts, high strength of the UHPFRC and the design method. The amount of energy dissipation that the UHPFRC circular bolted flange offers gives reason to explore more viable and reliable connections in order to maximize the potential of a CFBC. It is therefore apparent from this and other research that the concept of CFBC is one which should be explored more rigorously. According to the results, UHPFRC circular bolted connection show more ductile failure patterns which allowed large energy dissipation thus resulting to slower crack speed under slow loading rates. In the current study the maximum energy dissipation of UHPFRC circular bolted connection is 107 kN.m according to Eq. (1) [34] as shown in Fig. 24.

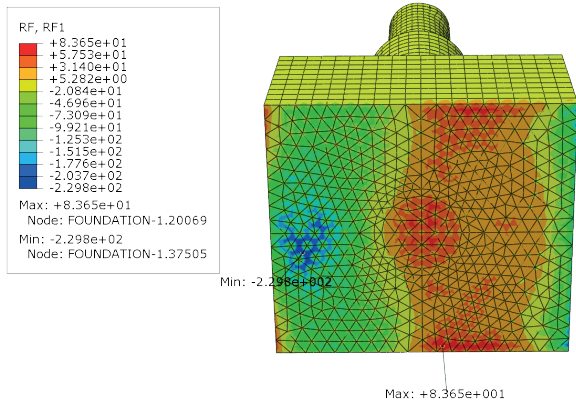
Fig. 27 Generated reaction forces in the UHPFRC connection in the horizontal direction

Fig. 27 shows the maximum reacted forces generated in the bottom surface of the specimen's foundation because of the specimen considered fixed in the foundation bottom surface. Since the massive weight of the specimen and the applied lateral displacement by using a 300 kN dynamic actuator, the maximum reaction forces at the fixed surface reached only 300 N.

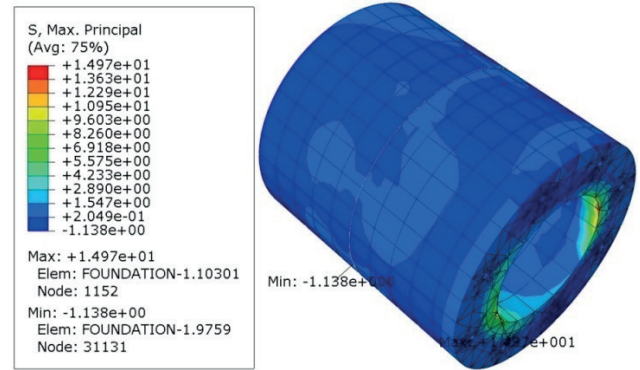
Fig. 29 Maximum stresses in the circular flange

It is worthy of note, that bending of bolts could result in a tremendous influence on structural well-being. The bending effect is largely dependent on flange thickness. The stresses due to bending are larger in the case of smaller thickness. In Blachowski and Gutkowski's case [7] the magnitude of the stresses for flange thickness of 15 mm was above yield limit. However, the analysis results of the current study showed that there is no prying effect in the connection's flange and there is no bending in the bolts. This is due to the flange thickness which is higher than the flange thickness in the previous studies [7, 8] the absence of the bolt pre-tensioning force, and using UHPFRC material for constructing the connection instead of steel material. In the present paper the magnitude of the maximum stresses for flange thickness of 500 mm was below yield limit as shown in Fig. 29.

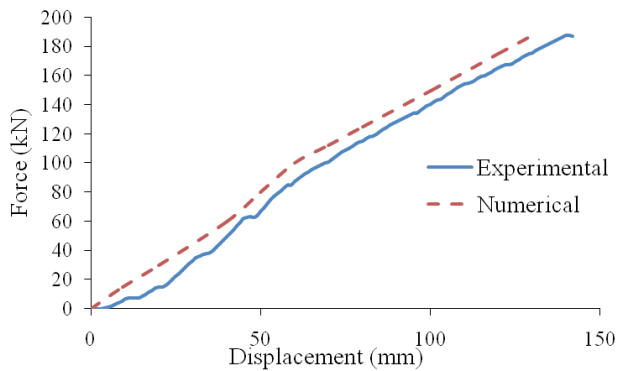
**Fig. 30** The difference between the experimental results and the numerical results

The developed finite element model for the cyclic simulation test was calibrated with reference experimental test results conducted in the current study. The lateral load versus lateral displacement curve obtained from the experimental test and the finite element simulation were compared in Fig. 30. The ultimate loads ( $P_{FEA}$ ), and the displacement ( $\delta_{FEA}$ ) predicted from the FE simulation were compared with experimental data as illustrated in Table 6. The simulation results were found to be in good agreement with experimental test results. The maximum percentage of difference between the experimental and the FE simulation results for the ultimate loads is 15.3 % while the difference in the maximum displacement is 73.14 %. The ultimate loads and displacement generated from the numerical simulations are very close to those recorded from cycling experimental test. However, the behavior of the model in the experimental test in terms of deformation, cracks and crushes were close to that obtained in the numerical analysis as shown in Fig. 31.

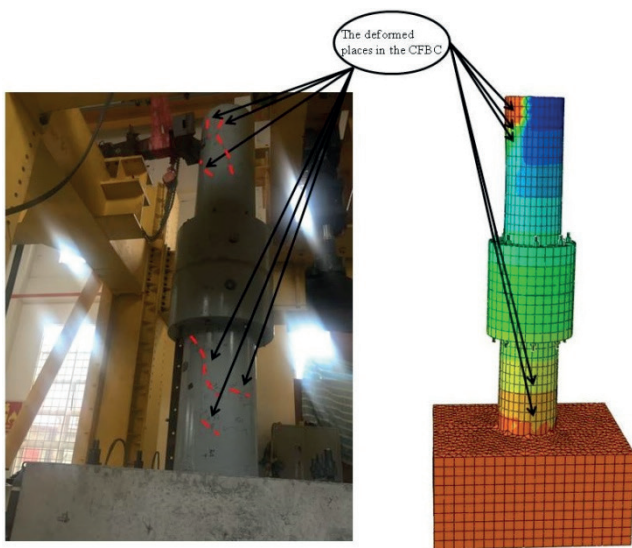
**Fig. 31** The connection behavior in both experimental and numerical analysis
