Characterization of Historic Binders and Stones of a Ruined Medieval Church (Hungary)

Zsuzsanna Kósa¹, Ákos Török^{1*}

¹ Department of Engineering Geology and Geotechnics, Faculty of Civil Engineering, Budapest University of Technology and Economics, H-1111 Budapest, Műegyetem rkp. 3., Hungary

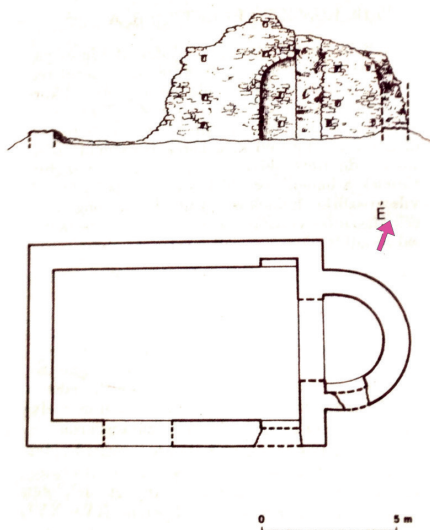
Fig. 2 The ground plan and longitudinal section periodization in [10]

structure can be observed in the old church of Tök, too. The structure has a simple ground plan. The church is positioned symmetrically along the longitudinal axis, oriented to the east. At the east, the end of the nave is connected a round apse directly with higher floor level (Fig. 2).

Remaining parts of altars were installed into the north and south side-walls. The internal size of the nave is about 9.5 m long and 6.1 m wide and the semi-circular apse has about 2.3 m times 3.3 m dimension. The rectangular parts of the ruin have a length of 14 m and a width of 8.5 m.

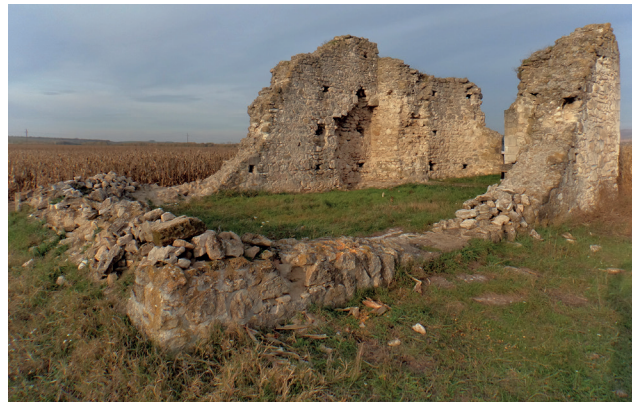
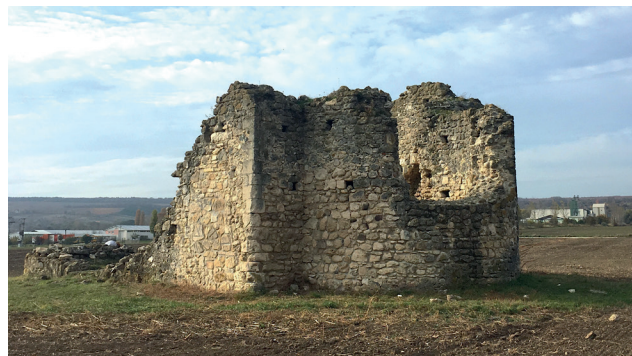
The masonry of the church now shows signs of weathering and significant parts are missing (Fig. 3). Opposite to the sanctuary, the west oriented section of the walls is toppled almost down to the foundation. The other three sections are in better condition.

Although the western side of northern and the southern walls are almost levelled to the ground, the east-bound of these walls are higher and more robust, due to the reconstruction during 2000. The arch wall of the sanctuary was partly restored, and the southern wall inner part was also restored partly with a newly constructed altar according to the archaeological exploration. This did not hamper the the further deterioration of the walls, which still continues.

Fig. 3 The current condition of the ruined temple of Tök. (a) View from South showing the southern part of the apse. (b) View from Southwest

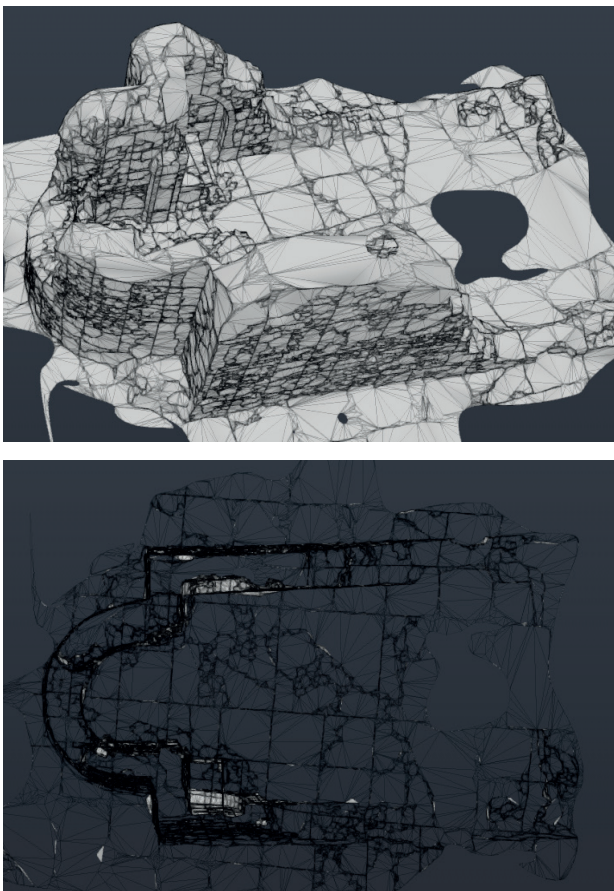
Images were taken from the ruin to create a 3D photo-realistic model. The digital images were processed using AutoCAD Recap Photo software. The software allowed to create a model of the ruin that displays the details. After taking more than 200 site photos, the software creates textures and generates the model of the entire structure to represent the current conditions (Fig. 4).

Fig. 4 The 3D geometric models of the ruin made with AutoCAD Recap Photo software based on 200 images

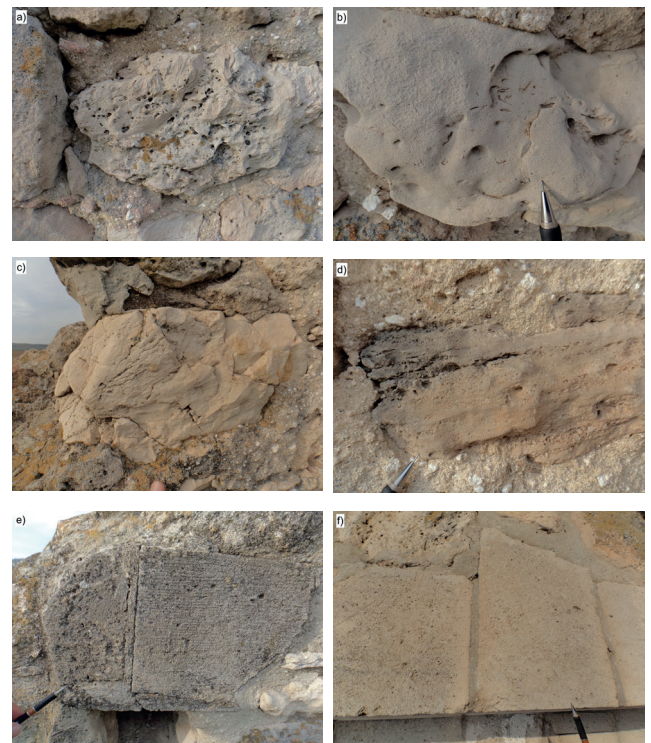
The limestones show great variety in their textural characteristics and porosity. The identified lithotypes are: i) coarse-grained, ii) fine-grained, iii) medium-grained and shelly, iv) cemented, v) oolitic and vi) cross-layered,

limestone (Fig. 5). Some of these lithotypes are found at Sósút area, and the oolitic variety is also the main construction material of Budapest [13]. Furthermore, in limited numbers, sandstone elements and sandy limestones were also discovered in the masonry. Variations in the characteristics of sedimentary rocks such as porosity, layering, the mineralogical composition can lead to differences in physical properties. These differences are evident when the differences in weathering forms and scales of weathering of masonry components are considered.

Fig. 5 Limestone masonry elements: (a) cemented macro-porous limestone; (b) sandy limestone; (c) highly cemented and cross layered limestone; (d) sandstone; (e) porous oolitic limestones (former replacement stone); (f) porous limestone (new replacement stone)

The values of the Schmidt hammer test helped in distinguishing the different lithotypes by surface hardness. The highest rebound values characterized the slightly cracked surfaced Triassic limestone (see Fig. 5(c)) and the second highest rebound values were detected on limestones with high sand content (Fig. 11). Low values characterize most types of porous limestones and porous new replacement limestones (see Fig 5(e-f)). The replacement stones generally have the lowest rebound values (Fig. 11).

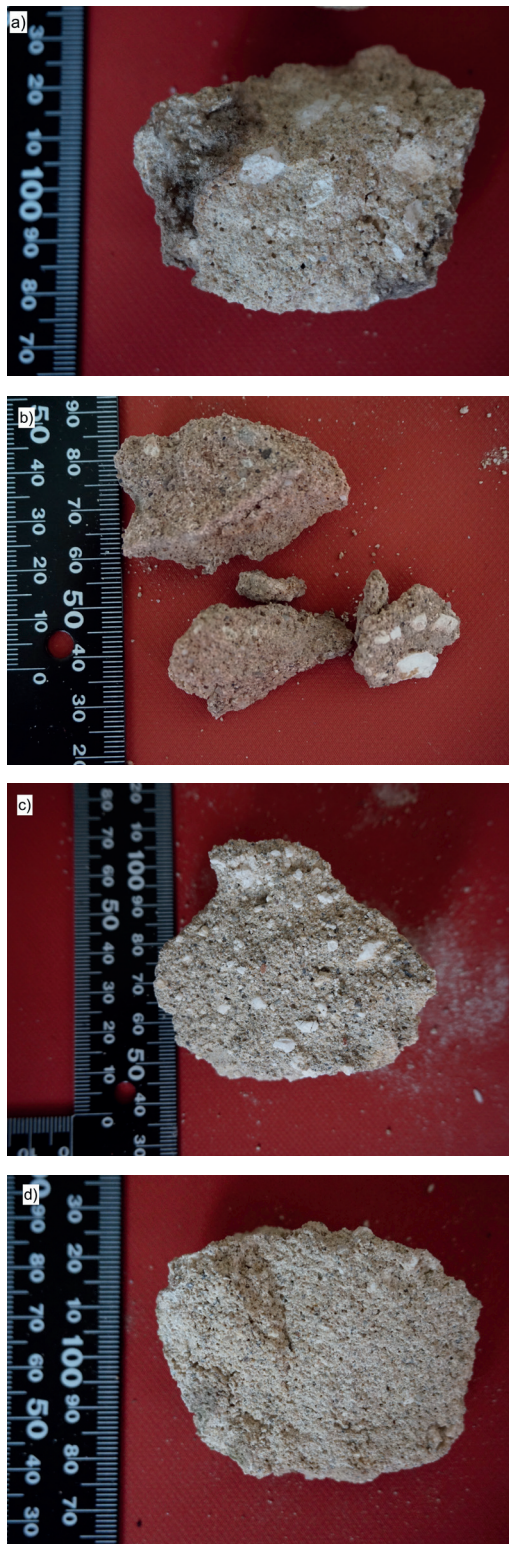
Visual inspection of historic mortars provides valuable information on their composition and origin. Tool marks, additives, as well as larger aggregate particles and type of binder, are often visible [14]. Two types of binder material were identified that were used for several types of mortars. Non-hydraulic lime binders – with a significant amount of non-hydrated white lime grains – were identified. These mortars contain different sizes of lime and sand grains, representing wide ranges and other additives. Additives of mortars are also visible in some samples; such as light pink stain and in other samples, black coloured fine sand-sized grains and brick scraps (Fig. 6 and Table 1). These types of mortars are the most common ones in the historic

Fig. 6 Original medieval mortar samples: (a) 1-02 sample of yellowish lime with large sand particles and remains of lime and dolomite grains; (b) 6-02 sample is a pink coloured mortar with crushed red bricks and remains of large lime and dolomite practices; (c) 7-02 sample yellow lime mortar with large sand particles and higher lime and dolomite grain content than sample 1-02; (d) 13-01 sample: yellow lime mortar with evident sand particles, and more homogenous composition

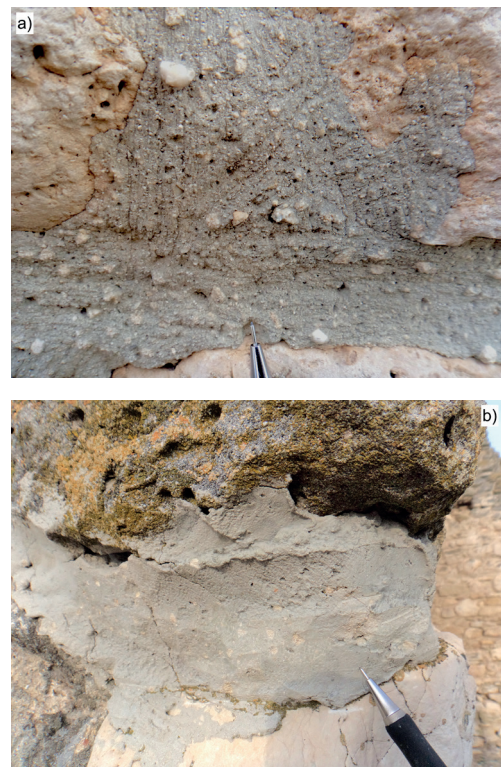
The latest (modern) mortars were used less extensively at the ruins. This grey newly applied renders are very distinct from historic lime mortars, because of the presence of high Portland cement content. The Portland cement gives light to dark grey colour to these renders. The grey cementitious mortars are less porous than the lime mortars (Fig. 7).

Fig 7 Examples of modern binders: (a) PC-1: Dark grey binder containing high amount of Portland cement, with white lime grains and black sand grains; (b) PC-2: Light grey plaster containing high amount of Portland cement, with very fine grinded sand

This is due to the fact that cement-based binder was used as repair mortar in the time of reconstruction, in 2000. At this time, the ruin was excavated and parts of the walls were restored.

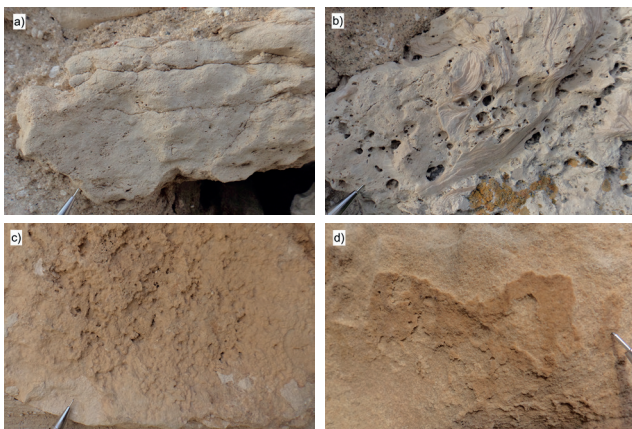
The most common weathering forms are selective dissolution that is observed at limestone ashlar (Fig. 8(a-b)). Weathering crust formation is common not only on limestone but also on fine-grained sandstone masonry elements. The multiple flaking of these crusts is a common decay form (Fig. 8. (c-d)).

Fig. 8 Weathering forms at the inner parts of the ruin: (a) and (b) selective dissolution; (c) and (d) multiple flaking on sandstone surface

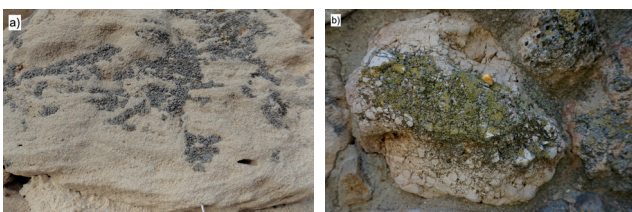
Biological weathering appears on all lithotypes. Light grey lichens and green lichens with the colonisation of green algae are also common (Fig. 9). The latter ones mainly occur on wet zones of the ruin.

Fig. 9 Biological weathering forms: lichens colonized the stone surfaces: (a) grey lichens on limestone (b) dolomite-breccia with light green lichen layer

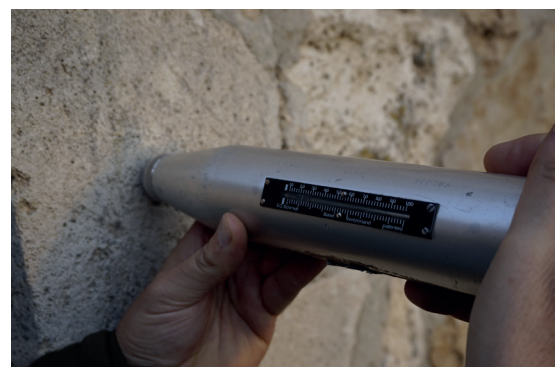
Schmidt hammer was used to test the surface strength of stone. The readings of the rebound values can be converted to compressive strengths or other parameters [17]. At the ruin of Tök an N-34 type of Schmidt hammer has been applied on each lithotypes of stone elements of the masonry (Fig. 10). At each tested element, at least ten tests were made and the mean values and standard deviations of the readings were calculated. The different types of stone surfaces, at where tests were made, are shown in Fig. 5.

Fig. 10 Surface testing with Schmidt hammer

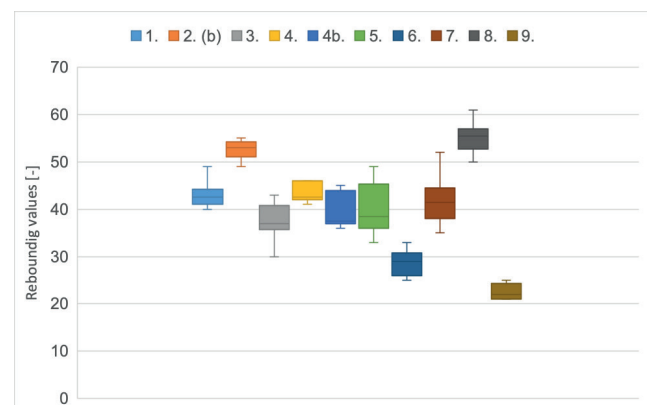
Fig. 11 Schmidt hammer rebound values on different lithotypes: 1. highly cemented limestone; 2.b porous limestone with fine sand; 3. porous sandy limestone with shells; 4. sandstone; 4.b coarse sandstone; 5. porous limestone with small pebbles and shells; 6. ooidal limestone; 7. cross-layered porous limestone; 8. Triassic, cross-layered limestone; 9. ooidal limestone (replacement blocks)

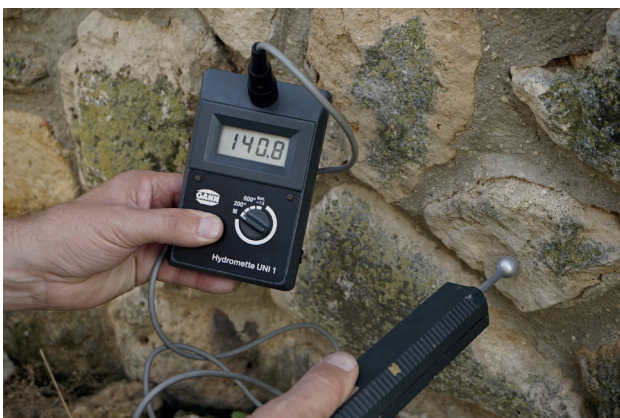
The moisture content of masonry materials is an important factor that influences the long-term behaviour of stones and binders [18, 19]. To analyse the relative moisture content of construction materials (stones and mortars), a Gann-Hydromette Uni, a portable moisture content testing device was used (Fig. 12). This portable device does not provide absolute values (percentage) of moisture content, but the obtained numerical values can be used in comparison with other measuring points. A profile of relative moisture content also provides information on the differences between materials. The relative moisture content of stone elements and binders have been measured on four sections of the walls, and more than 100 points were recorded at each section.

Fig. 12 Estimation of the structural moisture content with Gann-Hydromette Uni device

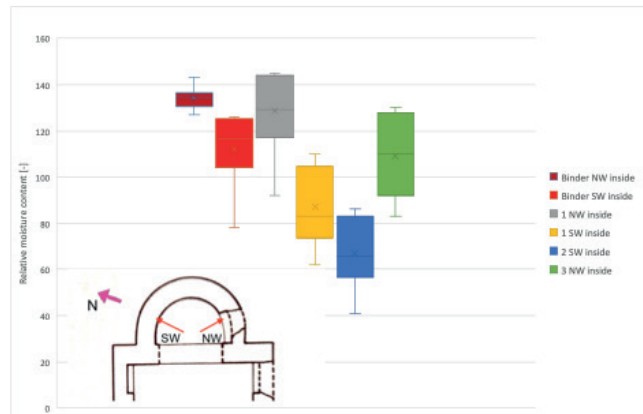
The average values of relative moisture content were high both at the external (Fig. 13) and at the internal side (Fig. 14) of the sanctuary.

The scatter of the moisture content is much higher at the internal part of the sanctuary (Fig. 13) than at the external part (Fig. 14). Micro-climatic conditions control these differences, namely exposure to wind or rain influences moisture content. In previous studies, it has been demonstrated that moisture content influences the behaviour of stone and render [19]. The pore structure also influences the water absorption and thus the frost resistance of the stone [20]. The differences in the porosity of stone and mortar, the compatibility [5] might lead to differential weathering and loss of stone material. The different moisture content

Fig. 13 The relative moisture content of different lithotypes and binders at the internal side of the sanctuary: binder highly cemented limestone (1); 2.b and porous limestone with fine-grained sand (2) and porous sandy limestone with shells (3)

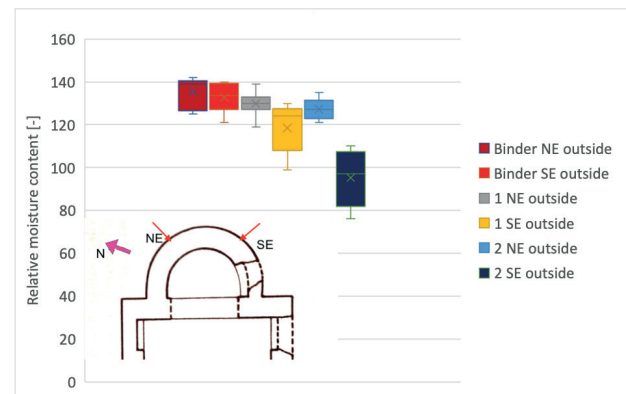
Fig. 14 The relative moisture content of different lithotypes and binders at the external side of the sanctuary: binder; highly cemented limestone (1); porous limestone with fine-grained sand (2)

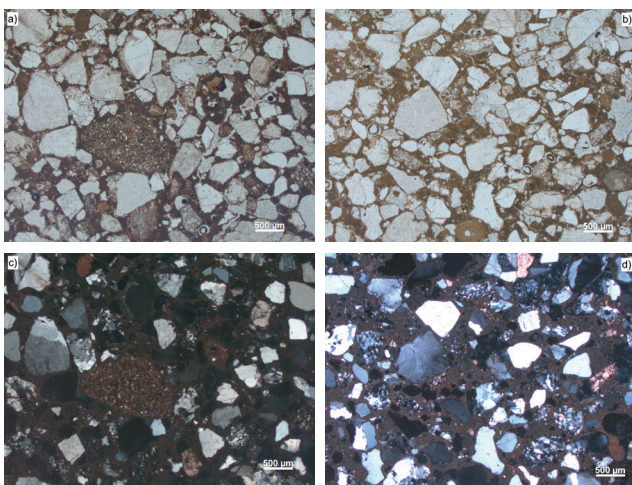
As it is visible under the microscope, the historic mortar is composed of small angular quartz grains and larger sand-sized lithic clast (Fig. 15). The binder of this mortar is lime. There are calcareous lumps that mark the improper preparation technique (Fig. 16) [23].

Fig. 15 (a-b) Thin section images of lime binders from investigation point 6-02-A. Coarse grains as aggregate particles appear white and the matrix appears dark red, (c-d) same thin section images but seen under crossed-polarized light, showing quartz sand (grey/white), and basalt fine aggregate particles and carbonated nonhydraulic lime binder (brown)

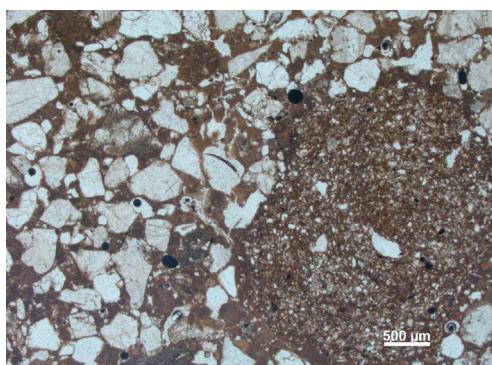
Fig. 16 Thin section image of lime binders from (sample 1-02). Coarse grains as aggregate particles appear white and the matrix appears dark

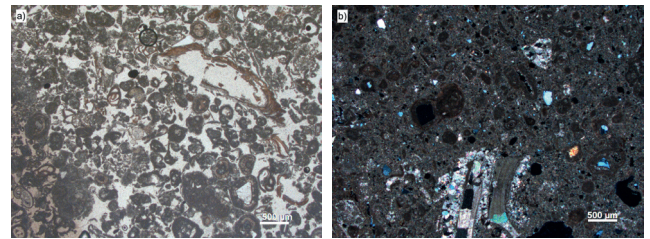
The microscopic analyses indicated that the micro-fabric of mortars are different from the porous limestone. In the latter one carbonate grains prevail (mostly ooids see Fig. 17), while in medieval lime-based mortars quartz grains dominate. These differences can also contribute to the differences in durability [1, 5].

The microscopic characters of the limestone lithotypes are also very different. In the oolitic limestone intergranular pores are common. While at bioclastic limestone

Fig. 17 Microscopic images of (a) ooidal limestone that contains larger bioclasts and (b) a shelly oolitic limestone with coated quartz grains

the intraparticle and mouldic pores are also present. The smaller pores are more prone to frost damage and this lithotypes might have lower strength [24]. It has been outlined that the porosity and pore structure of limestone are good indicators of their durability [20, 25]. The oolitic limestone lithotype is prone to freeze-thaw damage and also to thermal degradation [26].
