Mechanical Behavior of Soil Foundations Reinforced with Geosynthetics Exposed to Normal and Reverse Fault Ruptures

Nabiollah Ahmadi¹, Meysam Fadaee^{1*}

Received: 19 May 2022, Accepted: 19 September 2022, Published online: 08 November 2022

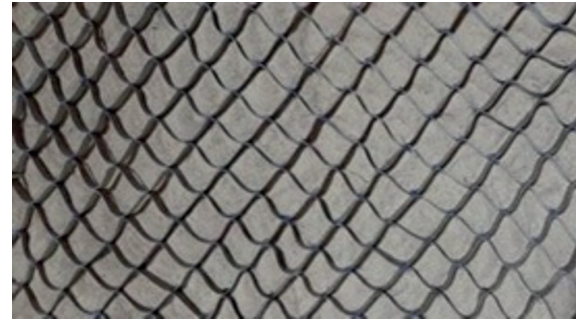
Fig. 3 Sample geocell used in laboratory model

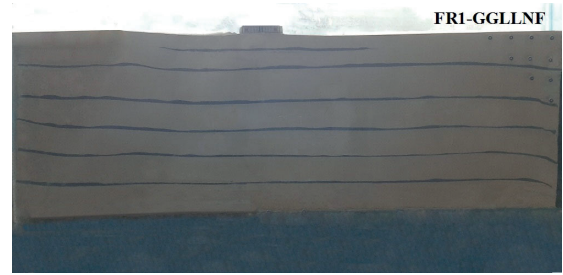
Fig. 15 Images from foundation reinforced with one geocell-geogrid layer at different offsets: (a) $h = 0$ cm; (b) $h = 2$ cm; (c) $h = 4$ cm; (d) $h = 6$ cm

In this test, one layer in which the geocell was positioned under the geogrid was used for reinforcement. The aim of combining these two layers was to obtain greater stiffness and tension resistance. This layer was located at a depth of $2B/3$ beneath the footing.

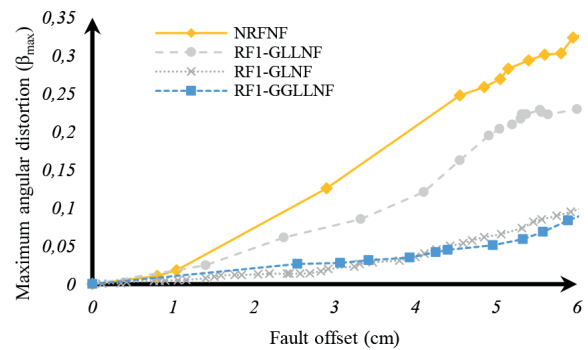
Fig. 20 Fault offset and maximum angular distortion for foundations reinforced with one geogrid layer, one geocell layer and one geogrid-geocell layer under normal faulting

Fig. 20 shows the quantitative decrease in angular distortion in the soil foundations reinforced with one geogrid layer, one geocell layer and one geocell-geogrid layer compared with that of the unreinforced soil foundation for a normal fault rupture. The results indicate that the minimum value of β_{\max} occurred in the soil foundation

reinforced with one geocell-geogrid layer; however, the maximum value of β_{max} was for soil foundation reinforced with one geocell layer. The acceptable behavior of soil foundation reinforced with geogrid layer against normal faulting related to the high tensile strength of the geogrid.

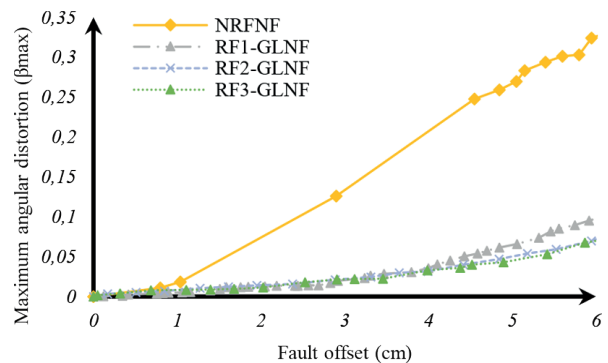
Fig. 22 Fault offset and maximum angular distortion for foundations reinforced with one, two, and three geogrid layers

Fig. 22 shows the quantitative decreases in angular distortion for the soil foundations reinforced by one, two and three geogrid layers compared to the performance of the

unreinforced soil foundation for reverse fault rupture. The smaller β_{max} values occurred because the acceptable tensile strength of one geogrid layer increased with the use of two or three layers.
