# Experimental Analysis of Out-of-plane Behavior of Masonry Infill Walls Strengthened with Textile Reinforced Mortar and Wall Post in Autoclaved Aerated Concrete Frames

An experimental study was carried out to contribute to the rather limited data on the out-of-plane (OOP) behavior of masonry infills in reinforced concrete (RC) frames strengthened with the wall post and the textile-reinforced mortar (TRM). For this purpose, one unreinforced specimen served as the control, one specimen was reinforced with the wall post, and two specimens were reinforced with the TRM. They were fabricated and subjected to cyclic OOP loading until a drift ratio of 6%. Load and displacement values were recorded, and the research team discussed the failure mechanisms of the specimens. Results showed that the application of the wall post had the highest efficiency as it increased the load by about 3 times, while this value for TRM-strengthened walls was only 1.5. Strengthening modified the cracking, shifting it towards the middle parts of the wall, changing it from a brittle to a failure mode. Comparison of the envelope curves of specimens revealed significant improvements. The ultimate displacement and

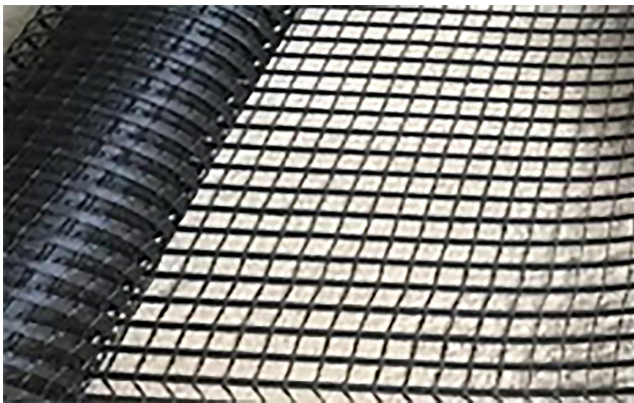
Fig. 1 The geogrid used in the current study

The geogrid utilized in the present investigation is presented in Fig. 1. It had a width of 550 mm, while its longitudinal and transverse ribs had lengths of 25 mm and 35 mm, respectively. The maximum strain was determined to be 0.12. The tensile test results shown in Fig. 2 indicate that the geogrid could withstand loads of 5.5 kN and 2 kN in the transverse and longitudinal directions, respectively.

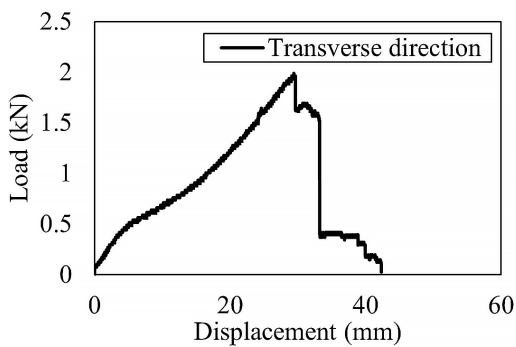
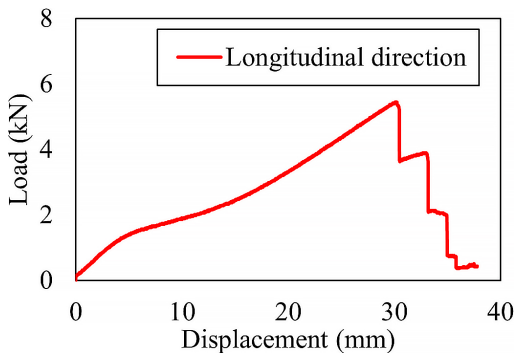
Fig. 2 Load-displacement response of geogrid (a) transverse direction, and (b) longitudinal direction

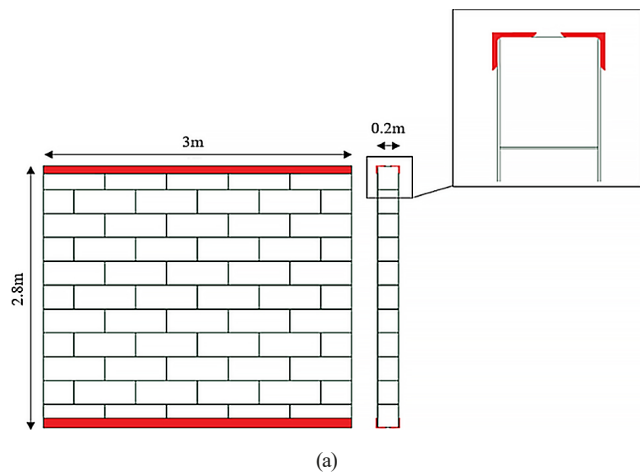
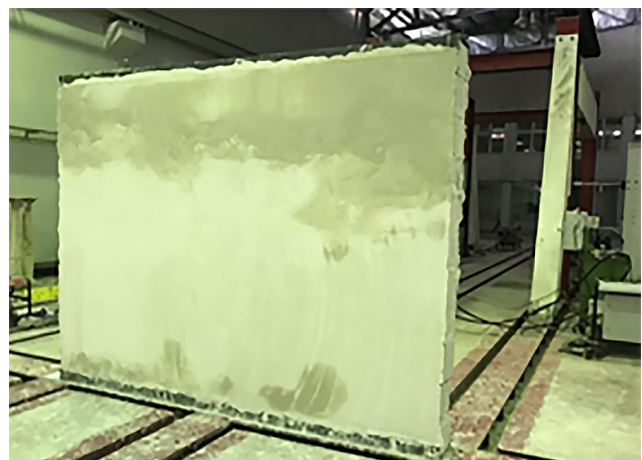
Fig. 3 AACW specimen (a) schematic view (unit: meter), and (b) real test specimen

In the AACW wall, bonding between the blocks of this wall was provided with a mortar composition having a thickness of 2 mm, and interface strength (i.e., cohesion) of 0.3 MPa. To provide a rigid connection between the ground floor and the specimen, two No. 10 angles were used and to create a uniform load distribution, two

No. 8 angles were used at top of the wall where the OOP load was applied according to Fig. 3.

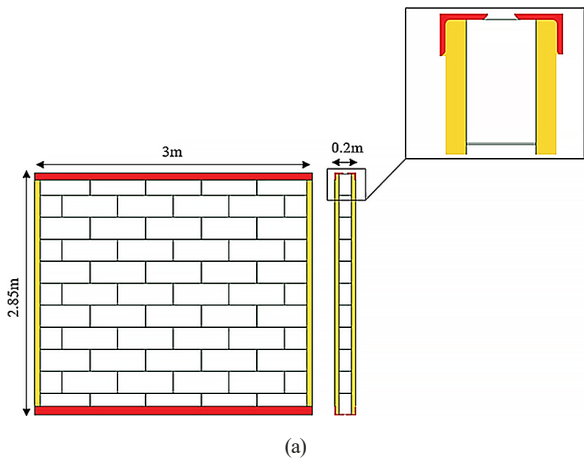
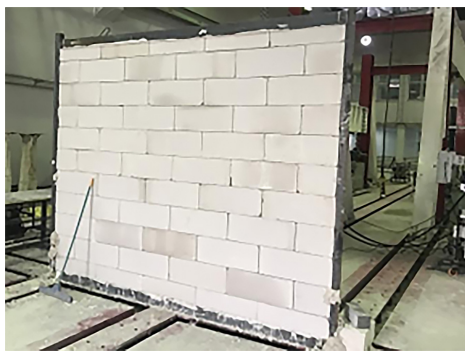
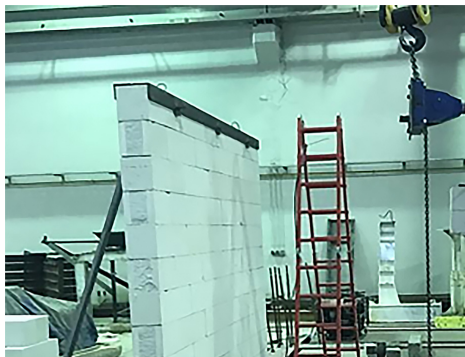
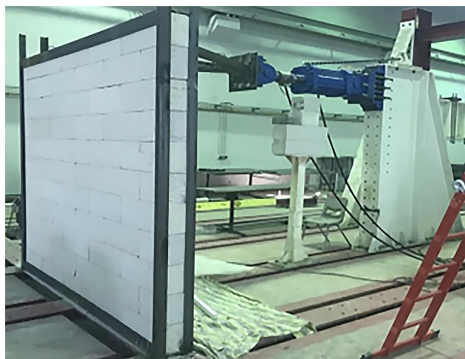
**Fig. 4** AACWRS specimen (a) schematic view (unit: m), (b) real test specimen, (c) perimeter connection of wall with angles

Two No. 8 angles were used with steel belts of 3 mm in thickness on both ends of the wall. Detailing of angles positioning as well as the test specimen are given in Fig. 4.

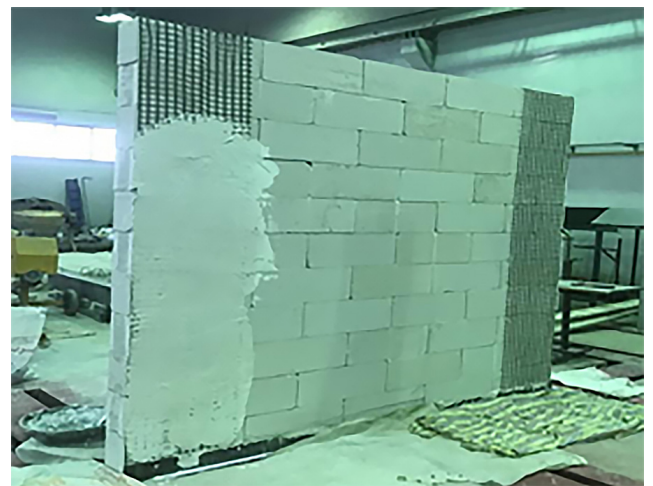
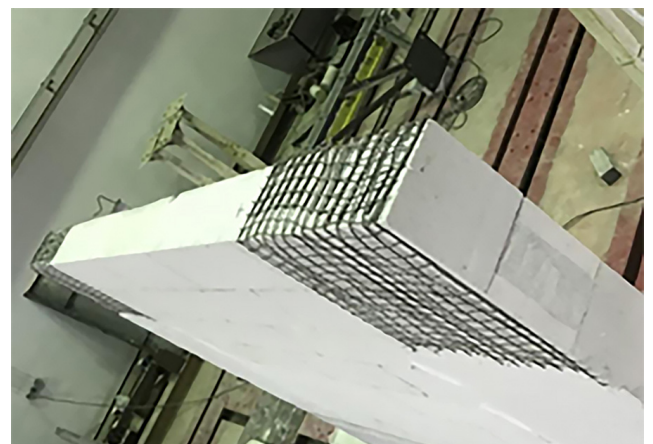
**Fig. 5** AACWRT specimen (a) schematic view (unit: meter), (b) real test specimen, and (c) detailing on top of the wall

Two rows of geogrid were wrapped around the wall at its both ends and were fixed in place with a common gypsum.

It is noteworthy that, two No. 8 angles were used to apply a distributed load subsequent to application of geogrid on AAC blocks. Fig. 5 shows the details of the work.

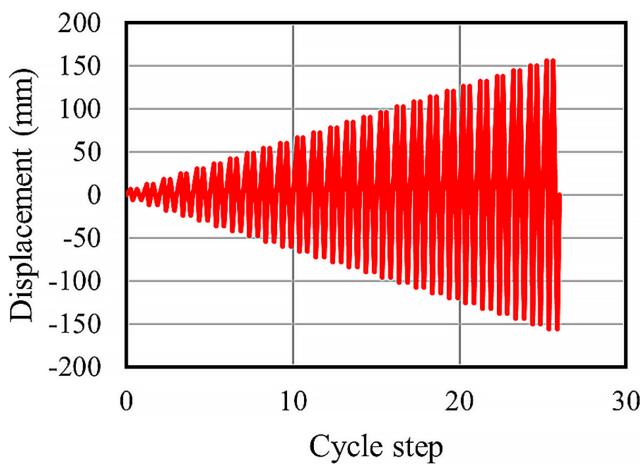
Fig. 6 Displacement-controlled loading protocol

Cyclic loading was applied at the highest elevation of the to reach the drift ratio of 6% using a 1000 kN hydraulic jack according to the loading protocol of Fig. 6. Each complete cycle step consisted of two cyclic loadings (amounting to 262 steps in total), with an increment of 6 mm in each sub-step. Load values and its corresponding displacements were recorded in each step of loading. Fig. 7 shows the test setup and loading of specimen AACW. Displacement was measured by the internal linear variable displacement transducer (LVDT) of the loading jack which was used to apply loading to top of the wall.

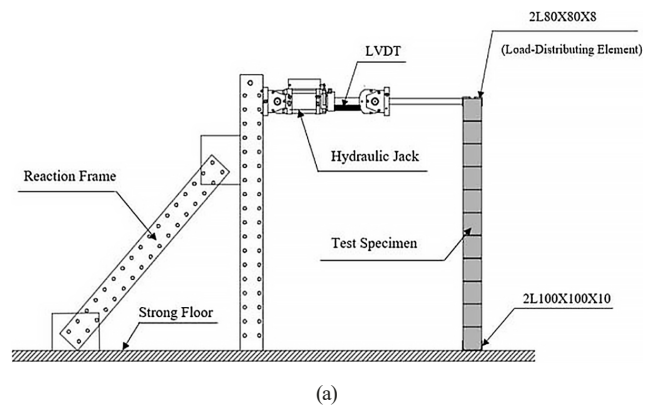
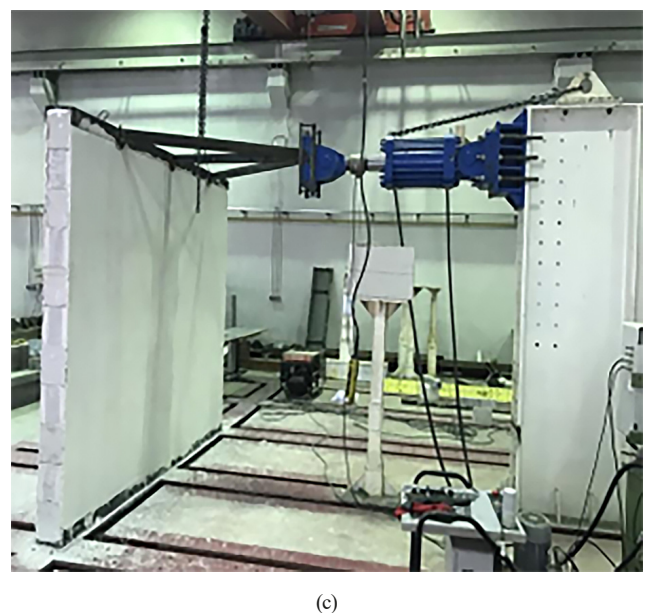
Fig. 7 (a) side view sketch of test setup, (b) top view sketch of test setup, and (c) loading of specimen AACW

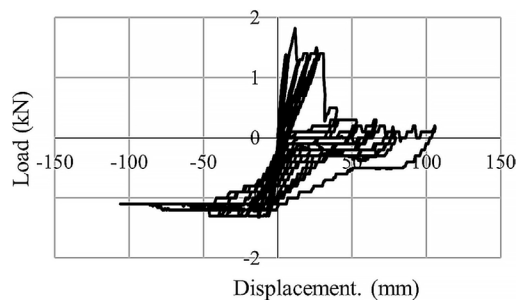
**Fig. 9** Force-displacement curve of specimen AACW

Fig. 8 shows the deformed shape and failure pattern of AACW specimen. Upon increase of deformation of the wall, cracks initiated from the external corners of the first row of bricks at the bottom of the wall and propagated to the middle of the wall according to Fig. 8 (b) and (c). Further loading was characterized by the appearance of longitudinal crack at top of the wall, beneath the angle to which the load was applied Fig. 8 (d). Thereafter, initial cracks at the bottom of the wall widened and propagated until the wall failed Fig. 8 (e). Based on the force-displacement curve of specimen AACW given in Fig. 9, the initial part of the curve is linear until it reaches a peak load of 1.85 kN before dropping notably, undergoing a load plateau while displacements increase. Thereafter, the load drops suddenly to a value of 0.2 kN and fluctuates as the displacement values reach 110 mm. Given the overall trend, it is clear that the failure of the AACW specimen is brittle and the peak load value is its ultimate load capacity.

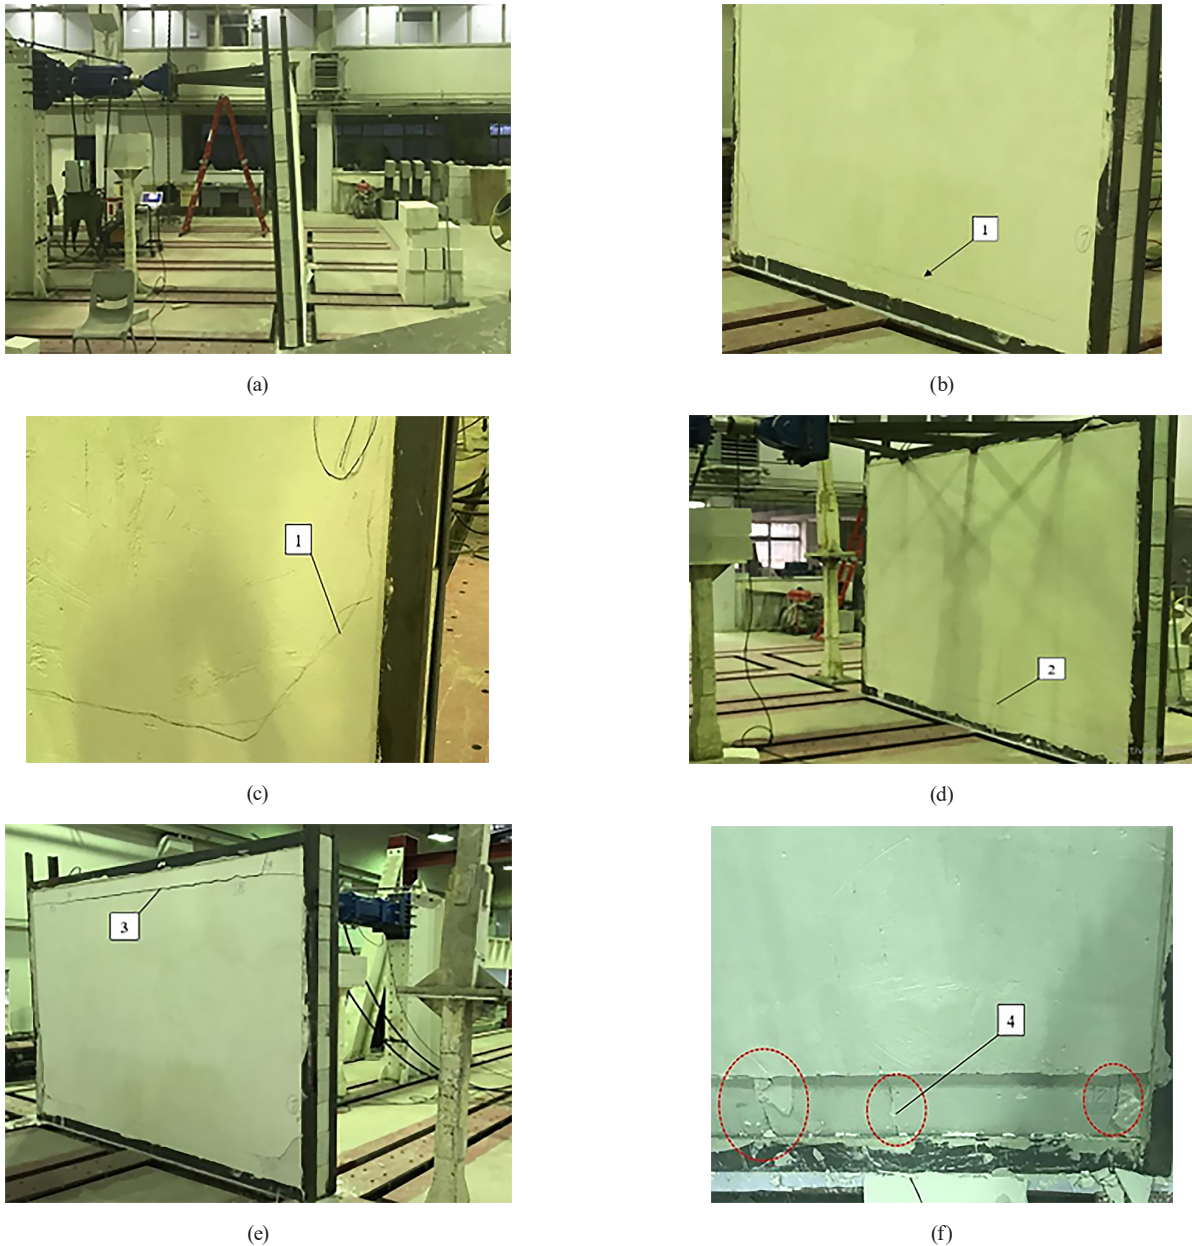
**Fig. 10** Specimen AACWRS (a) deformed shape of the wall, (b) formation of initial cracks at the second row of the wall, (c) propagation of cracks to the middle parts of the wall, (d) appearance of cracks at the first row of masonry blocks, (e) cracking of the wall at the top beneath the angles to which the load was applied (f) vertical cracks along the masonry blocks at the first row

Fig. 10 (a) shows cracking of specimen AACWRS at various stages of loading. Unlike specimen AACW, initial cracks started at the outer corner of the second row of blocks and propagated towards the inner parts of the wall. Next, first row cracked as well followed by the formation of cracks at top of the wall beneath the angles to which the load was applied and thereafter, emergence of vertical cracks at the masonry blocks of the first row at the bottom of the wall. Unlike the force-displacement trend of specimen AACW, in specimen AACWRS (Fig. 11), initial linear reversed cyclic loading was not followed by a

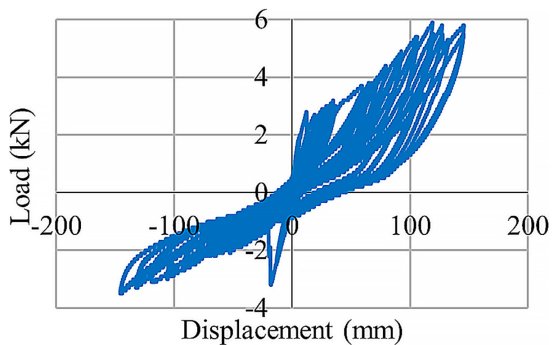
**Fig. 11** Force-displacement curve of specimen AACWRS

sudden drop of the load capacity but in contrast, displacement-hardening was observed given the presence of post-wall strengthening until the specimen reached a rough load capacity of 6 kN, sustained this load value for almost

30 mm, before failing at 150 mm. Failure mode of the specimen was not brittle and the failure occurred gradually by the distribution of cracks.

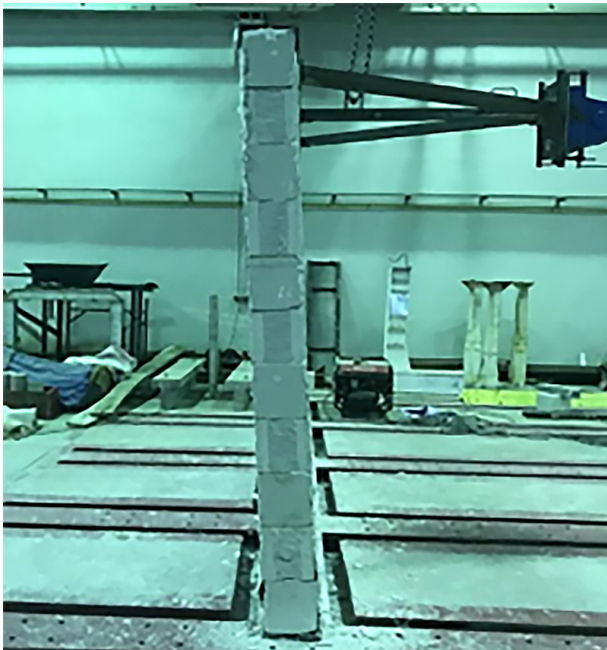
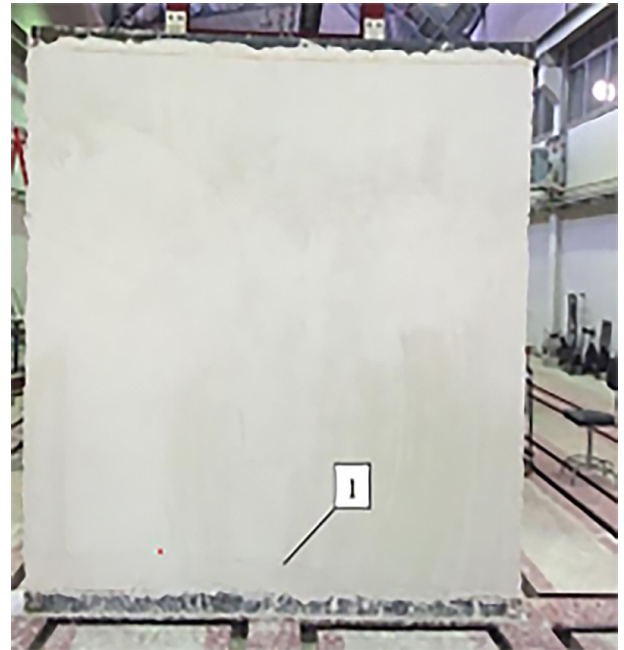
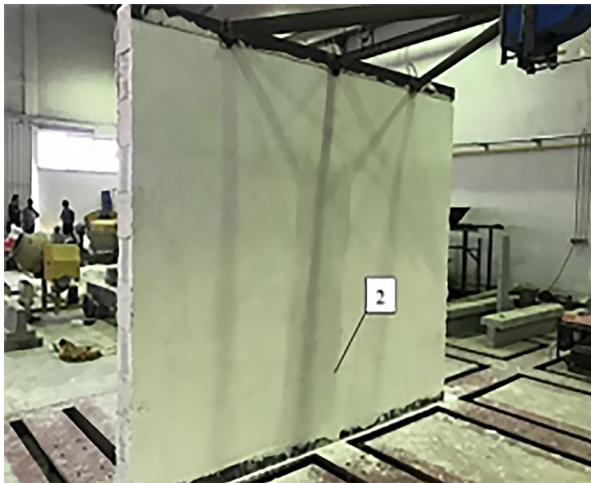
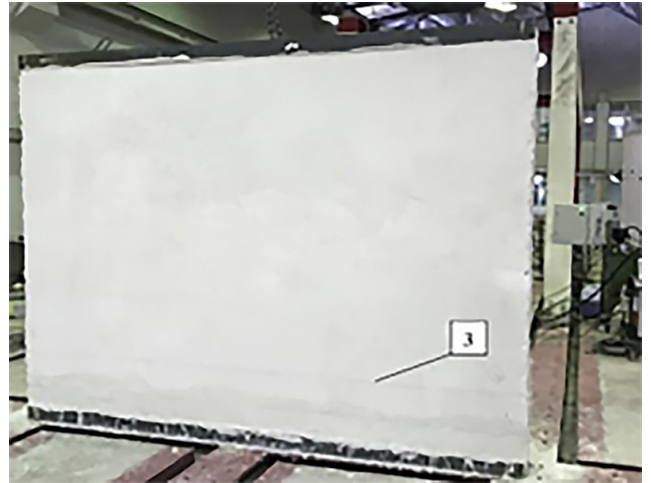
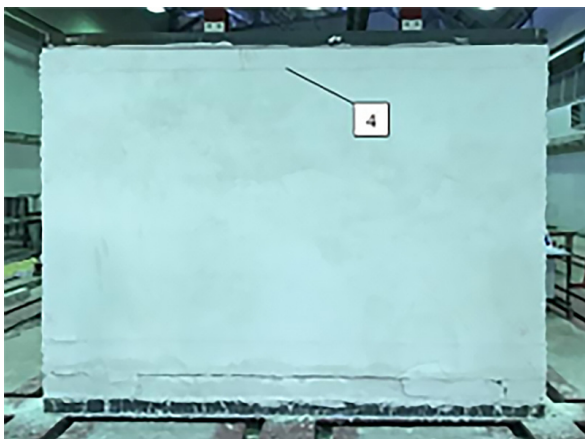
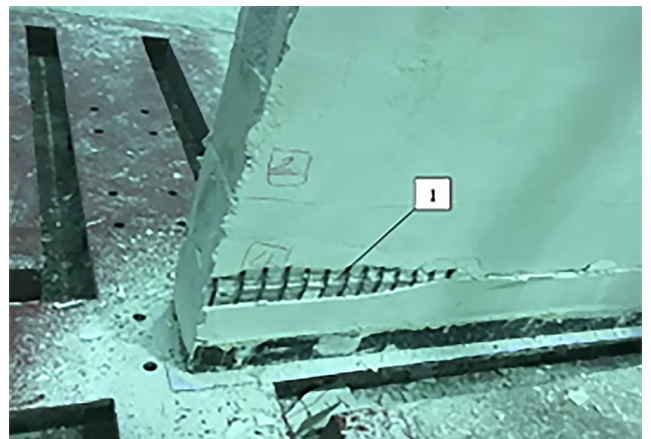
**Fig. 12** Specimens AACWRT (a) deformed shape of the wall, (b) emergence of cracks at the first row of masonry blocks, (c) cracks on the front face (loading face), (d) cracks on the back face, (e) presence of cracks at top of the wall beneath the angle to which the load was applied, (f) exposure of TRM due to spalling of gypsum

Fig. 12 shows the loading as well as the evolution of crack at various stages of loading. Primary cracks initiated at the first and second rows of blocks, followed by the emergence of the cracks at top of the wall and finally exposure

of TRM by the spalling that occurred at the bottom of the wall.

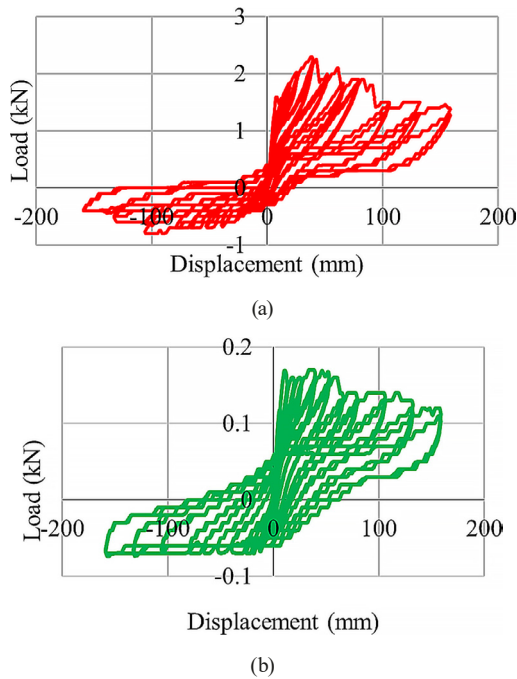
**Fig. 13** Force-displacement curves of specimen AACWRT  
 (a) AACWRT-I, and (b) AACWRT-2

Fig. 13 shows the force-displacement curve of specimens reinforced with TRM. In these specimens similar to specimen AACWRS, failure of the wall was ductile characterized by displacement-hardening behavior of the wall after the first cycle followed by a stable and/or slight decreasing trend of the specimen to reach displacement values of 150 mm. This gradual evolution of cycles at relatively large load values indicates the energy absorption capacity of the walls

and their ability to deform adequately, giving signals to its failure rather than a sudden brittle failure.

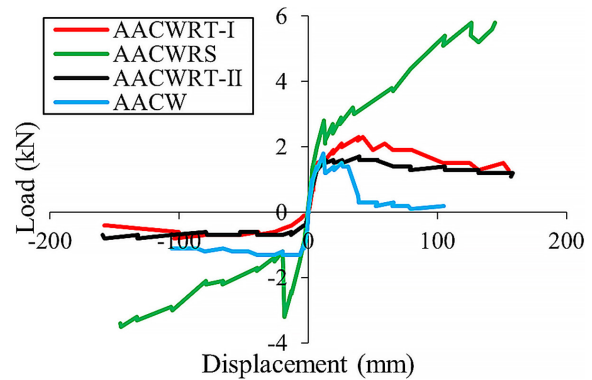
**Fig. 14** Envelope curves of all test specimens

Fig. 14 shows the envelope curves of all the test specimen. It is observed that the AACWRS specimen has shown both the highest load value and energy absorption followed by TRM-reinforced specimens. It is clear from Table 2 (based on envelope curves) that application of TRM didn't contribute to the initial stiffness of the curves while the converse was true for the specimen strengthened with post walls; an increase of 27% in initial stiffness of the curve relative to the control specimen was witnessed. AACWRS specimen sustained load values as high as 3 times relative to the control specimen; this value for TRM-strengthened specimens was 1.5. Displacement-hardening behavior was also observed in all the specimens except for the control specimen which was mainly due to the presence of steel angles at the perimeter of the wall. The ultimate displacement ( $\Delta_{Ultimate}$ ) improved by 30%, and 48% for specimens AACWRS and AACWRT, respectively. Similarly, energy absorption ( $E$ ) values increased by 4 and almost 2 times for specimens AACWRS, and AACWRT, respectively.
