Evaluation of Material Characteristics and Structural Dynamic Properties of a Historical Church: The Case of 19th Century Bursa Derekoy Church (Ayia Paraskevi)

Şule Ayengin¹, Muhammed Bilal Bağbancı^{1*}, Özlem Köprülü Bağbancı¹

¹ Department of Architecture, Bursa Uludag University, Görükle Kampusu 16059 Nilüfer/Bursa, Türkiye

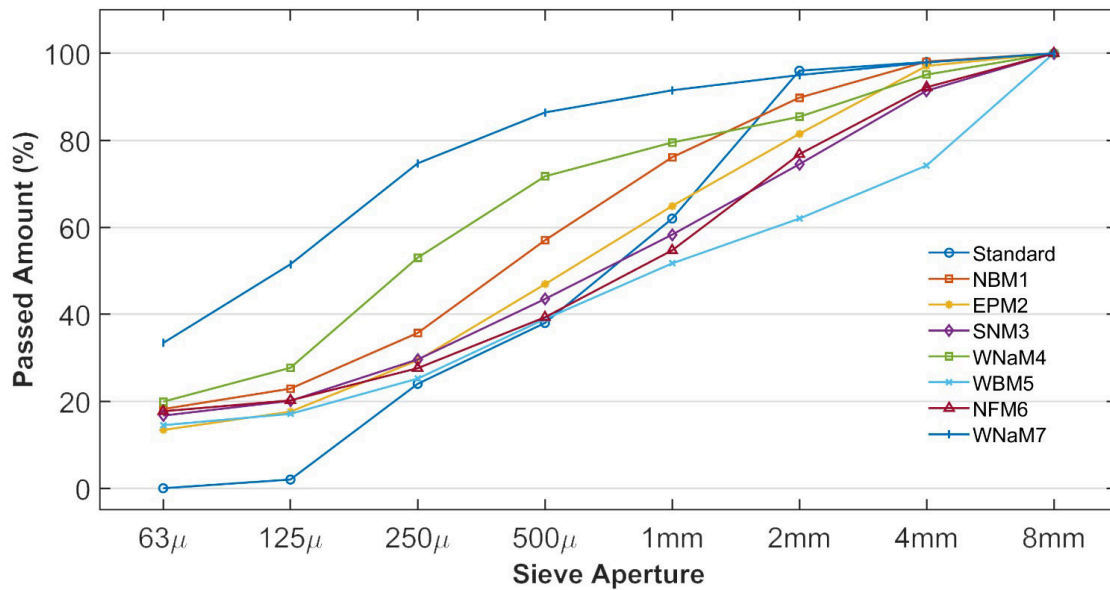
Fig. 4 Cumulative aggregate grading curves; aggregate from church mortars and plasters; standard aggregate according to EN 196-1 [37].

After the sieve analysis, the aggregates were grouped according to their size, as shown in Fig. 4 [37]. In studies on aggregate granulometry, the regular size of the grains is associated with the quality of the mortar. Moreover, a good mixing process is recommended during mortar preparation in order to ensure homogeneous distribution of aggregates [38].

WNaM7 has a quite different curve from other samples and the standard. After the sieve analysis, the aggregates were examined under the microscope, and varying amounts of volcanic rock, quartz and feldspar, and a small amount of slag, broken brick and fibrous additives were observed. In the WNaM7 sample, on the other hand, it was determined that the rate of fibrous additives was quite high.

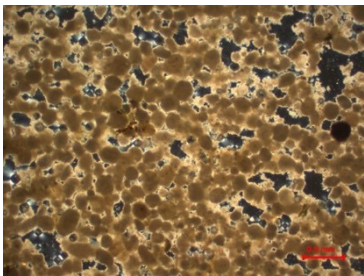
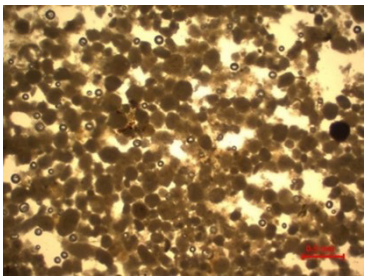
<p>Composition: peloids, microfossil – fossil shell fragments (small amount, small grained and homogeneously distributed), extraclasts/epiclastics (quartz fragments, plagioclase fragments, mica fragments, altered mineral and/or rock fragments), and substrate consisting of carbonate minerals (micrite).</p>
<p>WNaS2 thin section (2 nicols)</p>	<p>WNaS2 thin section (1 nicol)</p>

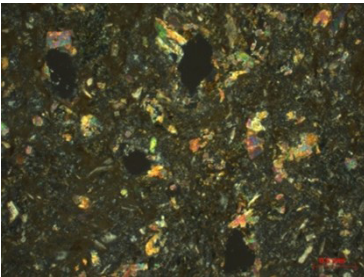
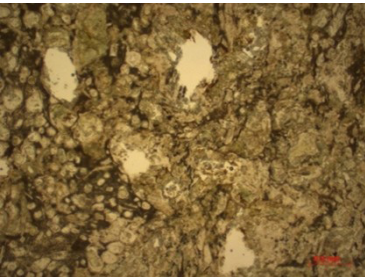
<p>Its main components are: rock fragments, mineral fragments (feldspar minerals), and microfossil – fossil shell fragments. There are thin and medium-thickness filled fractures and veins in the sample.</p>
<p>NTS3 thin section (2 nicols)</p>	<p>NTS3 thin section (1 nicol)</p>

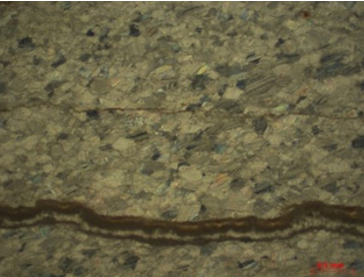
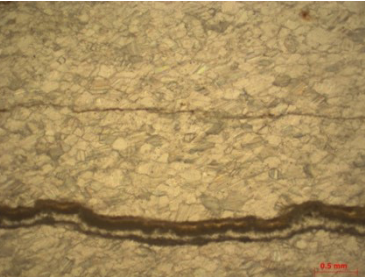
<p>Its components consist of fine-grained, homogeneously distributed carbonate minerals and filled fractures and veins. Widespread recrystallization continues in the formed carbonate minerals.</p>
<p>NFS4 thin section (2 nicols)</p>	<p>NFS4 thin section (1 nicol)</p>

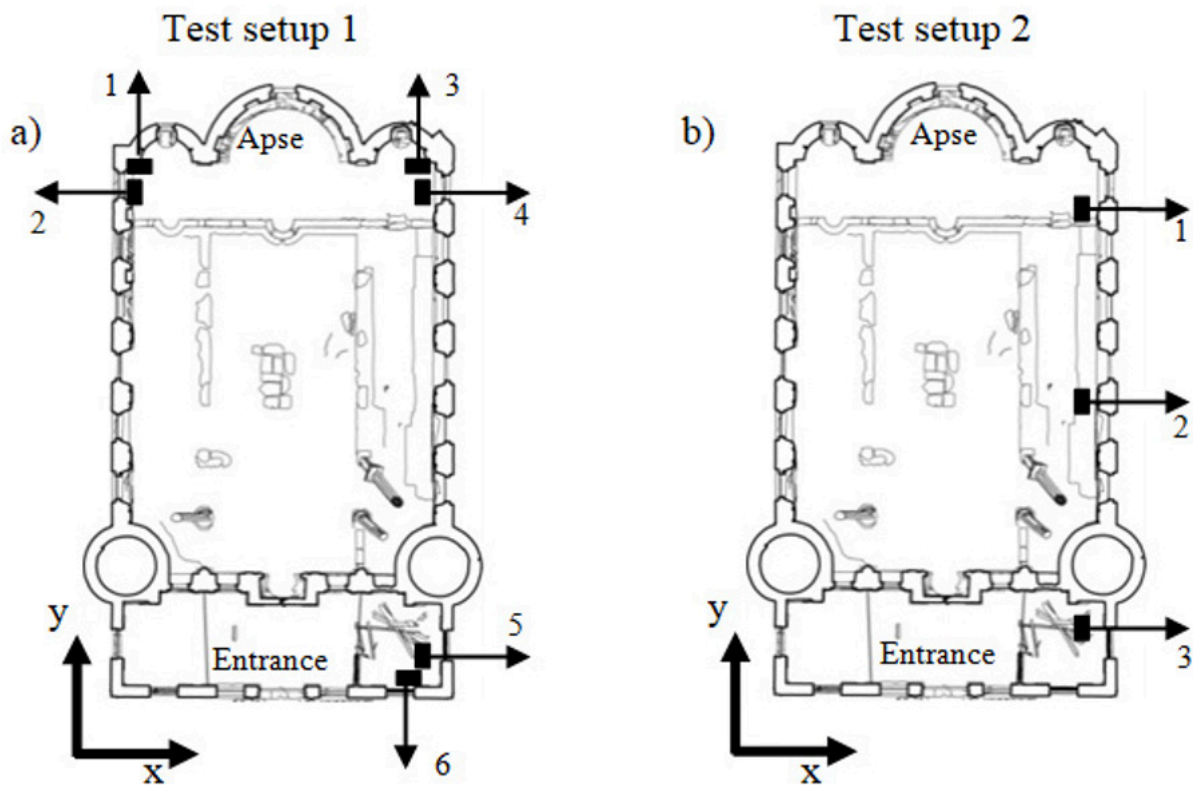
Fig. 7 Plan view of the sensor placements a) test setup 1 b) test setup 2

Thirty-minute test periods were applied for the accuracy of the tests. Accelerometers were placed 1.5 meters under the roof elevation. In the first test, accelerometers were placed on the corners of the whole structure Fig. 7 (a). After conducting test setup 1, the results were also checked by a second test which was conducted on an individual wall of the church in x direction Fig. 7 (b). The bending mode frequencies of the walls were determined with good accuracy and close results were obtained between test setup 1 and test setup 2.

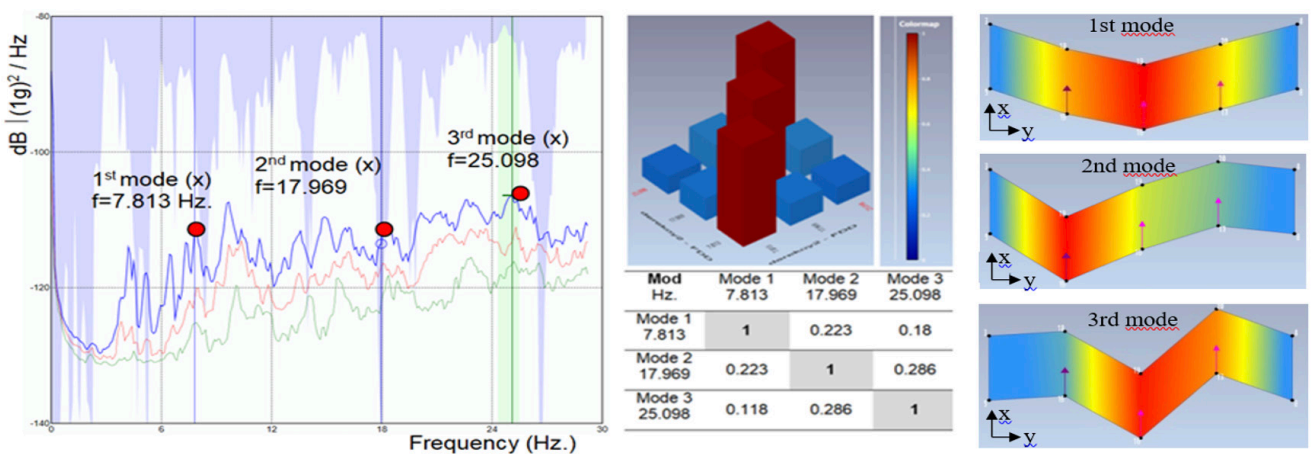
Fig. 8 Singular values of spectral densities, 3D and numerical presentation of MAC values and bending mode shapes of Derekoj Church obtained from test setup 2.

The singular values of the spectral densities, the 3D and the numerical presentation of MAC values, and the first three bending mode shapes in x direction obtained experimentally from test setup 2 are presented in Fig. 8.
