THEORETICAL AND EXPERIMENTAL EXAMINATION PERFORMED DURING THE LATEST REPAIRING OF THE CHAIN BRIDGE

Now, I should like to give a brief account about our work in the course of repair of the Chain Bridge.

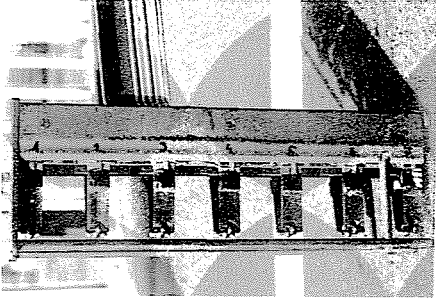
Fig. 3

In the course of the repairing started in 1987 it was shown that the corrosion in the anchorage chamber was very advanced due to the defective isolation (*Fig. 3*), but a direct measure of the corrosion could not be answerable in the narrow gaps of 29 mm between the eye-bars.

the unrusting and re-painting of the bridge steel structure,
the repair of the anchorage chamber's insulation,

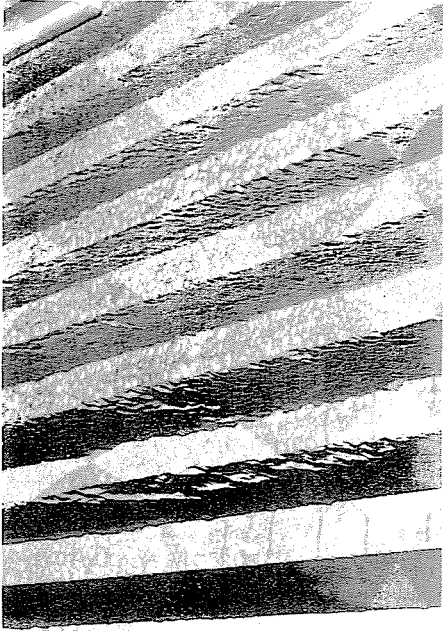
Fig. 4

measuring of the thickness, a special monitoring system was developed, by help of which the determination of the residual thickness remaining after the corrosion damage of the eye-bars in 7 places simultaneously along their height of 38 cm was possible (*Fig. 4*). The essential part of the instrument is a closed frame fixed to a rod at its lower end, and connected removable and easily re-adjustable at its upper end. The measuring springs are coupled to the frame-columns tilted towards each other so that the free distance between the feeler-rollers at the ends of the measuring springs should be about 15 mm. On the bottom of the measuring cantilever springs, the resistance strain-gages are bonded on both sides at the clamping. When the measuring instruments together with the measuring springs were adapted on the eye-bar to be measured, the measuring springs became deformed as cantilever beams according to the thickness of the eye-bar. The deformation is directly proportional to the bending moment in the clamping points of the cantilever, or to the strain of the exterior fibre due to the moment.

The 2×2 resistance strain-gages on the two measuring springs at the same height were connected in a full bridge-circuit to the measuring amplifier. Through this solution, it was achieved that the influence of measurement asymmetry was filtered out of the results.

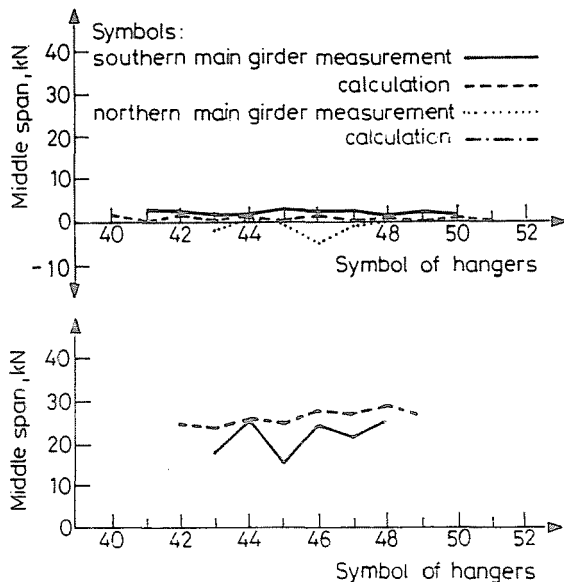
As the comparison shows, when the side-span is loaded, the suspension forces are arisen only within the side-span, while the suspension forces in the middle span are negligible.

Fig. 8. Measured and calculated suspension forces in the hangers at load position No. 13 (side-span loaded)

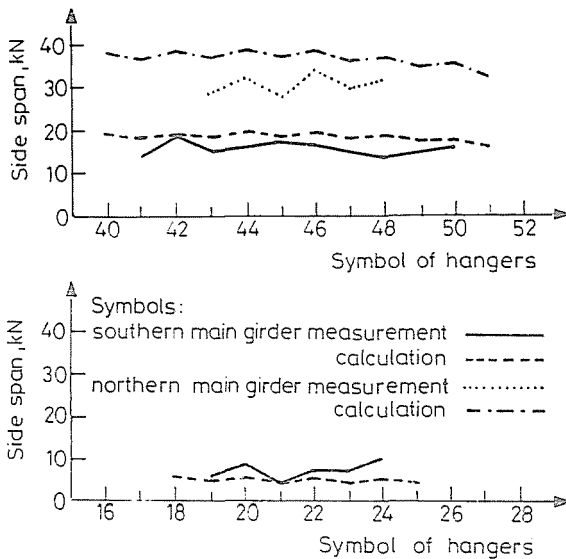
When the middle span is loaded (load position No. 10), not only the hangers of the loaded middle span but also those of the side-span take part simultaneously in load bearing, though smaller forces arise in the side-span than in the loaded middle one.

Fig. 9. Measured and calculated suspension forces in the hangers at load position No. 10 (middle span loaded)
