# ENGINEERING-GEOLOGICAL TEST ON SETTLEMENTS WITH CELLAR DIFFICULTIES

B. KLEB

Department of Mineralogy and Geology,  
Technical University, H-1521 Budapest

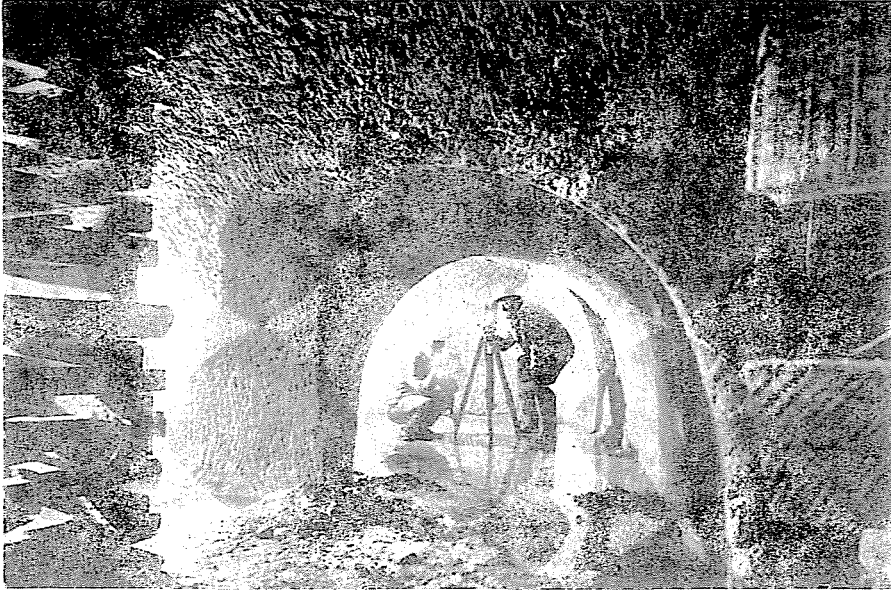
Fig. 9. Surveying of cellar branches

To project the points under the ground is a very difficult task, even in the easily accessible branches (Fig. 9).

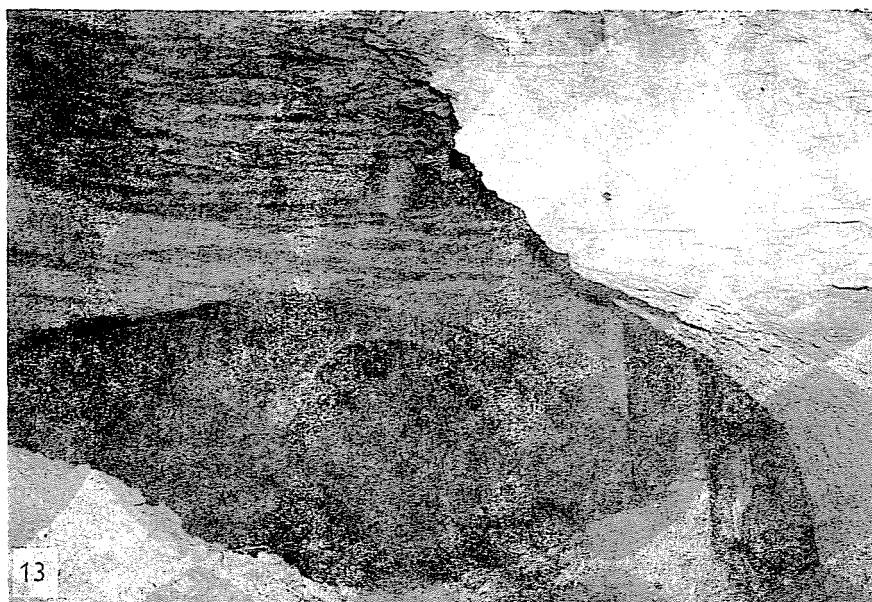
*Fig. 13.* Sink of a wide-span cellar roof in stratified tuff (Eger)

The *wide span* in the loosed rock ambient resulted in broken of inadequate strength in many places (Fig. 13). That causes problems especially in Eger where for gravel exploitation they formed large irregular shaped “halls” under the loose limnetic super incumbent without pillar supports.

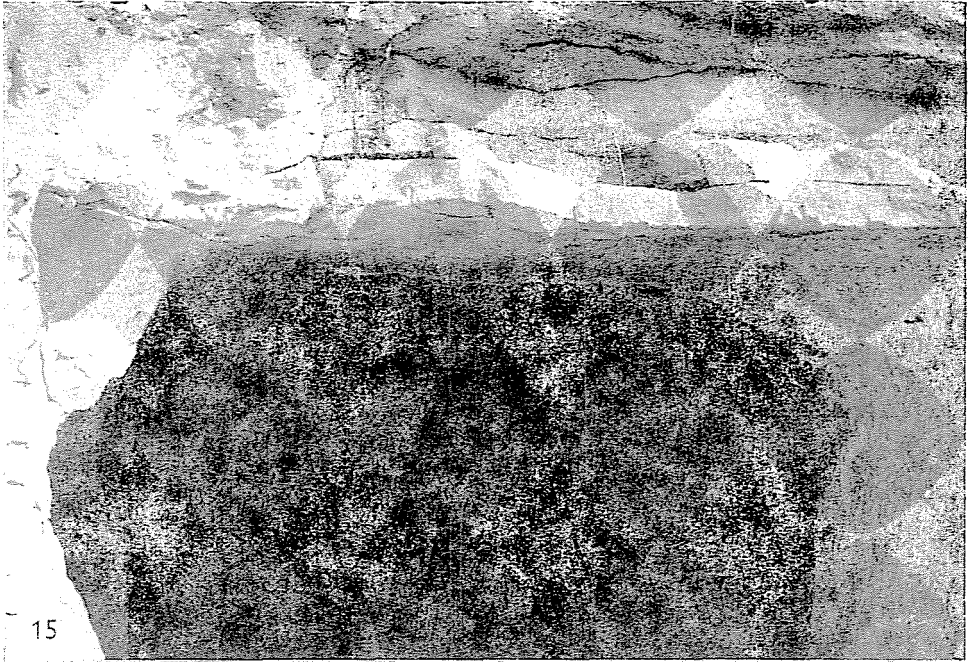
*Fig. 15. Roof sunk in rhyodacite dust-tuff*

In the examined areas we experienced that the cellars cutted to low-strength rocks, in their original condition are stable. The structure — the loose — pass beside the fissurance and stratification — affects the deterioration volumetrically, break down of the roof takes place in tuff and loess in these places (Figs 15—16). That is why the microtectonical and stratigraphical tests are important.

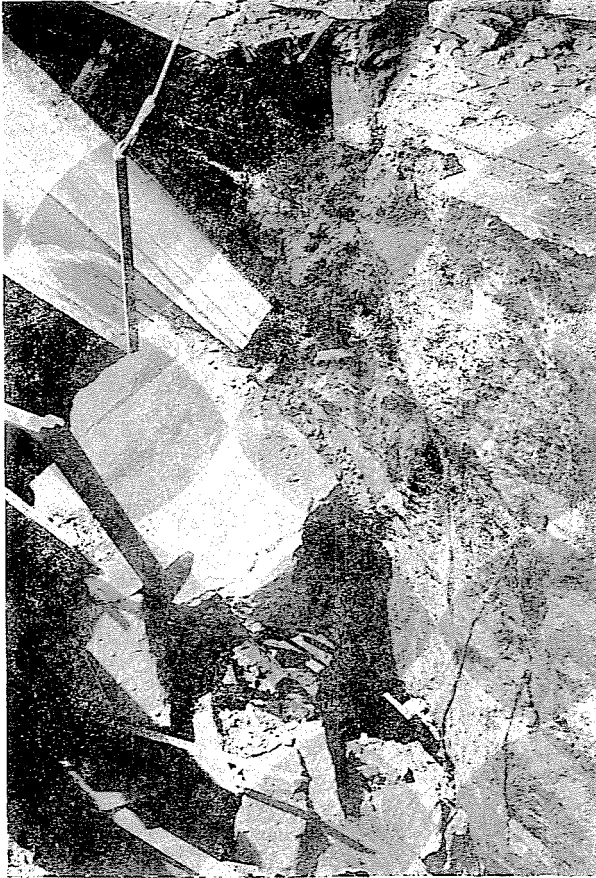
Fig. 20. Vertical rupture with building deterioration

Due to the drenching the *strength of the tuff is reduced to 1/3rd or 1/5th of its original value* (Fig. 18). Under this condition, since the cap of the tuff is of low strength clayey gravel or clay, during arch formation it frequently happens that the *2 to 3 m diameter well-like rupture extends up to the surface* (Figs 19, 20).

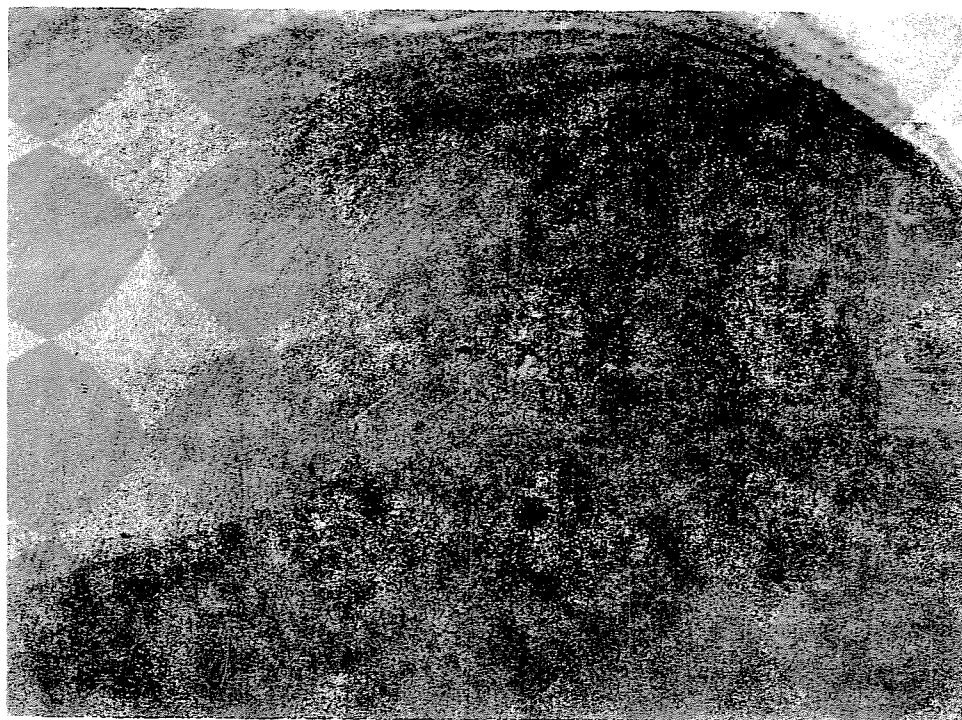
Fig. 21. Marks of water-flow in a flooded tuff-cellar (Eger)

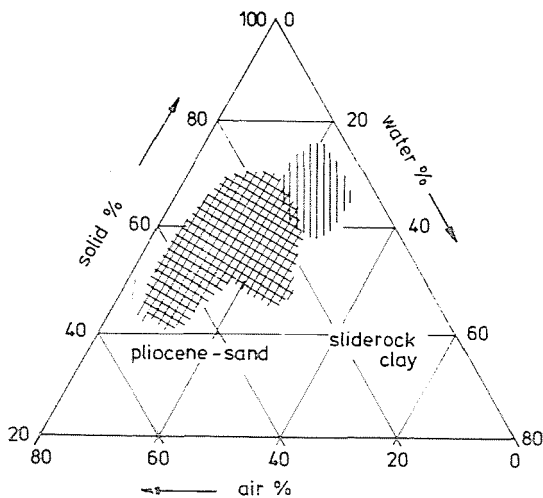
Fig. 22. The phase composition of rock ambient of cellars at Pécs

The ambient of cellars at Pécs that is Pliocene sand and superficial slide rock clay, regionally is less drenched (Fig. 22). In certain areas, however- "water-hillock" is formed referring to karst-water that according to our tri,

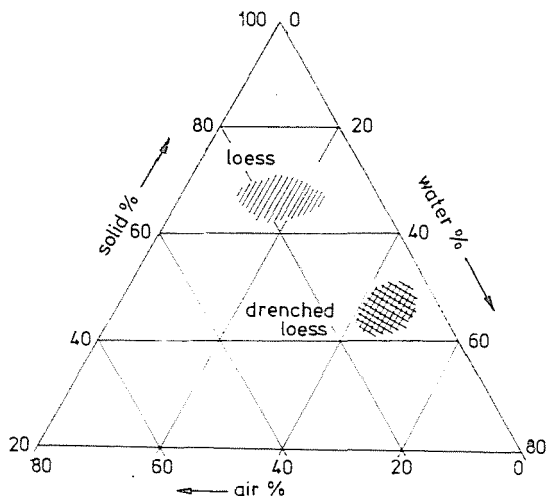
Fig. 23. The variation of phase composition of loess due to drenching (Szekszárd, Nagymaros)

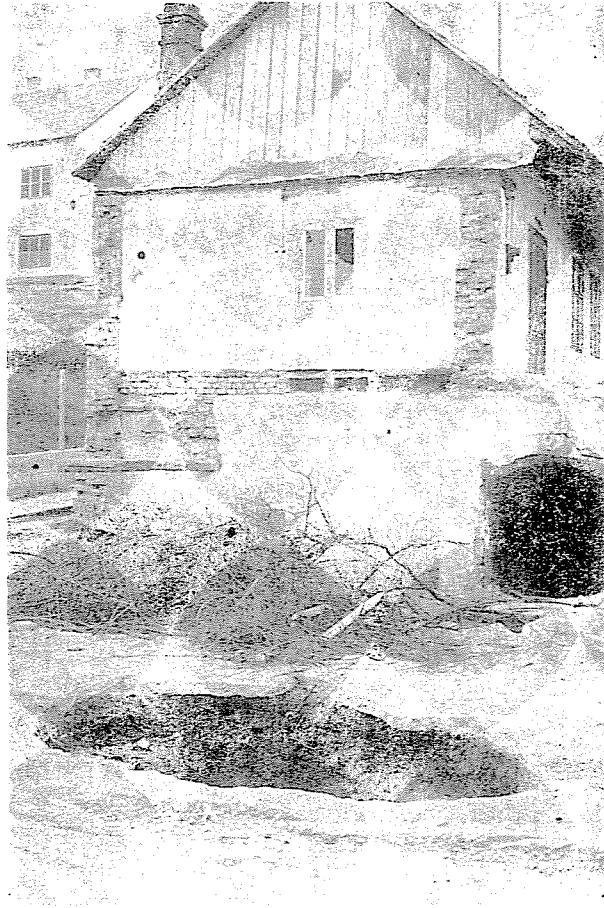
Fig. 24. Cellar rupture ranging up to the surface in loess

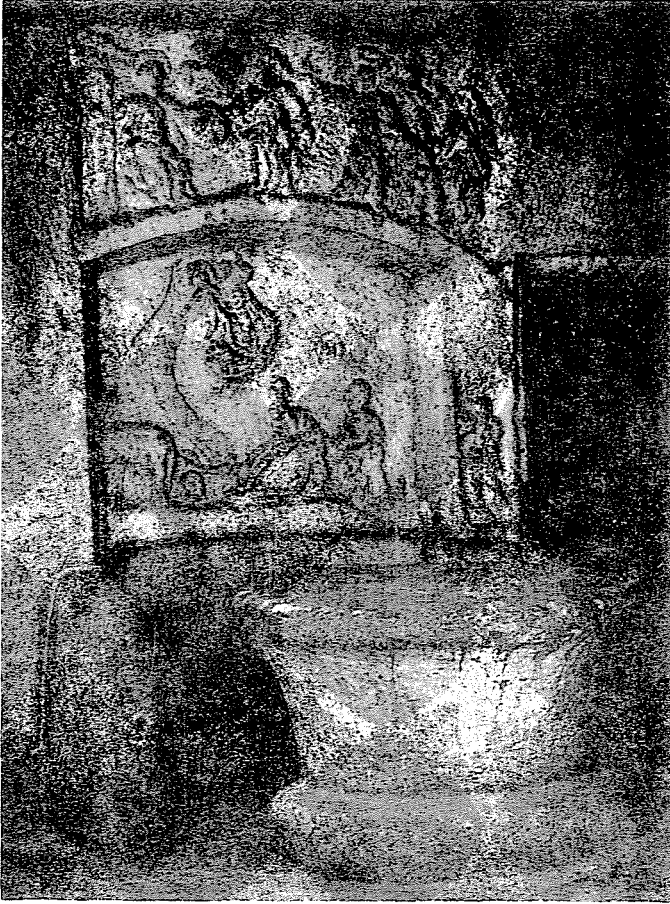
Fig. 30. A cellar, cutted to tuff with relief

In Hungary, most of the cellars were formed after the Turkish rule in the 18th—19th century. At certain settlements — Eger, Szentendre, Szekszárd, Ostoros, Nagymaros — the cellars are the *architectural memories* of the vine monoculture, at that time basis of the economic development. Among them there are some — first of all at the Eger region — containing artistical sculptures deserving protection as historical monuments (Fig. 30).
