# Assessment of Defect Severity in Wooden Pillars Using Ultrasonic Testing

Marwa Brougui<sup>1\*</sup>, Krisztián Andor<sup>1</sup>, Péter Szabó<sup>1</sup>

<sup>1</sup> Department of Wooden Construction, Faculty Wood Engineering and Creative Industries, University of Sopron, Bajcsy-Zsilinszky street 4., H-9400 Sopron, Hungary

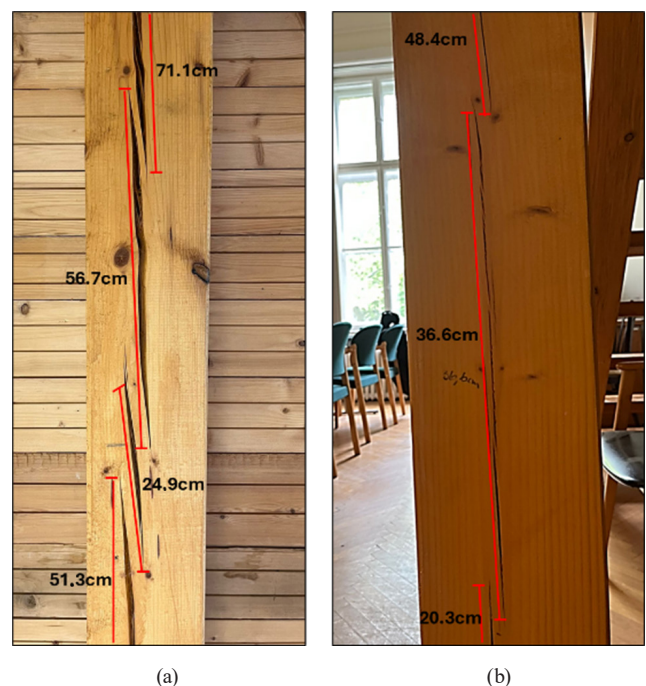
**Fig. 1** Crack length measurements on wooden pillars: (a) distribution and extent of surface cracks on Wooden Pillar 1; (b) distribution and extent of surface cracks on Wooden Pillar 3

Each pillar was inspected for visible surface defects. When cracks were present, their length and depth were measured using a high-precision digital caliper (accuracy  $\pm 0.01 \text{ mm}$ ). In cases where direct depth measurement was limited due to geometry, depth was inferred from surface morphology (Fig. 1).

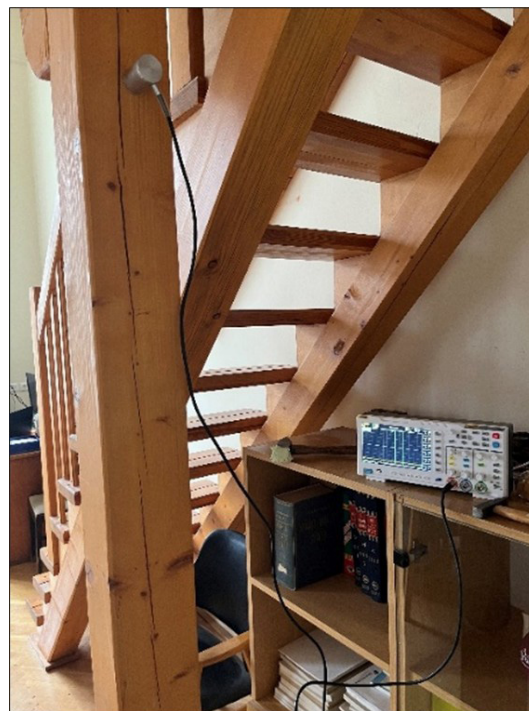
**Fig. 2** Ultrasonic testing of the wooden pillar using FNIRSI 1014D digital oscilloscope

The velocity ( $v$ ) of sound propagating through the wooden pillars was measured using a FNIRSI 1014D digital oscilloscope (Shenzhen, China), with a bandwidth of 100 MHz and a sampling rate of 1 GSa/s. A FAKOPP-type ultrasonic sensor was securely affixed to the wooden surface using beeswax to ensure proper coupling (Fig. 2). Acoustic waves were generated by striking the pillar with a metallic hammer at predetermined locations.

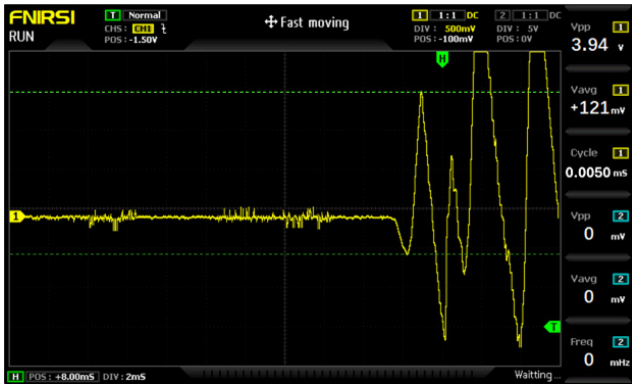
**Fig. 3** Measurement of time period ( $T$ ) using FNIRSI 1014D oscilloscope on wooden pillar ( $n = 1$ )

The FNIRSI 1014D oscilloscope was used to estimate the frequency of the acoustic signal. Since the device does not include an automatic frequency counter, the frequency was calculated manually from the waveform display. The time period ( $T$ ) was determined by measuring the horizontal distance between successive waveform peaks using the oscilloscope's time/div grid (as shown in Fig. 3).

The oscilloscope was connected to an ultrasonic transducer positioned at one end of the wooden pillar.

To ensure accuracy, at least three complete waveform cycles were analyzed per measurement, and the average time period was used to compute the frequency.

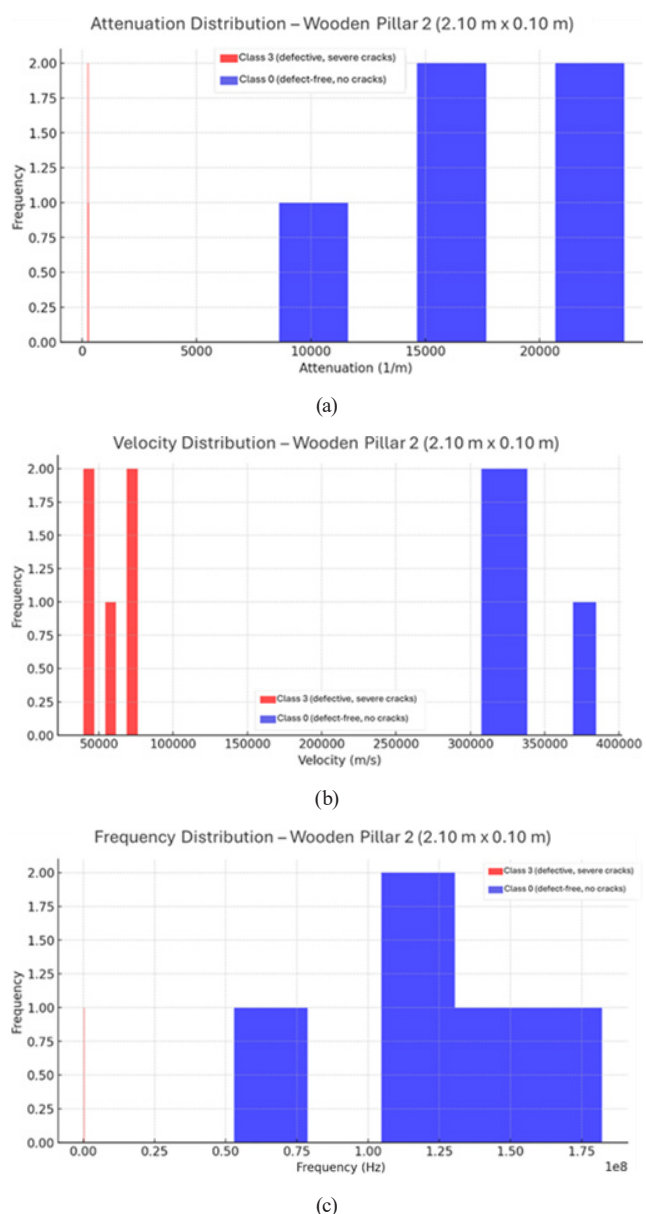
**Fig. 5** Ultrasonic properties measured in Wooden Pillar 2 across varying crack severity levels (Class 0–3): (a) variation in ultrasonic wave velocity; (b) frequency distribution of ultrasonic signals; (c) attenuation of ultrasonic signal amplitude

Similar trends are observed in Fig. 5. In Class 3 (defective region, severe cracks), wave velocities range from 39,696.79

to 76,178.04 m/s (mean:  $55,020 \pm 14,692.14$  m/s). This is significantly lower than the wave velocity in Class 0 (defect-free region, no cracks), which ranges from 307,512.08 to 384,474.55 m/s (mean:  $318,400 \pm 3,267.51$  m/s) as confirmed by Subhani et al. [29] and Li et al. [30].

The frequency in the defective region Class 3 ranges from 232,450.02 to 356,760.61 Hz (mean:  $320,832.62 \pm 44,800.37$  Hz), while Class 0 spans a wider range from 52,944,692.44 to 182,149,395.84 Hz, with a mean of 145,007,622.64 Hz.

Attenuation in the defective region (Class 3) ranges from 231.62 to 292.78 1/m (mean:  $258.96 \pm 27.67$  1/m), compared to the defect-free region (Class 0), which exhibit higher attenuation values (8,607.48 to 23,688.09 1/m, mean =  $16,392.86 \pm 7,858.02$  1/m). Consistently, the defective region exhibits lower wave velocities, higher attenuation, and a narrower frequency range, further emphasizing the detrimental impact of defects on the material's acoustic properties.

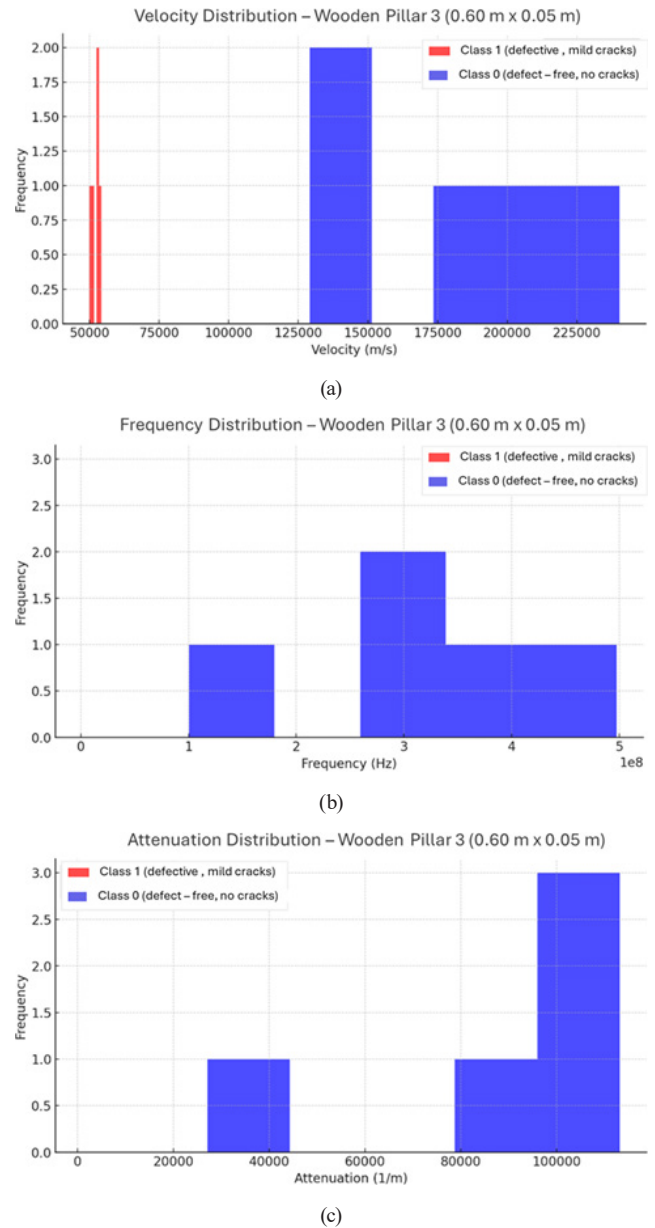
**Fig. 6** Ultrasonic properties measured in Wooden Pillar 3 across varying crack severity levels (Class 0–1): (a) variation in ultrasonic wave velocity; (b) frequency distribution of ultrasonic signals; (c) attenuation of ultrasonic signal amplitude

The wave velocity in Class 1 (defective region, mild cracks) ranges from 49,954.21 to 54,308.47 m/s (mean =  $51,420 \pm 1,754.55$  m/s), which remains significantly lower than that in Class 0 (defect-free region, no cracks), where the velocity ranges from 129,171.15 to 240,288.35 m/s (mean =  $188,000 \pm 26,092.61$  m/s).

The frequency in Class 1 ranges from 1,014,713.34 to 1,053,518.75 Hz, whereas the Class 0 exhibits a much broader range from 293,341,924.49 to 497,549,418.48 Hz.

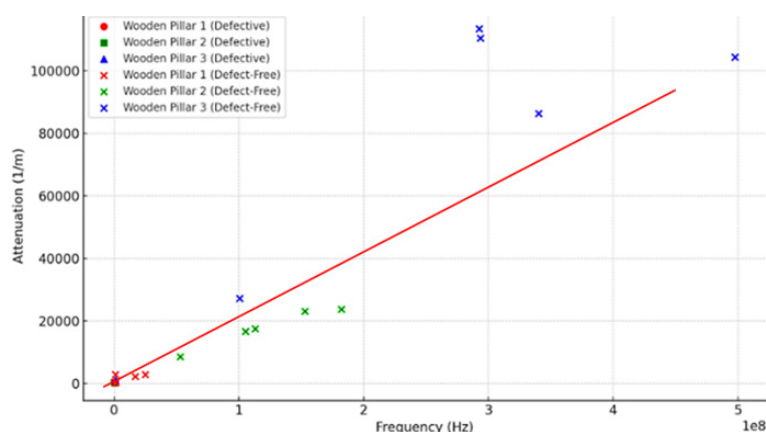
**Fig. 7** Relationship between frequency and attenuation in wooden pillars with varying crack severity (Class 0–3)**Table 4** Post-hoc Tukey HSD test results for pairwise comparisons of ultrasonic parameters across defect severity classes (Class 0–3) (significant differences ( $p < 0.05$ ))
