Effect of corrosion on the buckling of steel angle members – experimental study

Katalin Oszvald / László Dunai

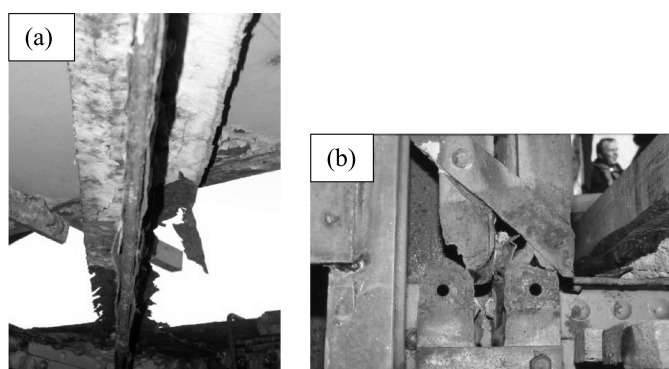
Fig. 1. Corroded structural details in (a) Margaret Bridge and (b) Liberty Bridge

Every structure is exposed to the influence of different environment and tends to suffer various types of damage as they get older. The steel structures such as truss bridges, transmission line towers and other structures can be corroded significantly, because of the different aggressive environmental and weather circumstances and due to the inadequate maintenance. Recently several bridges in Hungary had to be repaired due to the damages caused by corrosion. In the case of the Margaret Bridge in Budapest, the inadequate maintenance caused serious corrosion; several members of the stiffener frame/bracing system corroded, as shown in Fig. 1(a). In the case of Liberty Bridge – another Danube bridge of Budapest – the corrosion caused big loss of cross-section, leading to failure of a compression member, as it is illustrated in Fig. 1(b). Note that the corroded member shown in the figure was made of wrought steel.

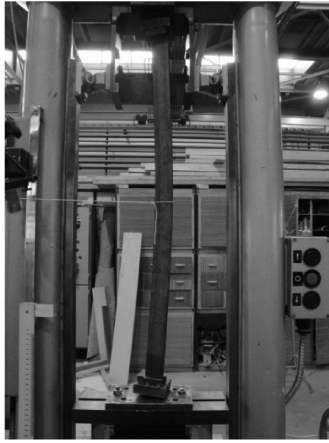
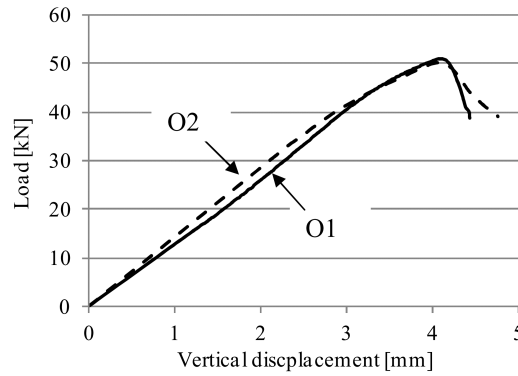
Fig. 2. Test setup and global failure mode; load – displacement curves

In the test set-up the support is hinge connection in the centre of gravity of the cross-section. Bearing ball is applied on the end-plate of the specimen in the test arrangement. The support is always applied in the centre of gravity of the original, non-corroded cross-section, with some random, unavoidable eccentricities. The differences between the original and corroded cross-section result in further eccentricity in the loading of the corroded members. Load cell is applied to measure the load and the horizontal and vertical displacements are measured by pulley systems with displacement transducers between the head of the

In the case of O1 and O2 members the observed failure mode is global flexural buckling about the weak axis. The yield mechanism is developed at the half-length of the member according to the expectation. In Fig. 2 the test setup and failure mode can be seen, together with the load – vertical displacement curves regarding to O1 and O2 non-corroded members. In case of O1 member the design buckling resistance is 40.18 kN and in case of O2 member it is 40.76 kN, according to Eurocode 3 design method.

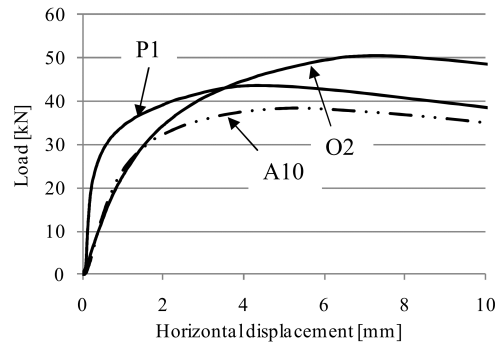
Fig. 3. Load – displacement curves of O2, P1 and A10 specimens

In the case of uniform corroded members the same failure mode, flexural buckling is observed, as in the case of non-corroded cases. As a typical example, the load – horizontal displacement curve of A10 specimen is shown in Fig. 3. The shape of the curve is similar to the original members having smaller ultimate load of the corroded specimen.

The pitting corrosion members had also global buckling mode. The effect of the whole-length uniform and the pitting corrosion on the behaviour is similar. The load – horizontal displacement curve of P1 specimen is illustrated in Fig. 3. Note that the initial stiffness is bigger in this specimen, what can be explained by the smaller, randomly resulted eccentricity.

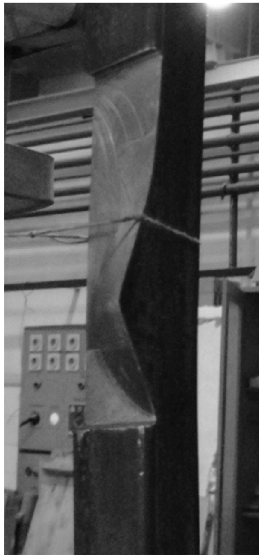
Fig. 4. Local failure mode; load – displacement curves

load-bearing capacity the post-buckling branch of the load-displacement curves shows increasing tendency after a sudden jump in the strength. Figure 4 shows the buckling shape of L1 specimen and the load – horizontal displacement curves of L1 – L3 specimens

Investigating the effect of corrosion positions of L1 – L3, the same buckling behaviour is observed. The character of the load – horizontal displacement curves is the same, as it is illustrated in Fig. 4; decreasing in degree of hardening is observed, when the position is come closer to the end of member. By investigat-

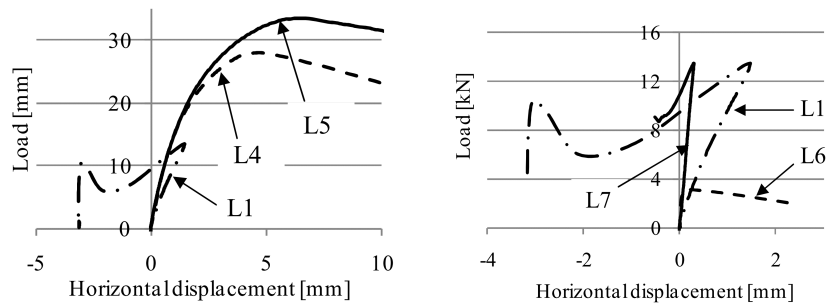
Fig. 5. Load – displacement curves of local corrosion specimens

ing the effect of extension of corroded surface (L1, L4, L5), the same initial behaviour are observed as it is shown on the load – horizontal displacement curves in Fig. 5. The ultimate failure mode is local buckling in L1 specimen and global buckling in L4 – L5 specimens.

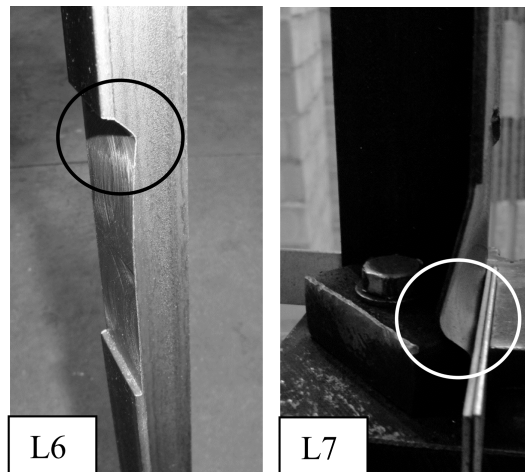
Fig. 6. Local buckling modes

Same failure mode and different initial behaviour are observed in the cases of specimens L1 and L6. L1 specimen shows initial global behaviour while L6 shows local phenomenon. Differences are observed in the buckling mode, the load level and the load – displacement curve. As it is expected the corroded specimen with higher initial imperfection (L6) significantly deteriorate the buckling behaviour. In specimen L7 the maximal cross-section reduction is lower than in L6, but approximately the same as in L4. The failure mode of L7 is the same local plate buckling as for L6, since one of the legs has about 80% thickness reduction. The similarity between L6 and L7 also can be observed by comparison the load – horizontal displacement curves and the buckling modes, as shown in Fig. 6.

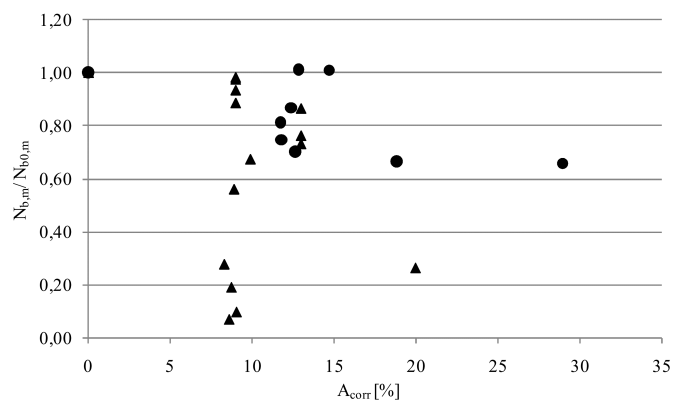
Fig. 7. Experimental results in the function of average cross-section reduction (• $f_y=335$ N/mm²; ▲ $f_y=357$ N/mm²)

The experimental results of the specimens in three groups are evaluated in this chapter jointly. Figure 7 presents the resistance results plotted in the function of volume reduction (A_{corr}). The mean resistance value is 28.5 kN and the standard deviation is 66% in members with 9% average cross-section reduction. In the case of specimens with ~ 13% A_{corr} the mean value of the resistances is 40.1 kN and the standard deviation is 13.3%. In the first case the locally corroded members cause the significant scatter, whereas the maximal cross-section decrease is high but the average cross-section decrease is much smaller compared to the uniform specimens. Disregarding locally corroded members the difference in resistance is smaller, but even the maximal decrease is 28% (A11) comparing to the original members. This observation shows that the estimation of the resistance by average cross-section might be uncertain and the A_{corr} parameter alone is not reliable to determine the resistance reduction.
