FOUNDATION STRENGTHENING AND GROUTING BY MEANS OF JET PILES FOR A 9+1-STOREY BUILDING WITH STRENGTHENED-CONCRETE FRAMING

Miklós MÜLLER

Department of Geotechnics Department
Budapest University of Technology and Economics (BME)
H-1521 Budapest, Hungary
Tel: +36 1 463-2117
e-mail: mmuller@epito.bme.hu

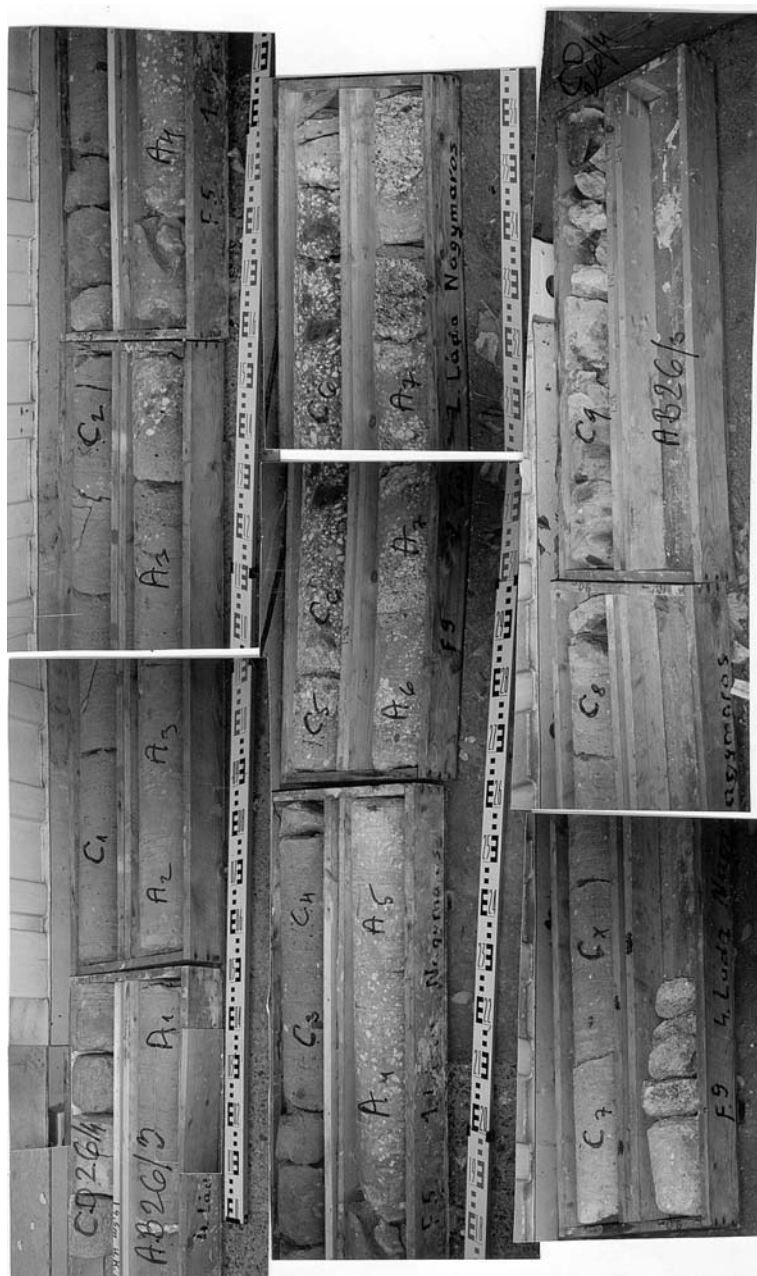
Fig. 7. The core specimens

For the proposal of designer Olajterv (Design Centre for Oil Industry) the investment company pointed out the jet piles marked 4 below the foundation body marked CD 26 and piles marked 3 below the unit marked AB 26 for checking the uniaxial compressive strength. Eurosound GmbH effected the core drilling sampling on behalf of Soletanche Hungaria. Their photos relating to that are to be seen in *Fig. 7*. We endeavoured to see out the specimens with $\sim 1 : 2$ diameter: height ratio from sound parts without inclusions.

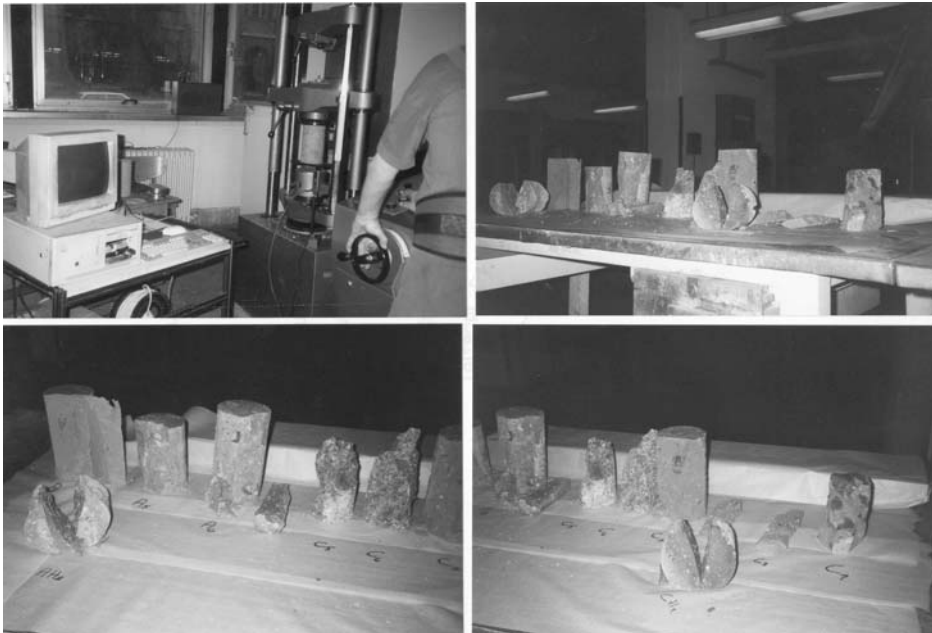
Fig. 8. The specimens after the breaking tests

We stored the core specimens prepared for compression in a moist surrounding saturated with humidity until beginning the execution of tests. We marked the specimens cut out of bore drilling 26AB/3 $A_1 - A_7$. The specimens cut out of bore drilling CD 25/4 were marked C1–C8 and one specimen not identified by depth was marked CX. The broken samples are to be seen in *Fig. 8*.
