# DETERIORATION OF REINFORCED CONCRETE REPAIR MORTAR LAYERS

Tamás KOVÁCS

Department of Construction Materials and Engineering Geology  
Budapest University of Technology and Economics  
H-1521 Budapest, Hungary

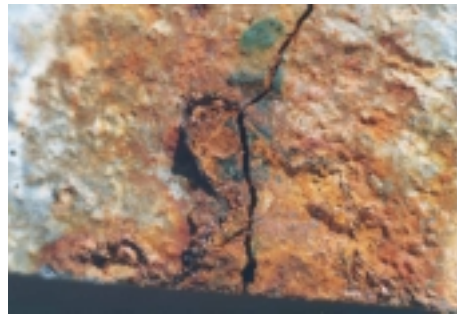
Fig. 4. The schematic drawing of the test set-up

We observed the following effect on the surface of the probes, before cutting them into slices. Except on probe IV, every prism has developed cracks, along the whole body of the probe. The cracks developed within the range of  $\pm 5$  mm over the reinforcement bars, and produced widths between 0.2 mm to 1 mm, in case of dispersion enhanced mortars, or, between 1 to 2 mm, in case of mortars not improved by dispersion (Fig. 4). Over the surface of these probes, iron stains appeared. Iron stains appeared also over the surface of steel fibre reinforced probes, which did not develop cracks, still, stains would appear around steel fibres near the surface, within circles of 1 to 2 mm diameter.

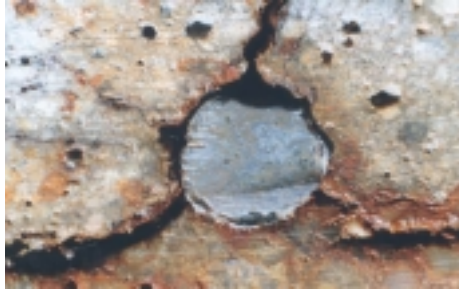
*Fig. 5.* The schematic drawing of the test set-up

Photos made of the sliced prism are on display in the Figs. 5 to 9. The rate

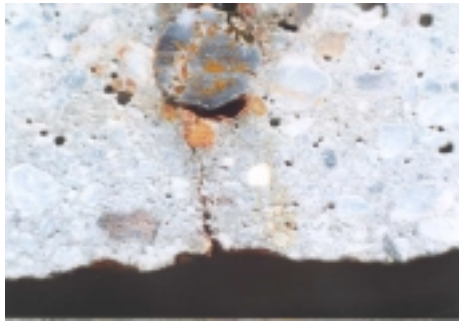
*Fig. 6.* The schematic drawing of the test set-up

The two probes not modified by dispersion but reinforced by steel fibre displayed cracks running to the surface, too. However, the widths did not exceed 1 mm, at maximum. In both cases, radial cracks in the concrete appeared, starting from the surface of the reinforcement. Cracks, which reached neither to the surface of the mortar nor on to the transition surface in the repair material or on the repaired concrete itself, were absorbed by the mortar (probe No. II, *Fig. 6*, probe No. III, *Fig. 7*).

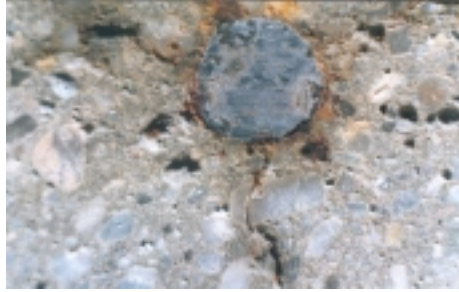
*Fig. 7.* The schematic drawing of the test set-up

of cracking development is highest on probe No. I which served for basis. This probe has developed three wide (1 mm to 2 mm) cracks. First, a crack running up to the surface appeared on the probe, then one of the other cracks developed and ran towards the adhesive layer, while the other intruded into the repaired concrete component (*Fig. 7*).

layer. In such an event, the repair layer will come debonded from the repaired concrete. This type of defect occurs, if no sufficient adhesion forces are effected by the adhesion layer or the repaired concrete did not have sufficient adhesion strength (in specifications maintained to be  $1.5 \text{ N/mm}^2$ , typically). In this event, because of the small  $\beta$  value, higher radial tensile strength values occur, which the weak transition layer cannot withstand. This type of defect was on display on probe No. I, the basic probe.

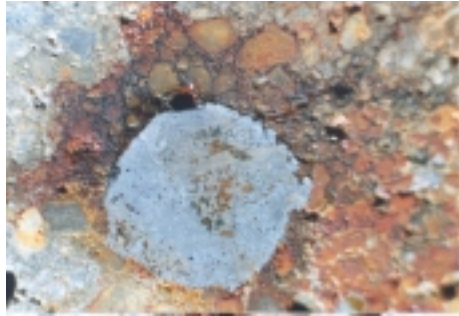
*Fig. 8.* The schematic drawing of the test set-up

From the group of probes modified by dispersion and reinforced by fibre repair mortar, only probe No. V, reinforced by plastic fibre developed cracks running out to the surface, the width of this was maximum 0,2 mm. In both cases, several radial cracks started, only to be absorbed in the repair mortar (probe IV, *Fig. 8*, and probe V in *Fig. 9*).

4. A rather favourable type of cracking would be, if the cracks do not appear on the surface of the repair mortar at all, they would be absorbed in the repair mortar. Such a situation could be produced by an optimum mixture of fibre reinforcement and dispersion. By adding dispersion, the tensile strength of the mortar increased substantially (compared to  $5.4 \text{ N/mm}^2$  in the original No. I probe, mortars modified by dispersion produced an average of  $9.5 \text{ N/mm}^2$ ), tenacity was increased by the fibres, further enhanced by the adhesion-increasing effect of dispersion. The fibres thus were able to accomplish a cracking limitation effect, they could absorb the growing cracks. This is the so-called trapping mechanism, which occurred in the probe IV and probe V.
