61 (4), pp. 794–802, 2017

RESEARCH ARTICLE

This paper summarizes the results of a R&D work in 2014. Five different types of andesite railway ballast material with different LA_{RB} (%) (Los Angeles abrasion) as well as $M_{DE}RB$ (%) (Micro-Deval abrasion) values were investigated in laboratory with pulsating test which models the real condition much better (the used parameters were determined accordance with international dynamic design method). Grain size distributions related to the five several aggregates were defined before and after pulsating tests. Particle breakages were then calculated by different method publicized in international literature. Relationships were searched between particle breakages due to laboratory test and LA_{RB} (%) as well as $M_{DE}RB$ (%) values of railway ballast samples. Time interval (cycle) of ballast cleaning work were attempted to compute with help of special parameters used by Hungarian and other railway companies underlined the limits of calculation method. Finally recommendations were formulated related to use of this new laboratory test method for estimation of ballast particle breakage.

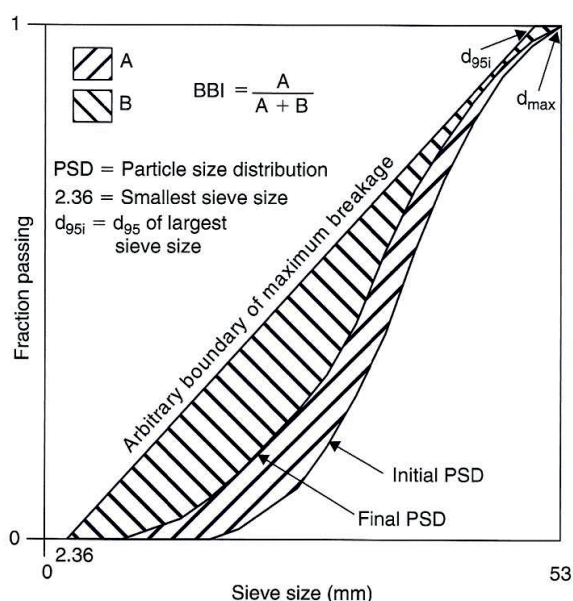
Fig. 1 Calculation of BBI [8]

Ballast Breakage Index (BBI) was introduced by Indraratna and Lackenby to numerize how the ballast material quality changes during deterioration [5]. This parameter is used in other relevant papers [6, 7, 8] The knowledge of the particle size distribution diagram before and after the examination is needed to calculate the index. The calculation relation is the following:

$$BBI = A / (A + B). \quad (1)$$

Understanding A and B values are helped by Figure 1.

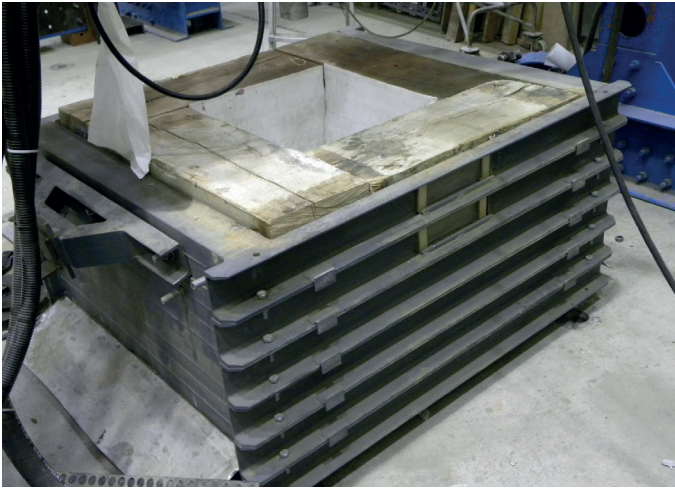
Fig. 3 Steel box and Viacon GEO PP TC 1200 geotextile laid onto 10-cm-sand layer, and the “box” built from wooden sleepers

The ballast samples were placed into a $46 \text{ cm} \times 46 \text{ cm}$ -basic-area, 30 cm-deep box formed in the middle of the shear box with exclusion made with railway wooden sleeper. In order to reduce wall effect and its possible exclusion the four inner walls (where the ballast particles contact the wood bottom) of the box were covered in one layer Viacon GEO PP TC 1200 type geotextile. A 460×420 mm-surfaced, thick steel loading plate was put on the ballast particles for a more even load spread. The structure is described in Figures 2–4 without the load plate.

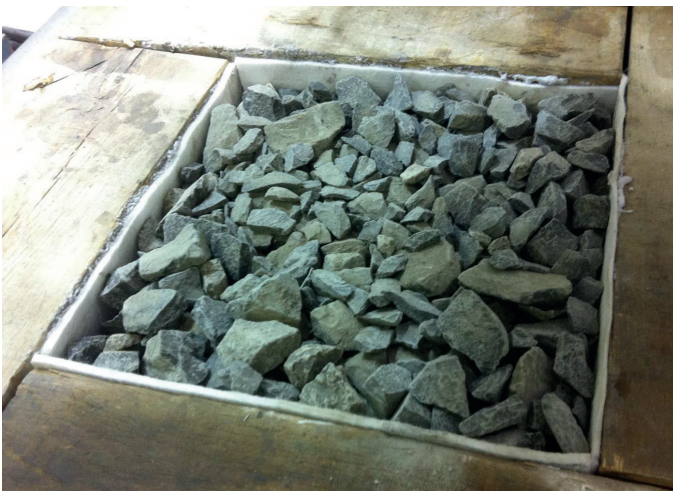
Fig. 4 Viacon GEO PP TC 1200 geotextile layers glued onto wooden sleepers, and either ballast sample in the “box”

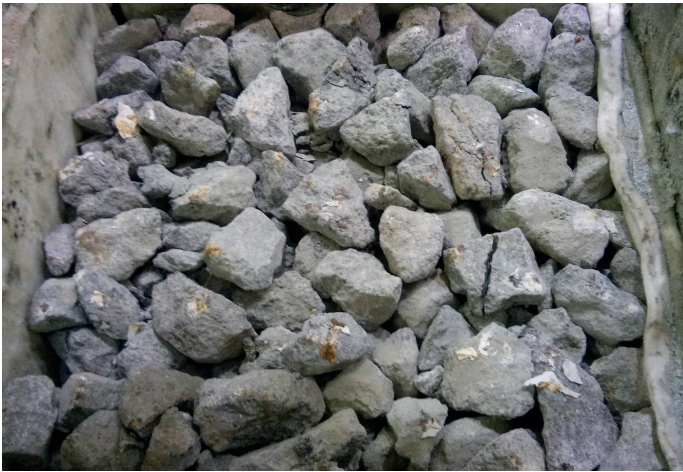
Fig. 7 Ballast sample 517 after pulsating test

Due to content limit only ballast sample 517 will be described after pulsating with the breakage particles as an example (Figure 7).
