# Material Characterization of Byzantine Period Brick Masonry Walls Revealed in Istanbul (Turkey)

RESEARCH ARTICLE

*In this study, the characteristics of mortars and bricks used in the walls of the historical building, which were revealed during the subway station construction excavations, probably belonged to religious place, have been investigated. Results of the analyses indicated that the mortars are hydraulic but they have a low compressive strength and a high porosity. The bricks whatever used as masonry unit or aggregate were produced from calcium rich clay at a firing temperature of 850–900°C, they are of low apparent density, high porosity and relatively high compressive strength, and also show pozzolanic activity.*

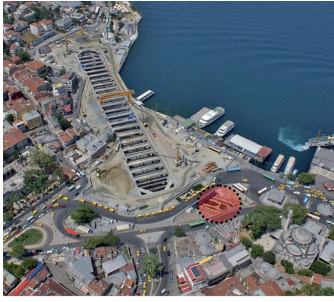
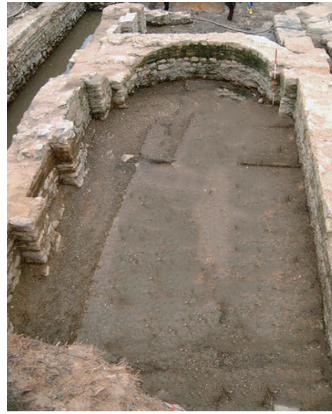
**Fig. 1** (Left) An air view of the apsidal building remains (the apsidal building is circled by black dotted line) and adjacent region [3]; (Right) Revealed foundation of the apsidal building

In this study, the characteristics of ancient mortars and bricks used in the walls of the building, which was revealed recently during the subway station construction excavations in Uskudar (county of Istanbul), very close to the Bosphorus, have been investigated. Unfortunately, the investigation had to be limited to foundation remains that have reached today (Fig. 1). Plan of the building, the used materials and observations on the construction system indicate that the building was constructed at the late Byzantine period and utilized as a religious place, probably a chapel [3].

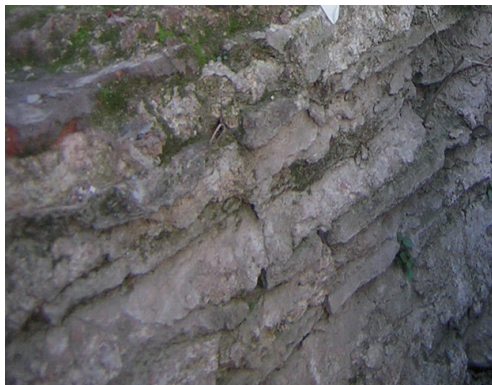
**Fig. 2** The brick-mortar walls of the building

The most significant indicators about dating of the building are the walls of the building and the arrangement of the bricks. The wall construction was based on hidden brick row behind extraordinary thick bedding mortar and this method is also called as “recessed brick technique” (Fig. 2). The most important examples of this construction method exist in Istanbul and this technique was used from the second half of the 11th century to the end of the 12th century [3]. In-situ measurements show that the thickness of the mortars vary between 45 and 55 mm whereas the dimensions of the bricks are approximately 250 × 250 × 25 mm.

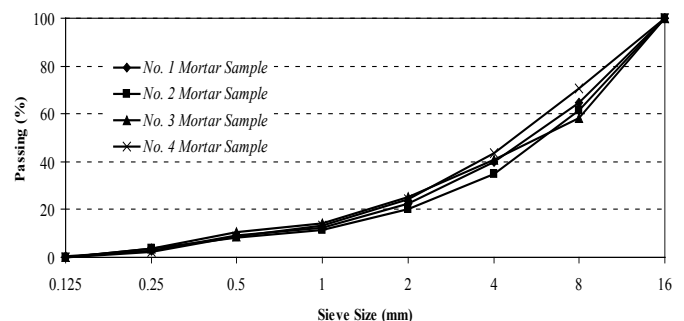
**Fig. 5** The aggregate size distribution of the mortars

The aggregates, which remained after acid loss analysis, were sieved in order to determine aggregate size distribution. The maximum aggregate size is 16 mm and the coarse aggregates with particle size greater than 4 mm constitutes the largest fraction of the entire aggregates (Fig. 5). It has been reported by the authors that the particle size distribution obtained after the acid loss analysis are mostly greater than the original one since the undissolved paste phase adheres to the aggregates and/or the aggregates adhere to each other [6].

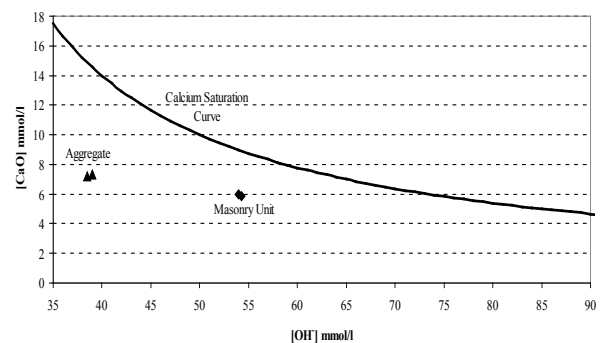
Fig. 11 The Frattini test results (Duplicate samples were prepared and the individual results are plotted)

The results of the Frattini test are presented as a graph of concentration of [CaO], in mmol/l, versus concentration of [OH<sup>-</sup>], in mmol/l, in Fig. 11. The points lying below the saturation curve indicate the removal of [Ca<sup>2+</sup>] from the solution which is attributed to pozzolanic activity and the points above the curve reveal no pozzolanic activity. The results shown in Fig. 11 indicate that all bricks, used as either the masonry unit or the aggregate in the mortar, show pozzolanic activity. This

conclusion also supports the hydraulic characteristic of the mortars indicated by XRD and TGA results.

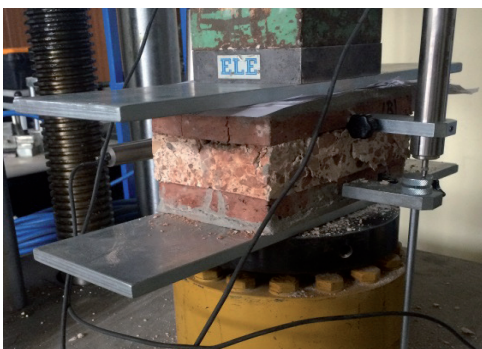
Fig. 12 A brick-mortar-brick composite and set-up for the compression test

The compression test was conducted on three brick-mortar-brick composites and the dimensions (width x length x height) of the prepared specimens were (78–100) x (100–182) x (80–88) mm. Upper and lower surfaces of the brick-mortar-brick samples were fixed with capping mortar and then, the prepared specimens were tested under uniaxial compressive loading in order to determine the mechanical properties. The displacements of composites were measured using linear variable displacement transducers (LVDT), as follows: two vertical LVDTs (one per each side) were used to measure axial deformations and one horizontal LVDT was placed on the mortar in order to record lateral deformations as shown in Fig. 12. The compression test was performed with a displacement controlled universal testing machine with a loading rate of 1 mm/min and each composite specimen was loaded until the failure occurred.
