Existing steel Structures and Bridges, refurbishment, sustainable development, in situ tests, strengthening, eccentricities, aqueduct, cracks, remaining fatigue life

1 Introduction: Refurbishment of existing steel structures as an integral part of sustainable development

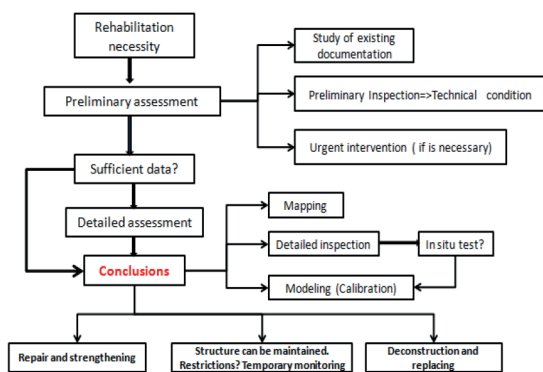
Fig. 1 Flowchart regarding the refurbishment of existing steel structures

The estimation of the carrying capacity of existing structures is a complex matter. One of the most important aspects is the experience of the expert. In a first step the expert have to inspect carefully the structure and to make an estimation, based on simplified analysis methods and a preliminary evaluation about the technical condition of the structure. During the visual inspection the corrosion state, must be also evaluated. Figure 1 presents the main steps in the evaluation of the existing structures.

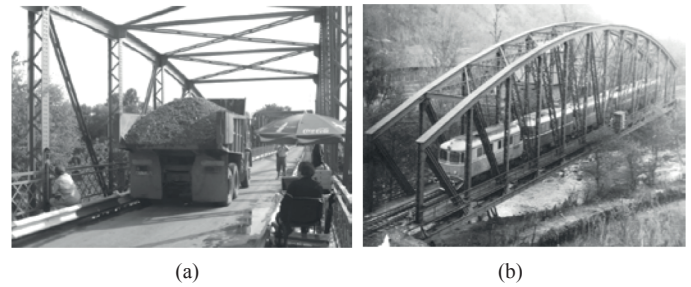
Fig. 5 In situ tests on bridges: (a)-highway bridge; (b)-railway bridge

In situ tests of the structure are very relevant, especially for important structures and complicated statically schemes, but there are expensive and time consuming. In situ tests measuring stresses and deformations [10], are used often for existing steel bridges (Fig. 5).

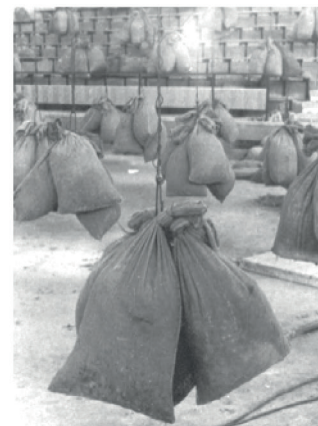
Fig. 6 In situ test of Sports Hall double layer with $L = 60$ m and $B = 50$ m.

Important data about the technical condition of the structure can be obtained and the calculus model can be calibrated (validated). The existence of a Romanian Standard – in this direction – can be mentioned [11]. In situ tests can remove the doubts about the safety of the structure. In Fig. 6, a Sports – Hall with 2000 places is presented; the owner asked for a test; in every joint of the roof lower chord, four bags with sand were hanged, realizing 1,2 of the design load. Stresses with strain gauges and deformations were measured. The general behaviour of the structure was satisfactory.

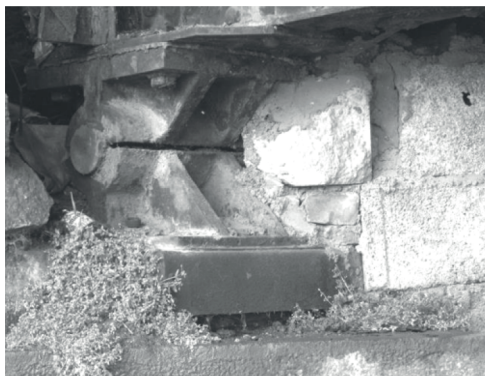
Fig. 7 Non-functional bridge bearing

- Stresses and deformations in joints (secondary stresses due to the rigidity of joints);
- Restraint due to non-functional or corroded bearings (Fig 7);

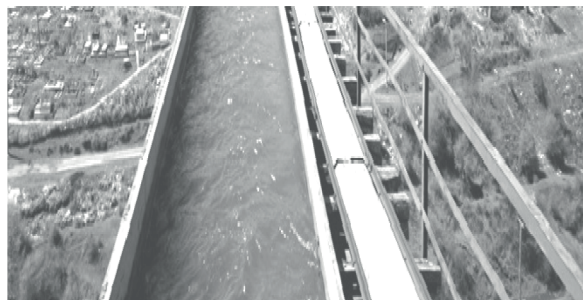
Fig. 12 Aqueduct Reșița, after refurbishment

Additionally, the longitudinal slope and the deflection of the structure which remained in acceptable limits ($L/400$) were checked. In conclusion, the structure can be maintained in utilization without special measures. It is technical monument still in use (Fig. 12).

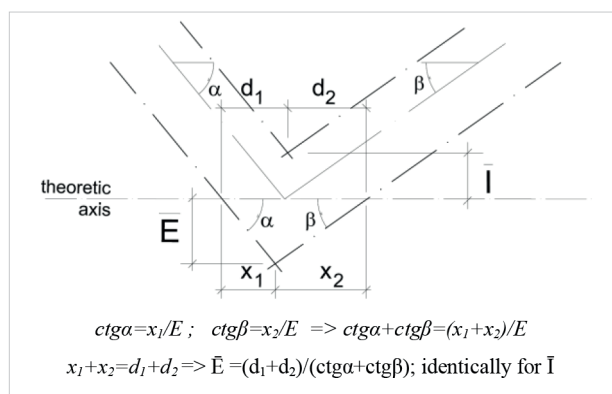
Fig. 15 Eccentricities d_1 , d_2 and transformation in \bar{I} and \bar{E}

In order to systematize the calculus, the eccentricities d_1 and d_2 (figure 14) are transformed in the values \bar{I} and \bar{E} (figure 15).

With the transformed eccentricities \bar{I} and \bar{E} , the bending moments $M_{\bar{I}}$ and $M_{\bar{E}}$ can be determined (figure 15).

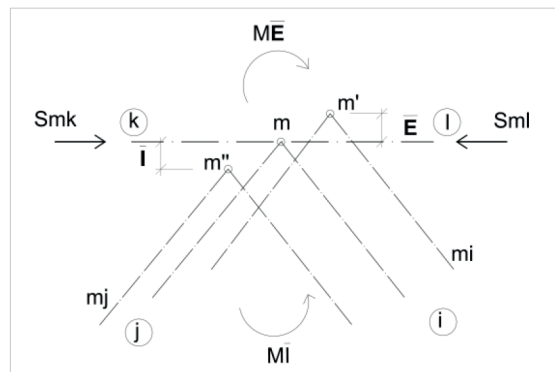
Fig. 16 Bending moments produced by the eccentricities \bar{I} and \bar{E}

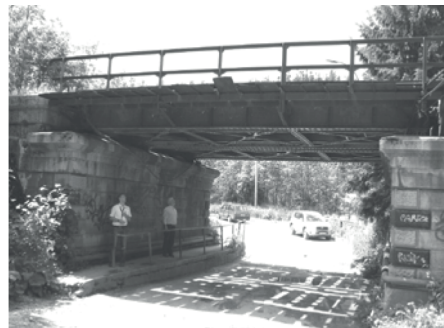
Fig. 20 Railway underpass; span L = 8,60 m.

Existing railway bridge. The third example refers to a railway bridge situated on the main railway line from Bucharest to Braşov (figure 20). The underpass is situated in the centre of the Sinaia town, a well-known touristic zone. The structure is relatively new and was built in 1940, during the doubling of the line [18].

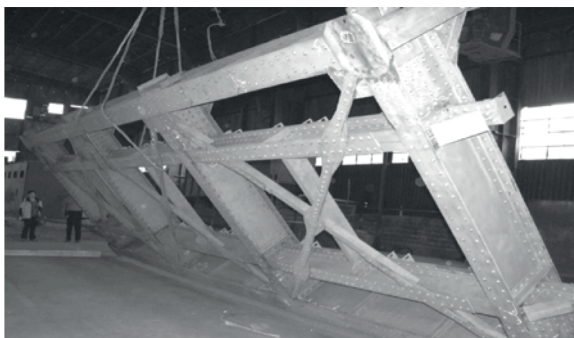
Fig. 23 The structure analyzed in the plant

The structure was transported in the steel plant and carefully analysed (Fig. 23); cracks and defects were detected confirming the above fatigue calculations (Fig. 24 and 25). The bridge is not too old (approximately 70 years), but due to the lack of maintenance and some defects, the safety of the bridge is not assured.
