# Structural analysis of the baroque parish church of Zsámbék

Miklós Armuth / Dezső Hegyi / András Árpád Sipos

## Abstract

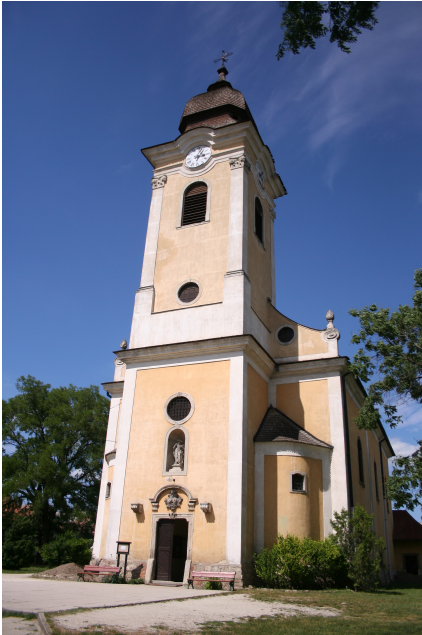
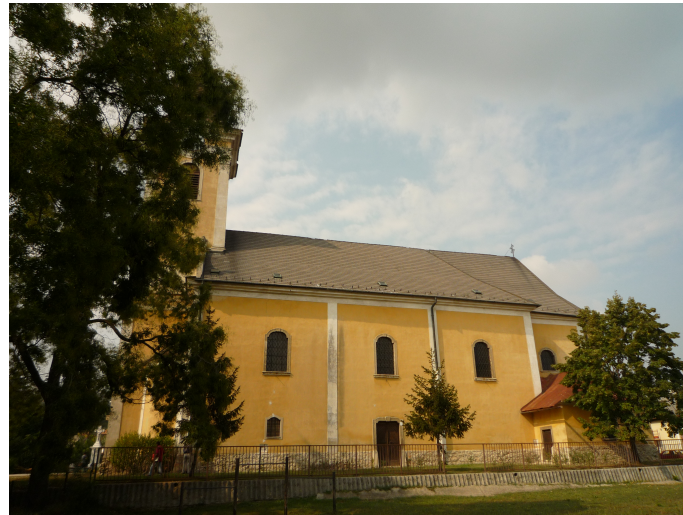
**Fig. 4.** Views of the main entrance and the South-East side of the building

The main failures of the structural walls are vertical cracks, typically located around and above the windows (Fig. ??). The largest cracks appear in both longitudinal walls at the windows closest to the tower. The width of these cracks is between 0.4 and 0.7 mm. There are more cracks on the NW wall facing to the main road of the village; several cracks can also be found around the vestry.

The vaults above the nave have longitudinal cracks of 1.0-3.0 mm width. These cracks also appear on the arches supporting the vaults.
